## 3. COA-072961-2020

1830 West Grace Street

Commission of Architectural Review

STAFF REPORT

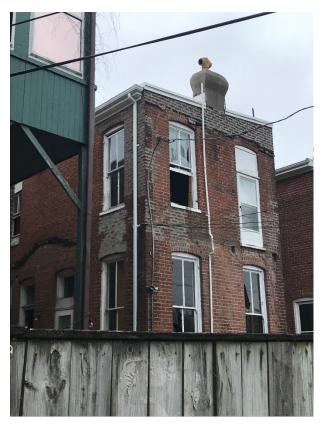
Figure 2. Historic 2/2 windows on side and rear.

- Many of the window and door openings were modified by a previous owner prior to the establishment of the district in 1996. A majority of the existing windows are wood 6/6 windows that do not fit the original opening. Some of the historic 2/2 windows remain on the sides and rear of the home.

- Windows 105,106, 107, 207, and 208 be retained and restored
- The dimensions of the masonry openings for the visible windows be submitted to staff prior to the issuance of a building permit.
- The new windows be wood or aluminum clad wood.
- The new door and transom fit the existing masonry opening without requiring additional trim, and dimensions of the existing brick opening and the proposed door color be submitted for administrative

Windows, #1, pg. 69	Retain all original windows, and ensure that hardware is in good shape, reusing serviceable window hardware and locks.	The applicant proposes to replace all of the windows in the home, both the replacement windows and the existing historic windows. Staff finds that though a majority of the windows are ill-fitting replacement windows, there are five historic 2/2 wood windows on the rear and visible side elevation of the home. Staff finds that these windows do not appear to be beyond the point of feasible repair and recommends that windows 105,106, 107, 207, and 208 be retained and restored as they are the only historic windows that remain in the building.
Windows, #12, pg. 69	Thermal efficiency can be enhanced through the use of weather stripping, storm windows, caulking, interior shades, shutters, blinds and awnings, if appropriate.	The applicant has indicated to staff that they would like to replace the rear windows because they are single pane. It has been shown that storm windows can increase the thermal efficiency of single-pane wood windows to match that of insulated glass. Staff recommends the applicant consider installing interior or exterior storm windows, which can be administratively approved.
