APPLICATION / CERTIFICATE OF APPROPRIATENESS

Project Description: Application for Revised Certificate of Appropriateness and Partial Demolition:

Additions and Rehabilitation at
125 N 25th Street
 St John's National Historic District
 Richmond, VA 23223

Application for Certificate of Appropriateness
COMMISSION OF ARCHITECTURAL REVIEW
 submitted Jan 27, 2017
 [revised from previous approved application]

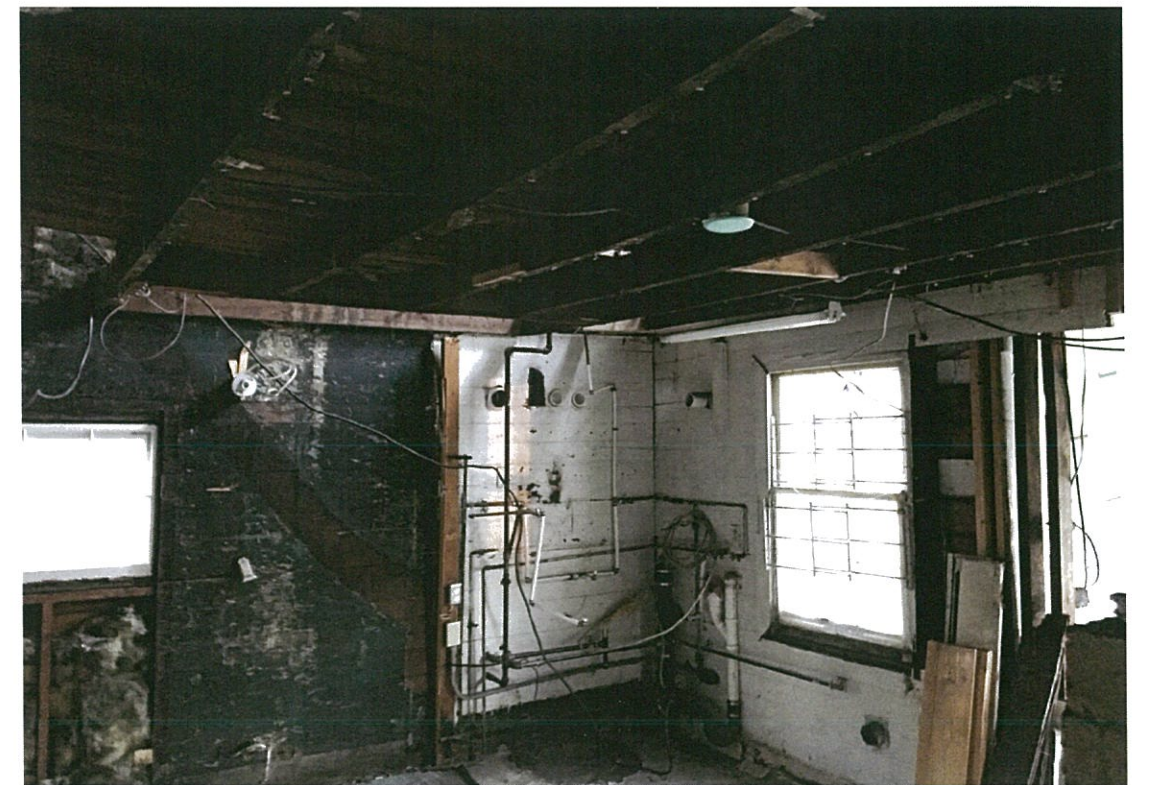
Existing Rear Section, Photograph 2 - 1st level south section

This view of the 1st level southeast corner shows localized repair of stud framing, joists and decking. While these repairs are presumed to have removed rotted and damaged material, the extent of additional damage adjacent to repairs, and in particular at the sill plates, even at this repaired area, made additional repairs to existing damaged structure infeasible and impractical.
