PK and Rec Inventory 2016-2017

# Property Condition Assessment

**3000 E. Belt Blvd  
Richmond, VA 23224**

**Inspection Date: 01/12/2018**

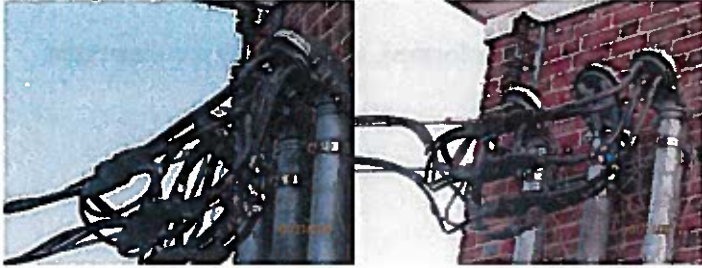
The building is equipped with (3) 600 amp, 120/240-volt, single-phase service.

This capacity was determined by the service entrance wiring, on the side of the building.

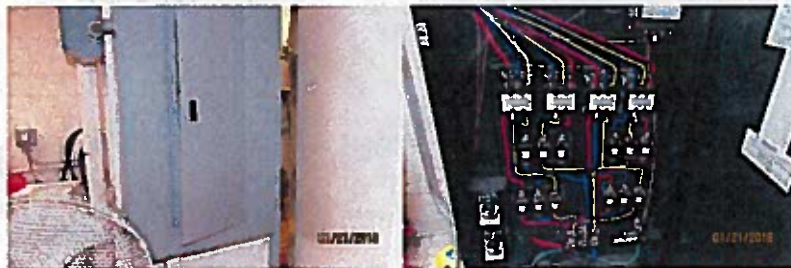
4.2.5 The general condition is considered to be good; the following improvements are recommended as follows:

- Service all interior panel
- Repair door on electrical panel

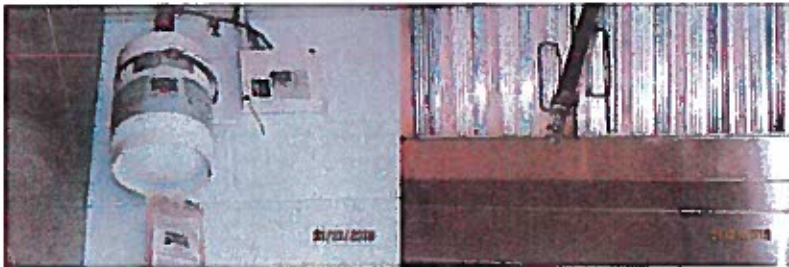
**Unit of electric oven needs to be service, cleaned and inspected**

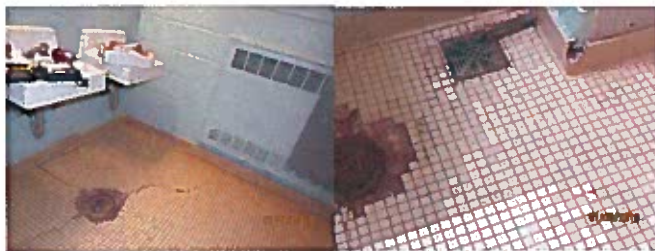
- 3.2.3 Interior flooring in both bathrooms needs to be replaced due to multiple cracks in ceramic floor tiles

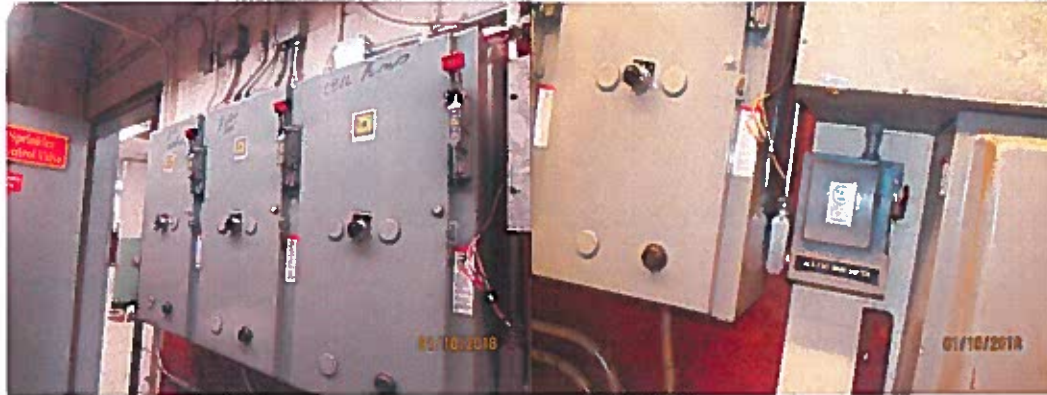
The building is equipped with a 400 amp, 120/240-volt, single-phase service.

This capacity was determined by the rating of the main disconnect switch.

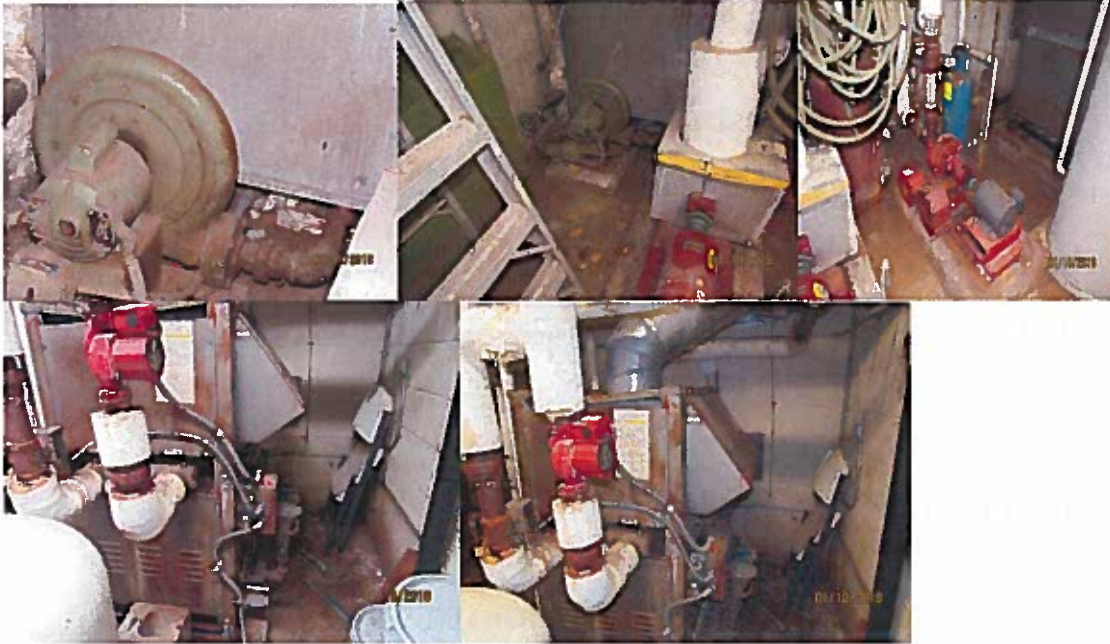
The interior is heated by a 4 zoned gas operated 800,000 btu boiler w/ several radiator, which needs to be serviced

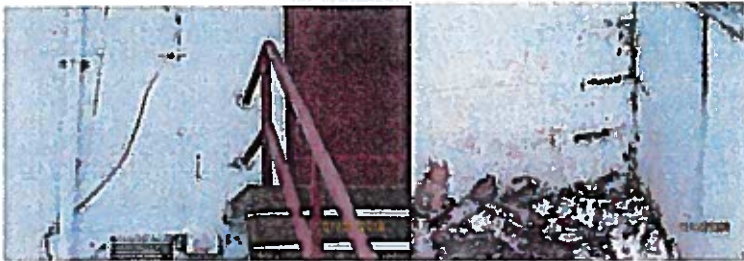
3.2.2 Minor to questionable foundation cracks observed during exterior inspection, which needs to be addressed

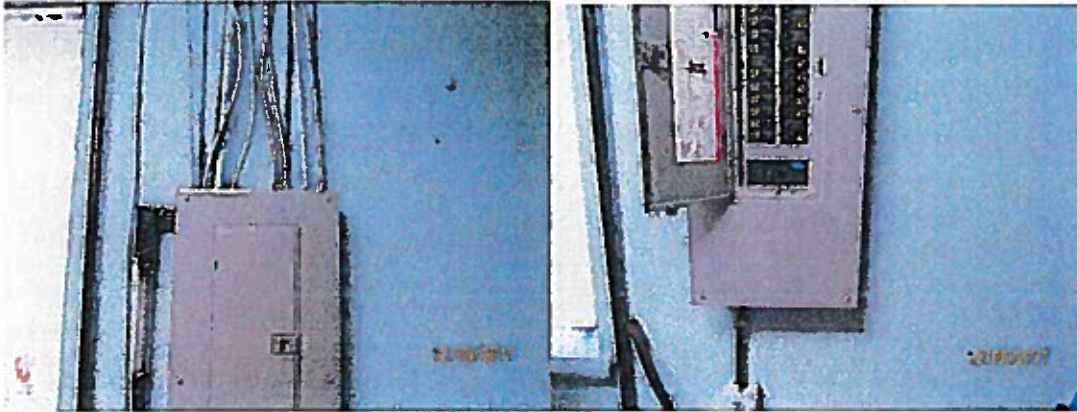
The building is equipped with a 200 amp, 120/240-volt, single-phase service.

This capacity was determined by the rating of the main disconnect switch.

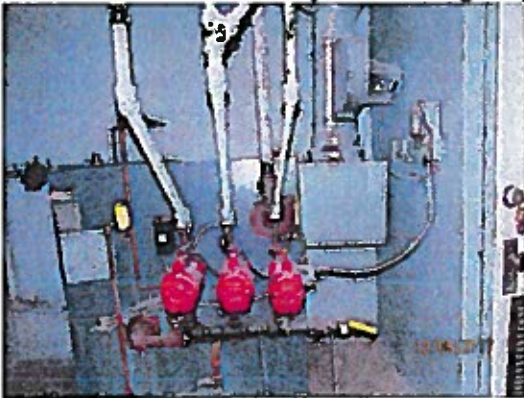
The main floor is heated by a gas-fired, mid-efficiency furnaces with a total output of 300,000 BTUs per hour (total).

The basement is heated by a 3 zoned gas operated 500,000 btu boiler w/ several radiator

Recommendations	COSTS	PRIORITIES (Time Frame)
Replace gas boiler	\$20,000.00	W/I 5+ years
Replace 5 mini split units	\$2000.00 ea.	Immediate

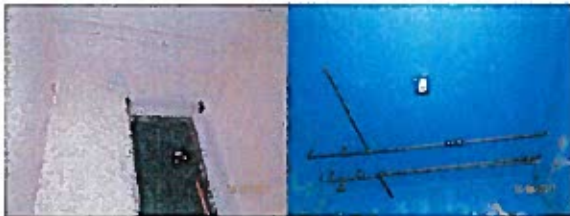
3.2.5 Cracking [minor] was noted throughout the concrete floor of the basement. The cracking noted is consistent with shrinkage of the concrete

<b>Recommendations</b>	<b>COSTS</b>	<b>PRIORITIES (Time Frame)</b>
Paint interior basement walls	\$1000.00	Immediate

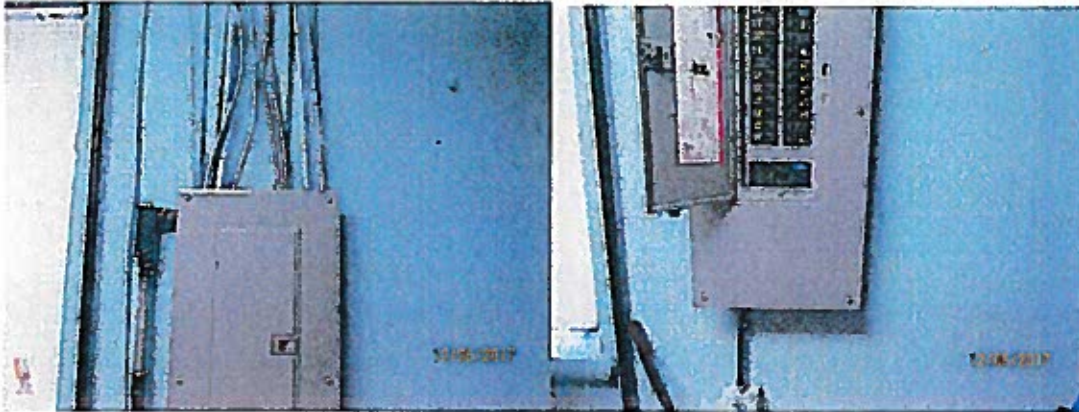
The building is equipped with a 200 amp, 120/240-volt, single-phase service.

This capacity was determined by the rating of the main disconnect switch.

- Replace interior ceiling light fixtures in basement w/ LED fixtures & bulbs

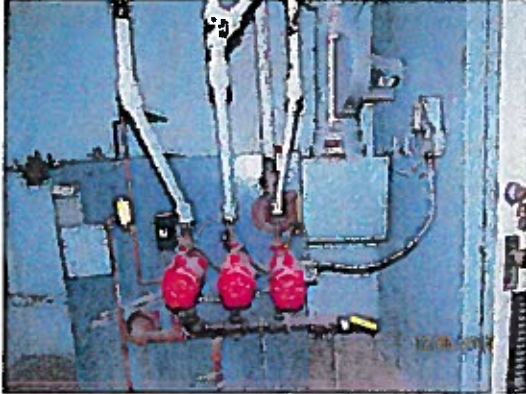
The main floor is heated by a gas-fired, mid-efficiency furnaces with a total output of 300,000 BTUs per hour (total).

The basement is heated by a 3 zoned gas operated 500,000 btu boiler w/ several radiator

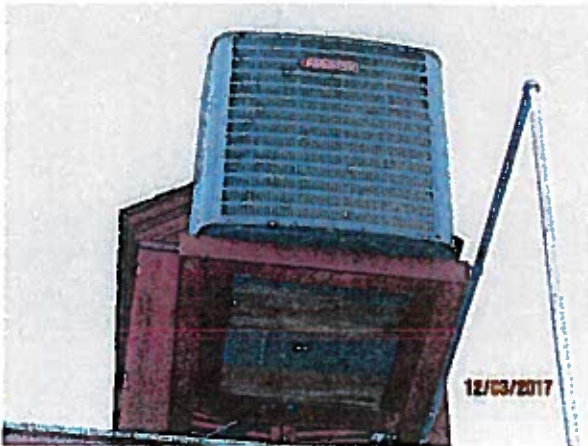
The main section of the building is air-conditioned by a 5 ton condenser unit.

The refrigerant used in the air conditioning systems was identified as R-22.

6.2.3 Replace missing covers on basement split units and replace missing condensate pump

6.2.94 The refrigerant lines are missing insulation. This should be improved.

Recommendations	Costs	PRIORITIES (Time Frame)
Replace older AC units	\$6500.00	24 Months

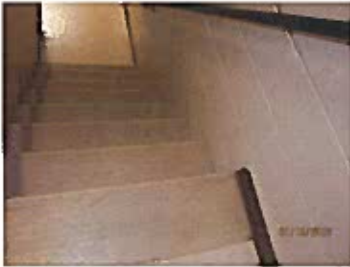
3.2.2 Interior flooring on main level needs to be cleaned in hallway area

Recommendations	COSTS	PRIORITIES (Time Frame)
Paint interior walls, throughout center	\$6000.00	Routine
Clean flooring in hallway throughout center	\$8000.00	Immediate

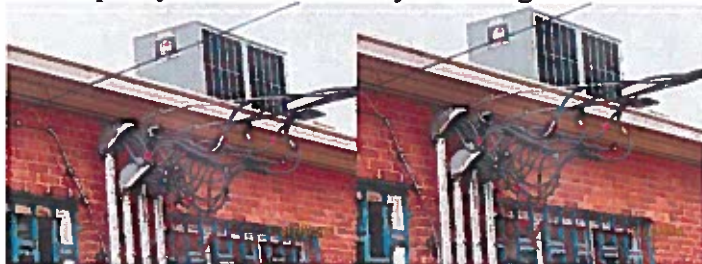
The building is equipped with a (4) 600 amp, 120/240-volt, single-phase service.

This capacity was determined by the rating of the main disconnect switch.

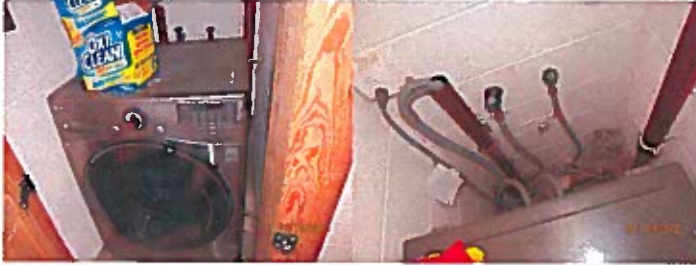
The main shutoff valve is located in front of the building in the front yard.

There is a single water meter for the building.

<b>Recommendations</b>	<b>COSTS</b>	<b>PRIORITIES (Time Frame)</b>
Service all drain lines under sink	\$350.00	3 mos.

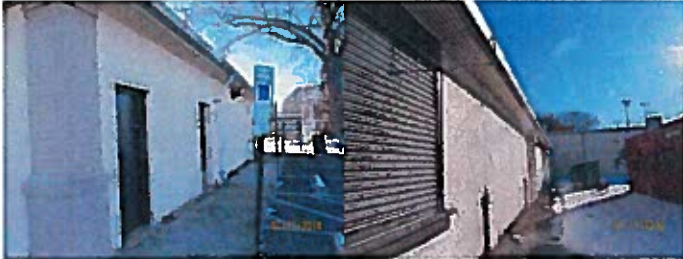
3.2.1 No major structural defects were noted.

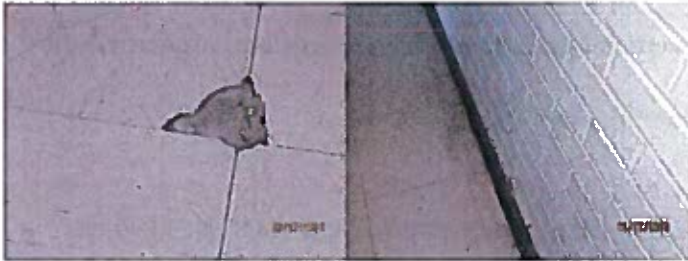
3.2.2 Interior flooring on main level needs to be replaced in hallway area

Recommendations	COSTS	PRIORITIES (Time Frame)
Paint interior walls, throughout center	\$6000.00	Routine
Replace or repair hallway flooring	\$2000.00	Immediate

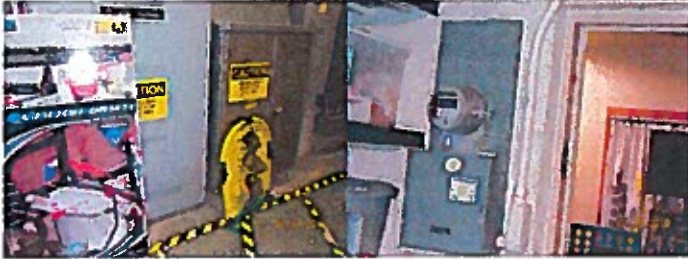
The building is equipped with a (2) 600 amp, 120/240-volt, single-phase service.

4.2.1 While detailed load calculations were not performed, no problems are suspected with the service capacity.

- Service all electrical panels throughout center
- Replace interior ceiling heater fixtures in ladies bathroom

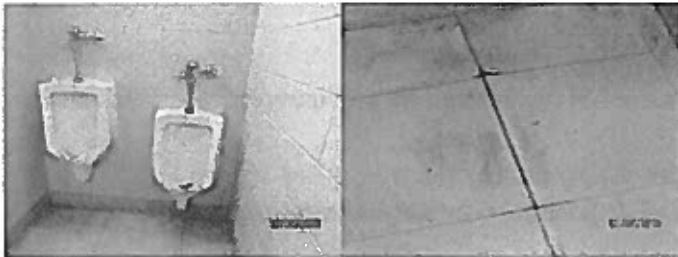
3.2.3 Interior flooring on men restroom needs to be repair or replaced due to warped tiles

<b>Recommendations</b>	<b>COSTS</b>	<b>PRIORITIES (Time Frame)</b>
Paint interior walls, throughout center	\$6000.00	Routine
Repair buckling floor and loose tiles in men's restroom area	\$3,000.00	Immediate

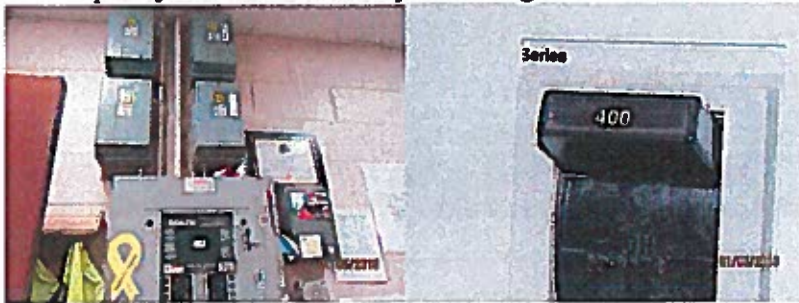
The building is equipped with a 400 amp, 120/240-volt, single-phase service.

4.2.1 While detailed load calculations were not performed, no problems are suspected with the service capacity.

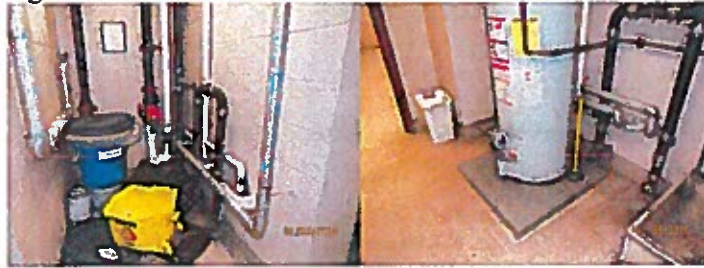
**8.1.2** Repair or replace toilet tank insert in female bathroom (water continuously runs in tank)

**8.1.3** Replace missing knob on hose bib

<b>Recommendations</b>	<b>COSTS</b>	<b>PRIORITIES (Time Frame)</b>
Service all interior drain line throughout center	\$350.00	Immediate

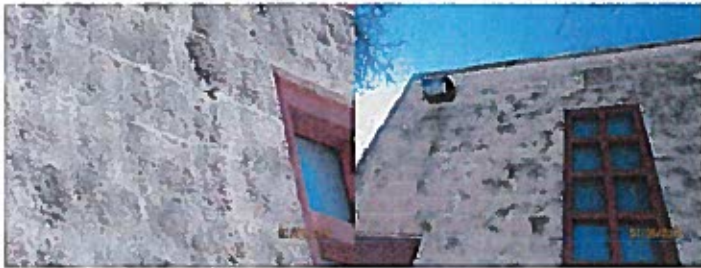
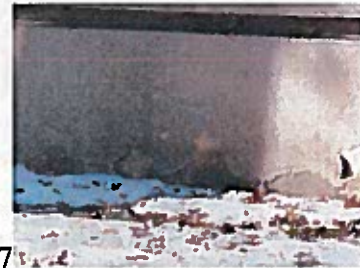
Repair damage (EIFS) **Exterior Insulation and Finish Systems** on the retaining wall

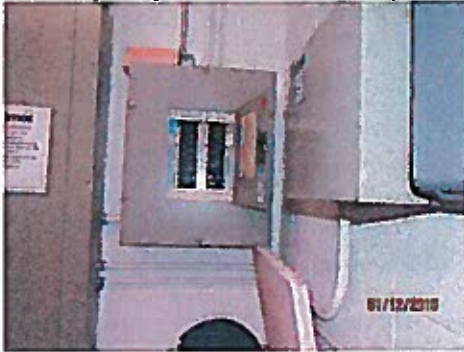
The building is equipped with a 600 amp, 120/240-volt, single-phase service.

This capacity was determined by the rating of the main disconnect switch.

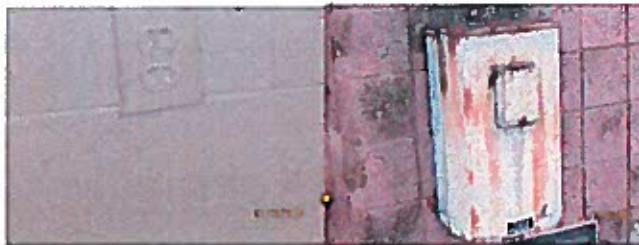
4.2.6 No major deficiencies were noted.

4.2.7 The general condition is considered to be good; however, improvements are recommended as follows:

- Replace painted wall outlets
- Paint exterior control box

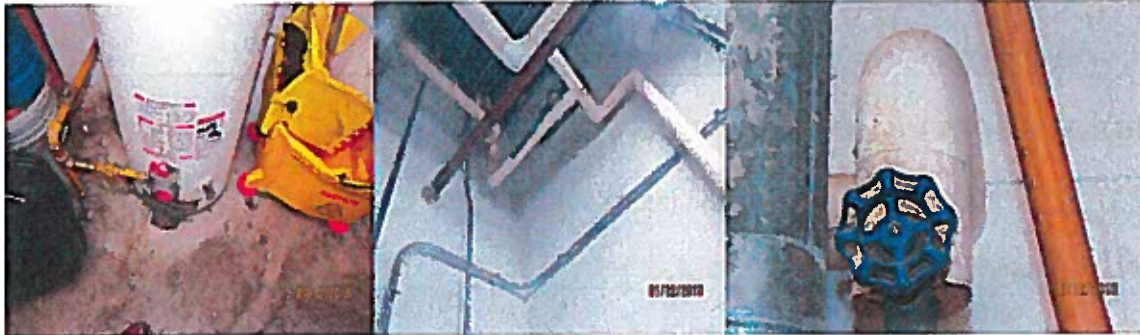
There is a 1 1/2 inch-diameter, copper, domestic water supply line to the building.  
(1) 50 gallons gas hot water heater.

<b>Recommendations</b>	<b>COSTS</b>	<b>PRIORITIES (Time Frame)</b>
Service all interior drain lines	\$250.00	Quarterly PM

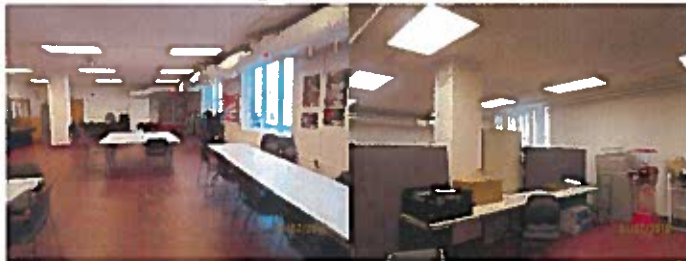
- 3.2.3 Interior flooring on main level looks in satisfactory condition (no issues at present time)

<b>Recommendations</b>	<b>COSTS</b>	<b>PRIORITIES (Time Frame)</b>
Paint interior walls, throughout center	\$6000.00	Routine

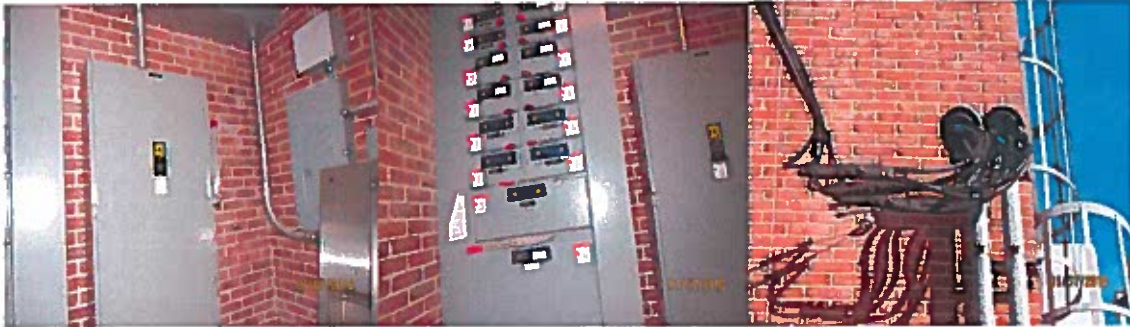
The building is equipped with a 600 amp, 120/240-volt, single-phase service.

This capacity was determined by the rating of the main disconnect switch.

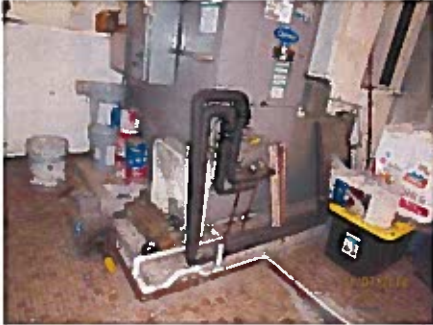
The main floor is heated by a gas-fired, mid-efficiency furnaces with a total output of 300,000 BTUs per hour (total).

The community center is heated by a in-line gas heat unit w/ interior vent ducts

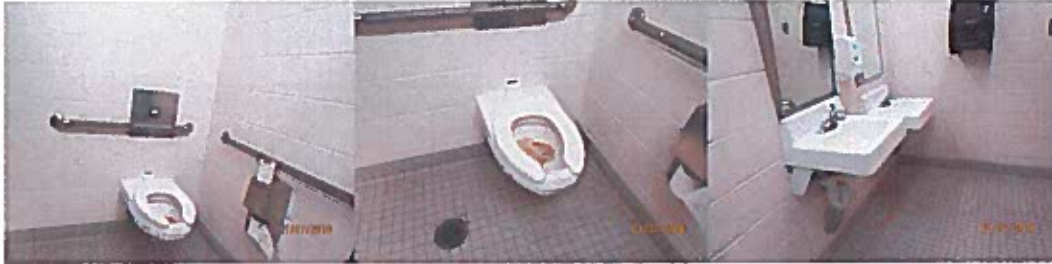
There is a 1 1/2 inch-diameter, copper, domestic water supply line to the building.

<b>Recommendations</b>	<b>COSTS</b>	<b>PRIORITIES (Time Frame)</b>
Service all interior drain lines	\$500.00	Monthly PM

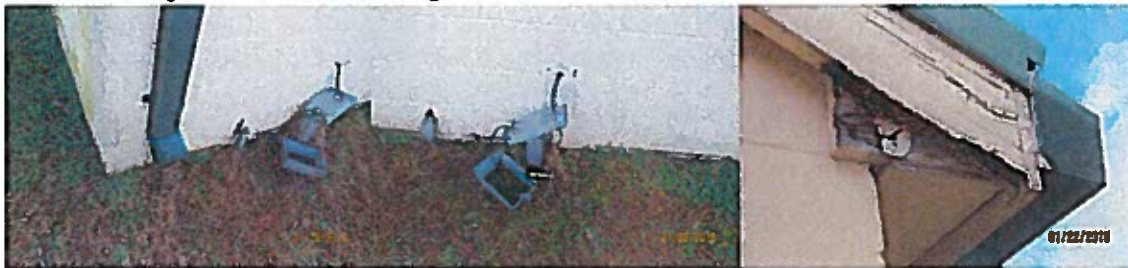
3.2.1 No major structural defects were noted.

3.2.2 Power wash and clean exterior wall surface

3.2.3 Clean up exterior surroundings

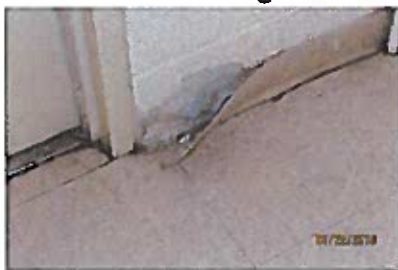
3.2.3 Interior flooring needs to be cleaned and strip/wax

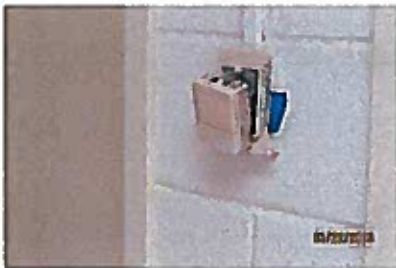
4.2.7 The general condition is considered to be good; however, improvements are recommended as follows:

- Replace or remount thermostat on interior wall

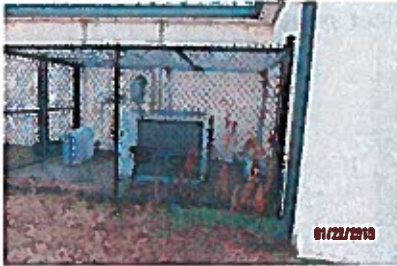
The main floor is heated by a gas-fired furnace that's roughly 1+ years old w/ interior aluminum vent ducting

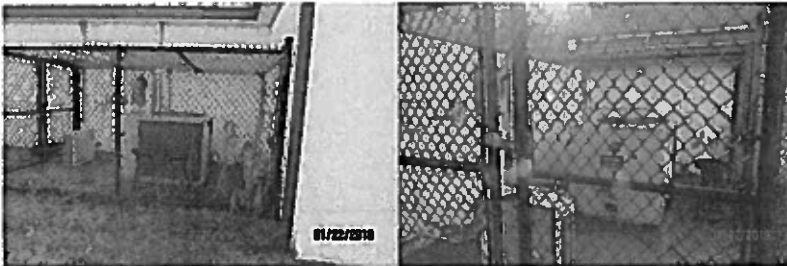
6.2.94 The refrigerant lines are missing insulation. This should be improved.

6.2.5 The air distribution is considered to be satisfactory.

Recommendations	Costs	PRIORITIES (Time Frame)
Service heating and cooling units as needed	\$500.00	Monthly/Annually

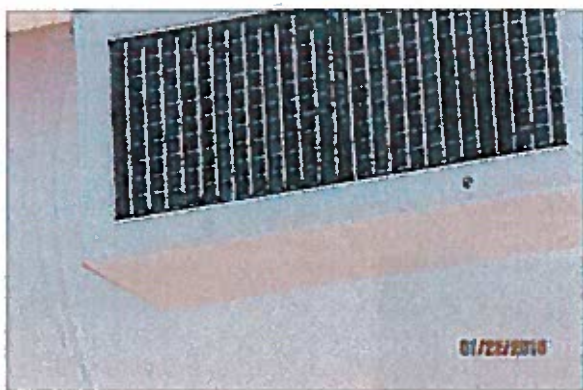
7.2.2 There is 2 ceiling exhaust fans in the wash rooms.

7.2.3 There is (1) complete vent system throughout the center.

<b>Recommendations</b>	<b>Costs</b>	<b>PRIORITIES (Time Frame)</b>
Clean out entire exhaust/ vent system as needed	\$2500.00	6 mos.

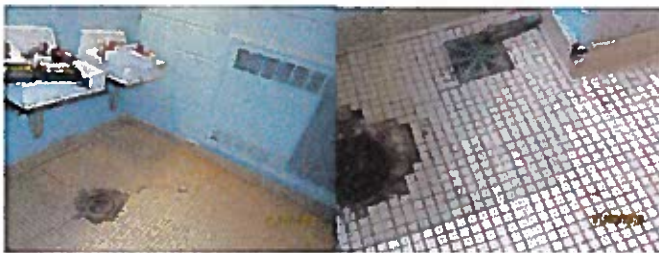
3.2.3 Interior flooring in both bathrooms needs to be replaced due to multiple cracks in ceramic floor tiles

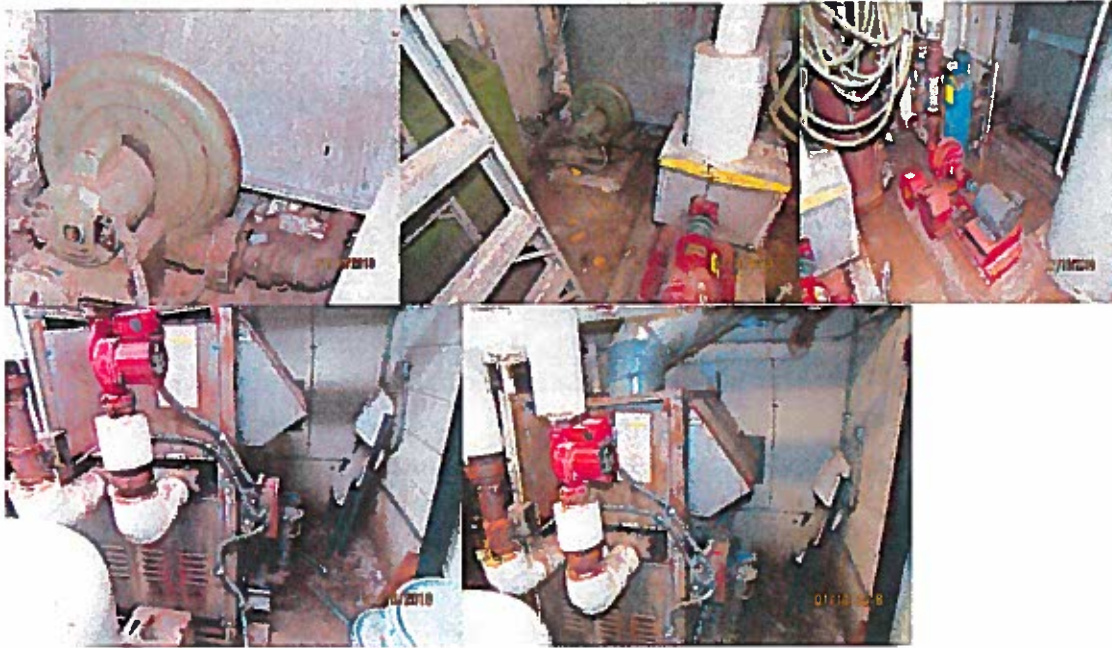
The interior is heated by a 4 zoned gas operated 800,000 btu boiler w/ several radiator, which needs to be serviced
