# Commission of Architectural Review SUBMISSION APPLICATION

LOCATION OF WORK: 600 W 19th St DATE: 08/28/2015

Exterior of house had years of deferred maintenance causing the deterioration of windows, siding, fencing and brick work. Additions to garage have completely rotted and need to be removed. Our intention is to rehabilitate the structure with products that will provide the look and feel of the original. These products will be more energy efficient to help keep costs down for all future inhabitants.

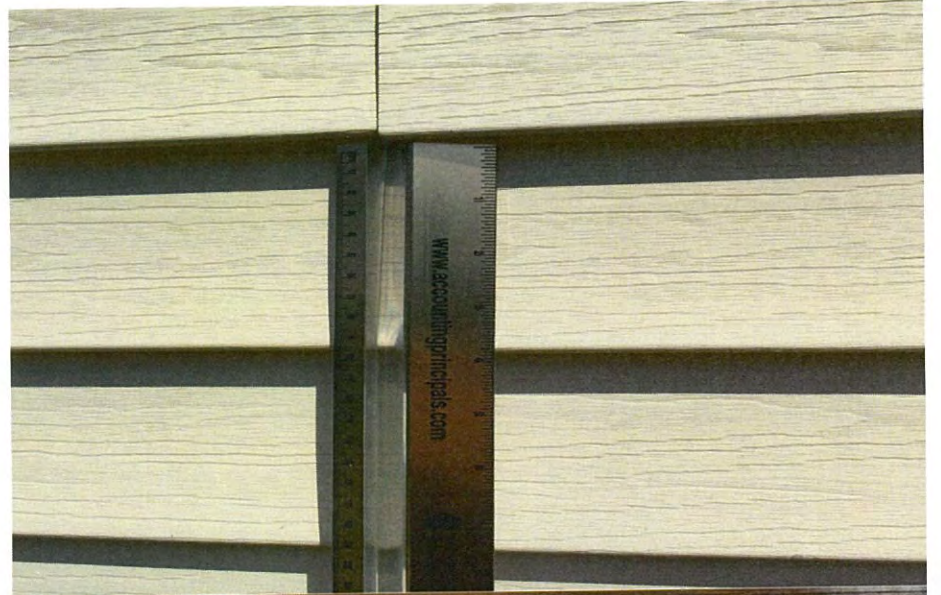
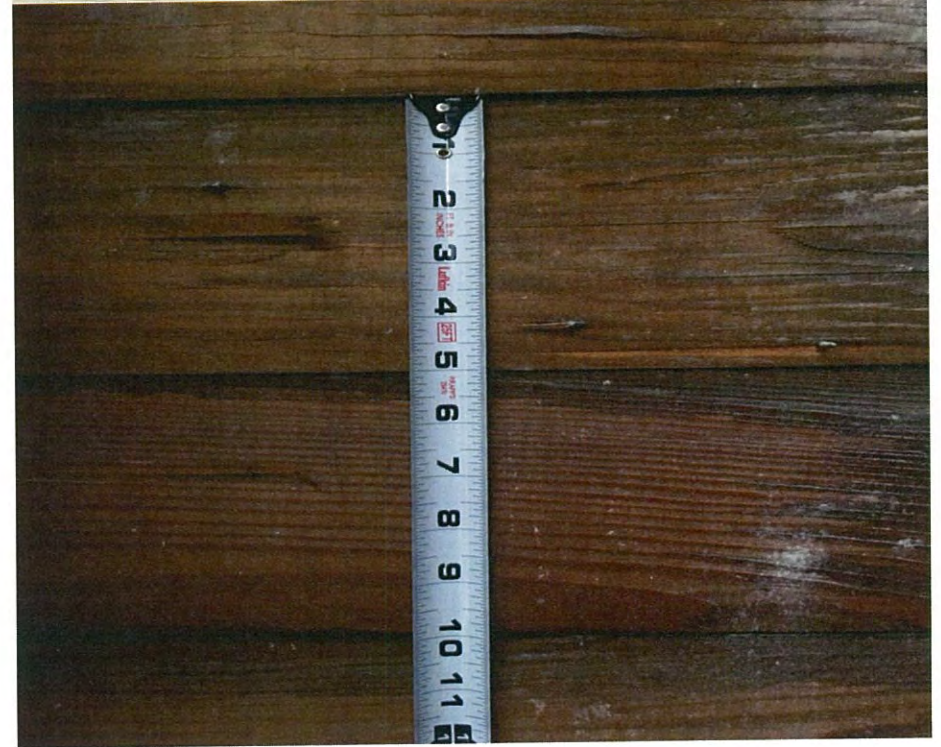
1. VINYL SIDING

Siding is faded, brittle and sagging. Original application was of poor quality lacking attention to detail. Missing pieces of existing siding would be difficult to replace because of age.

**Original wood siding covered with asphalt shingled then covered with vinyl. Vinyl is brittle and can't be replaced.**

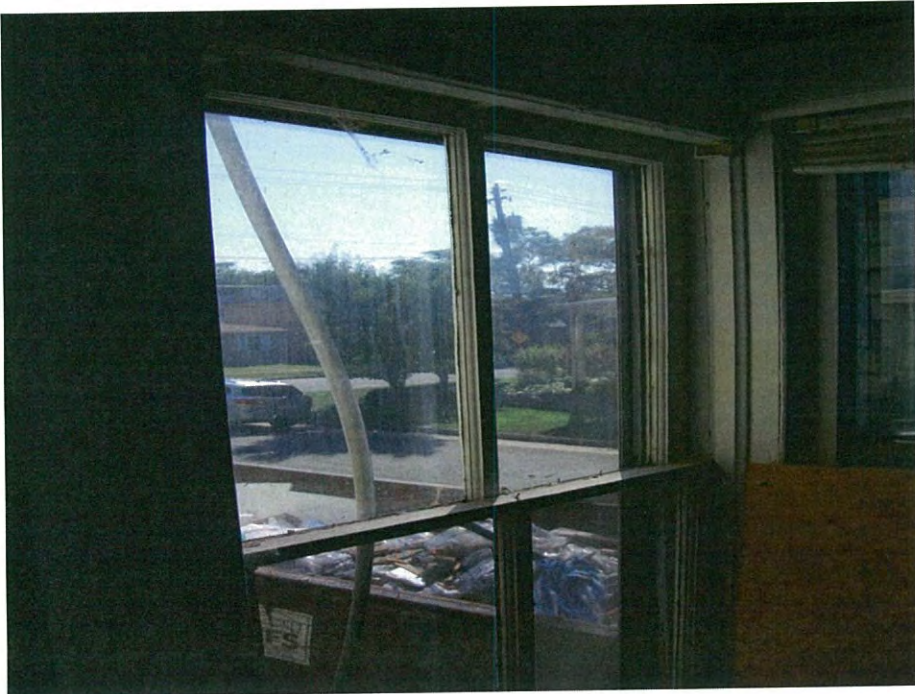
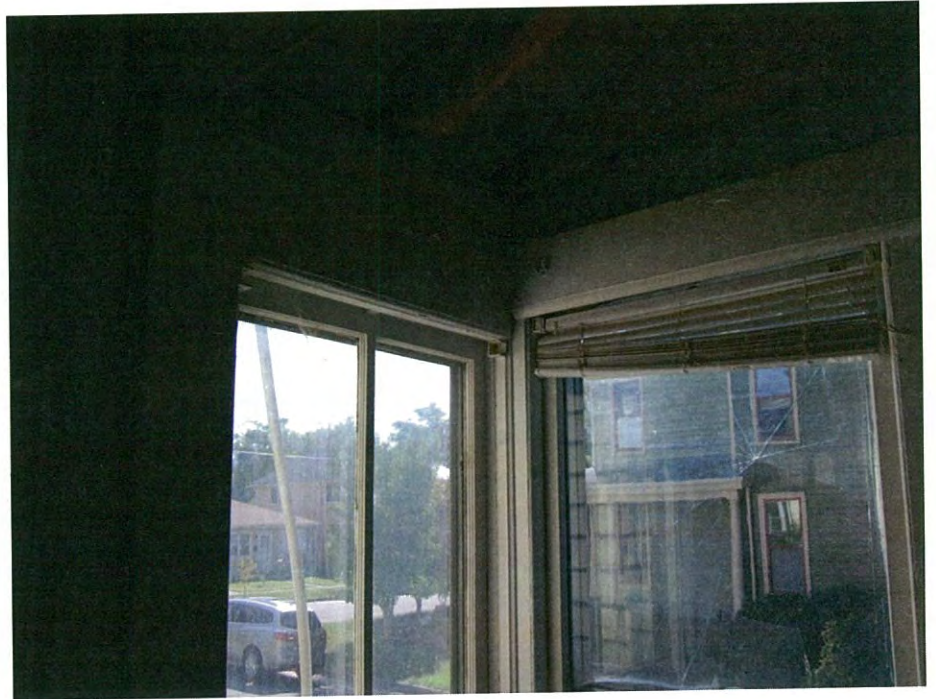
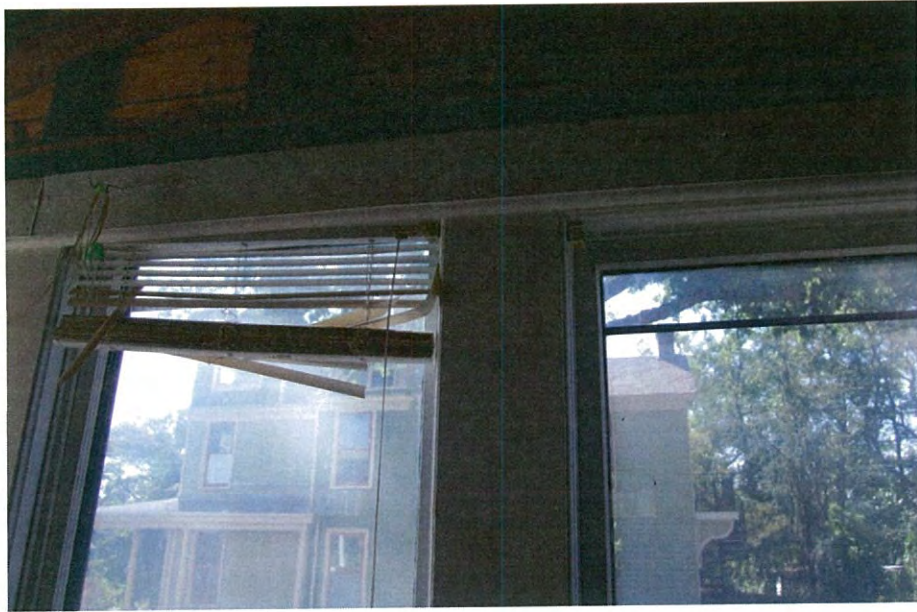
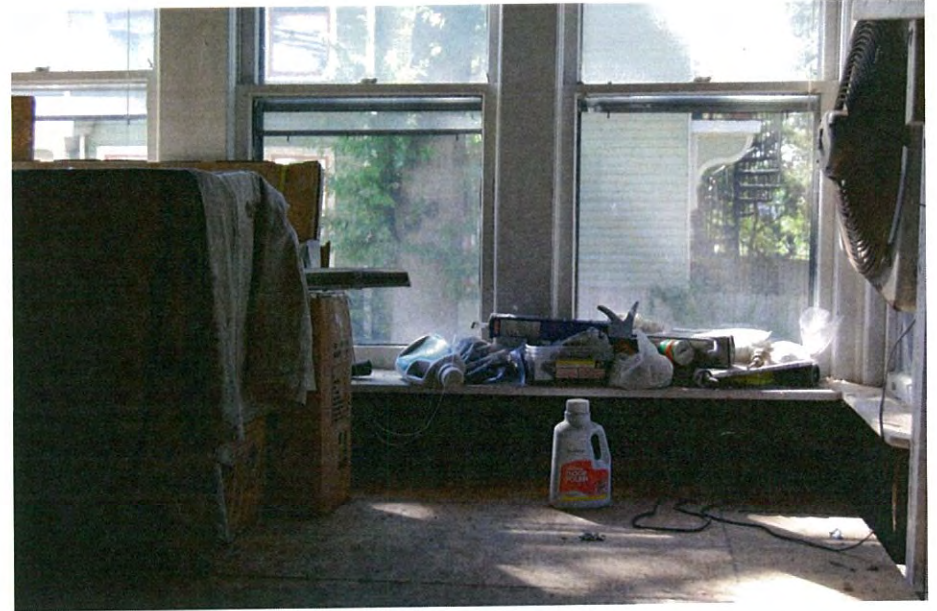
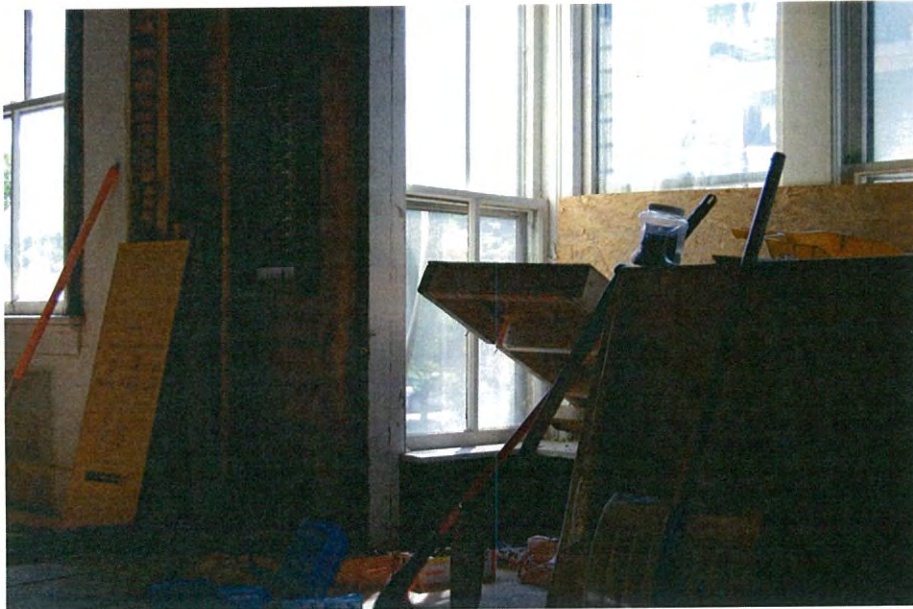
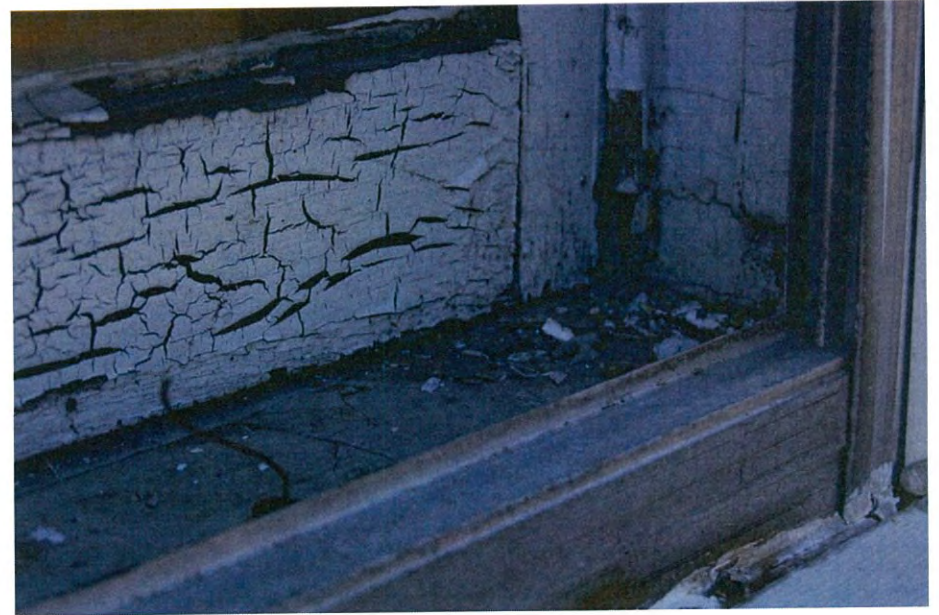
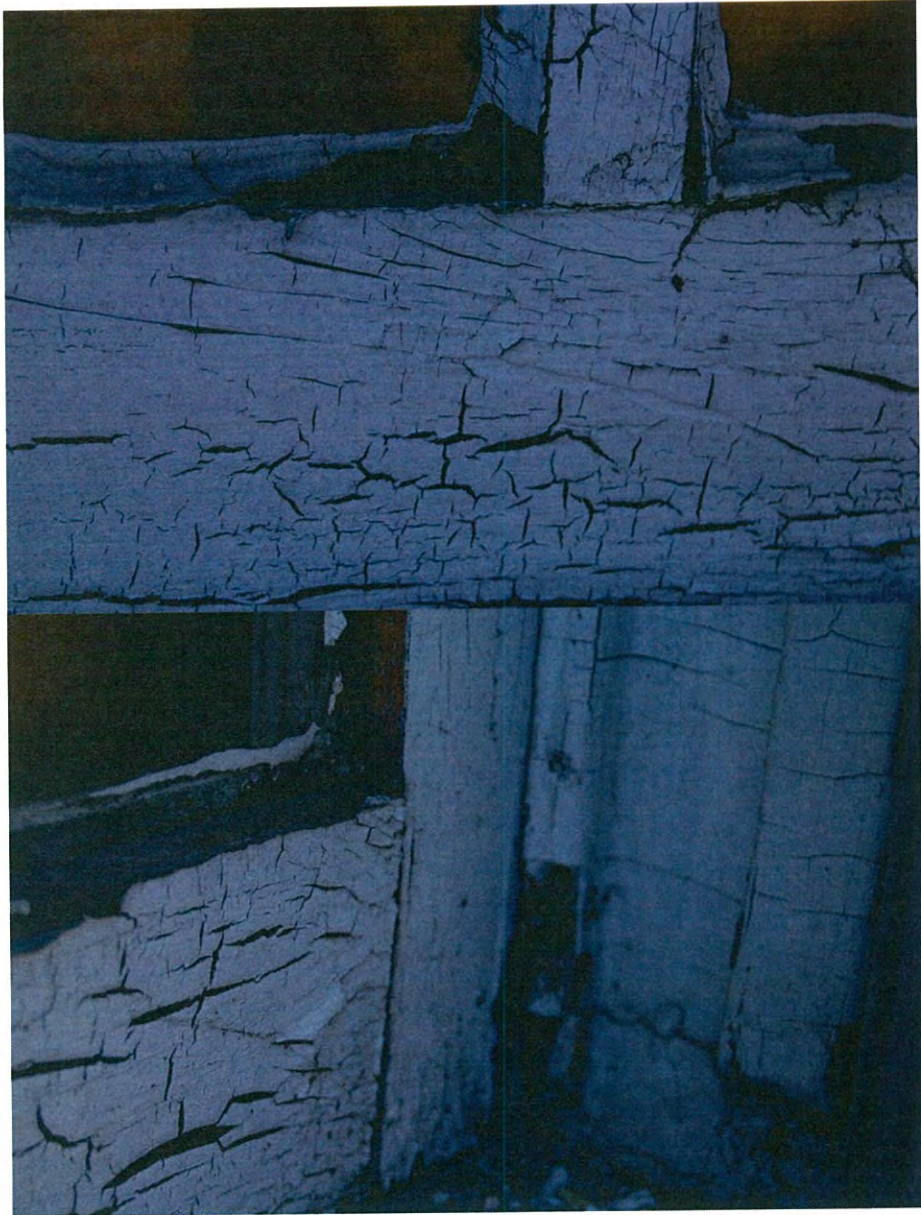
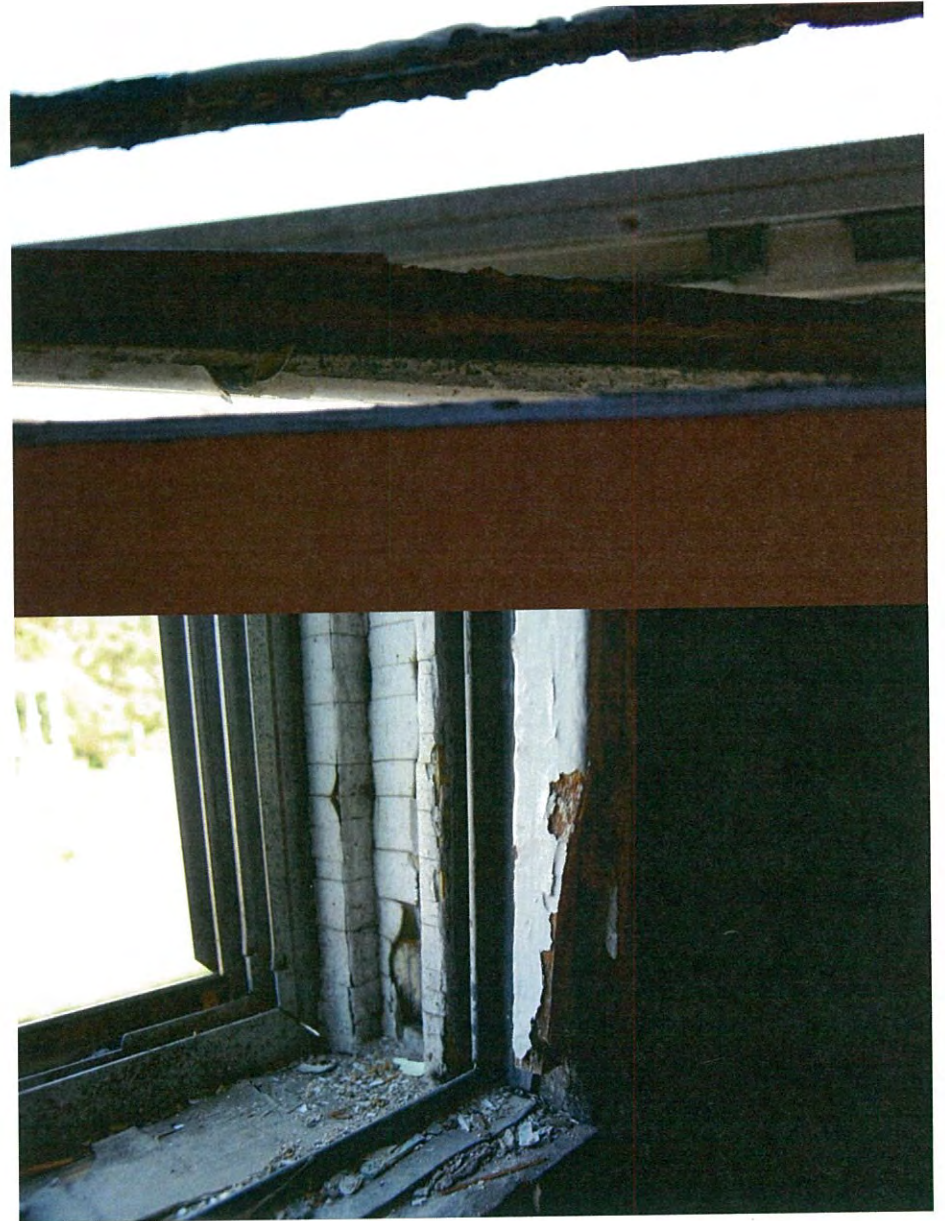
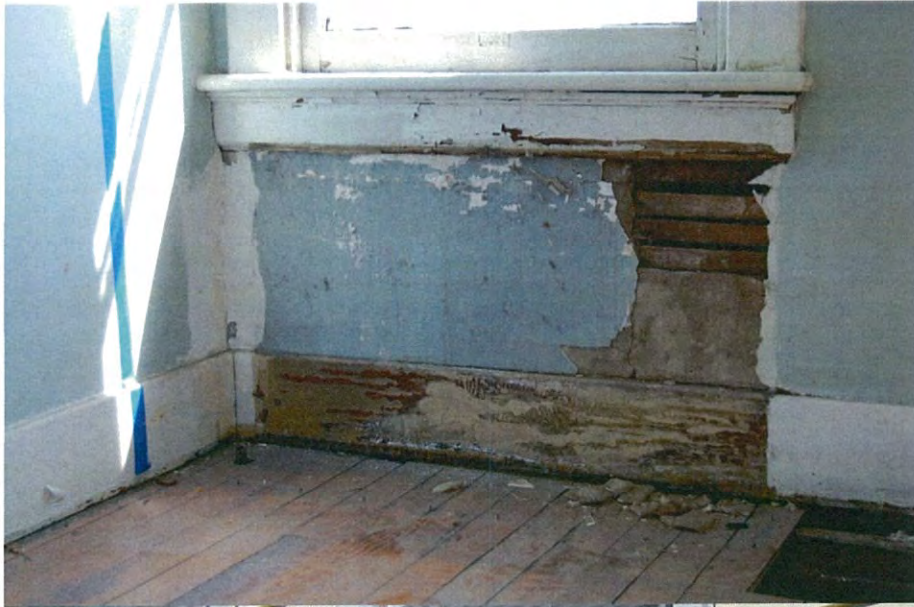
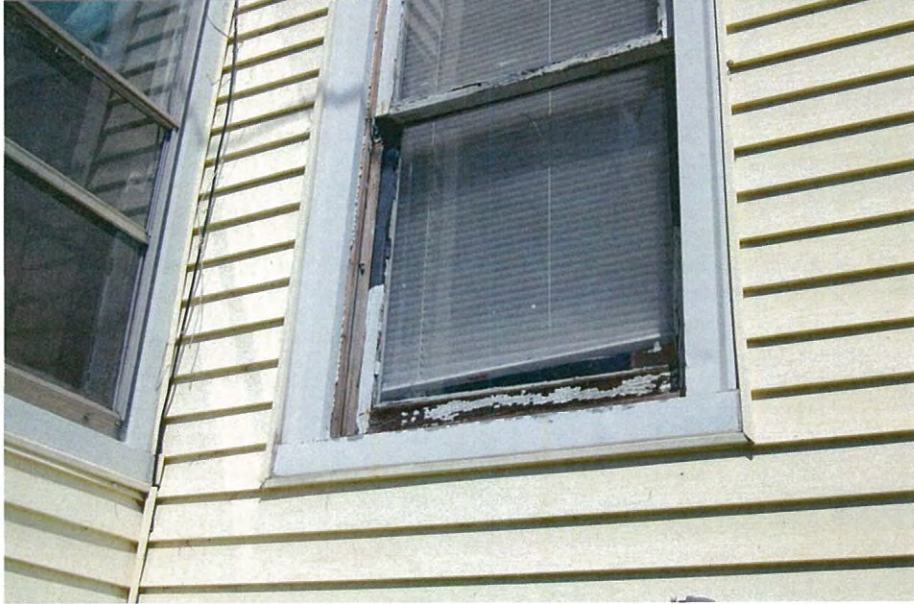
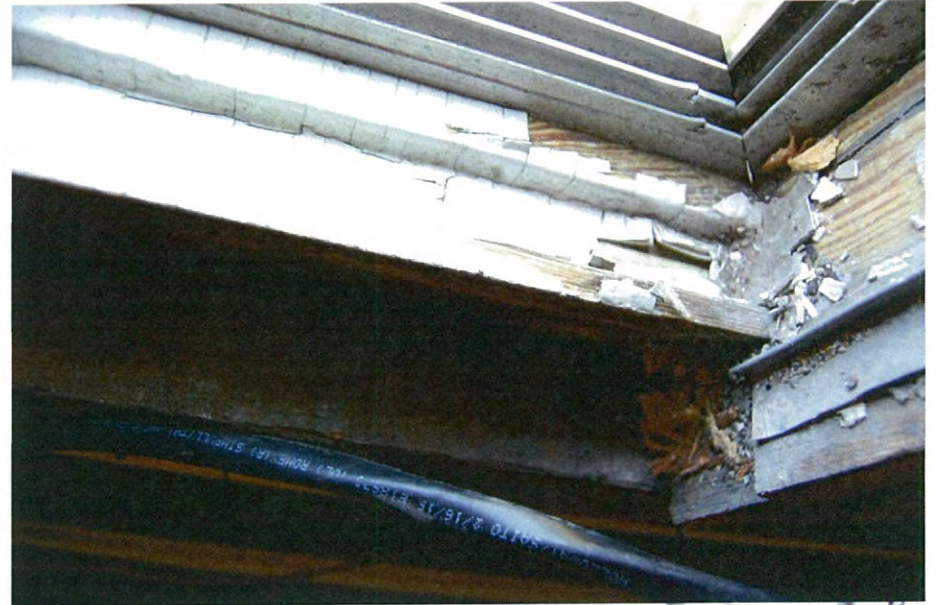
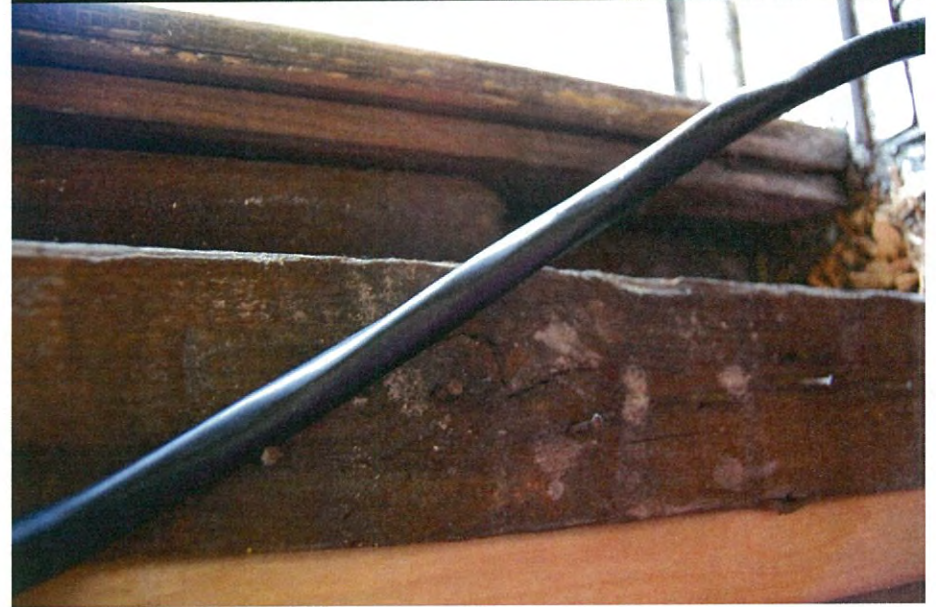
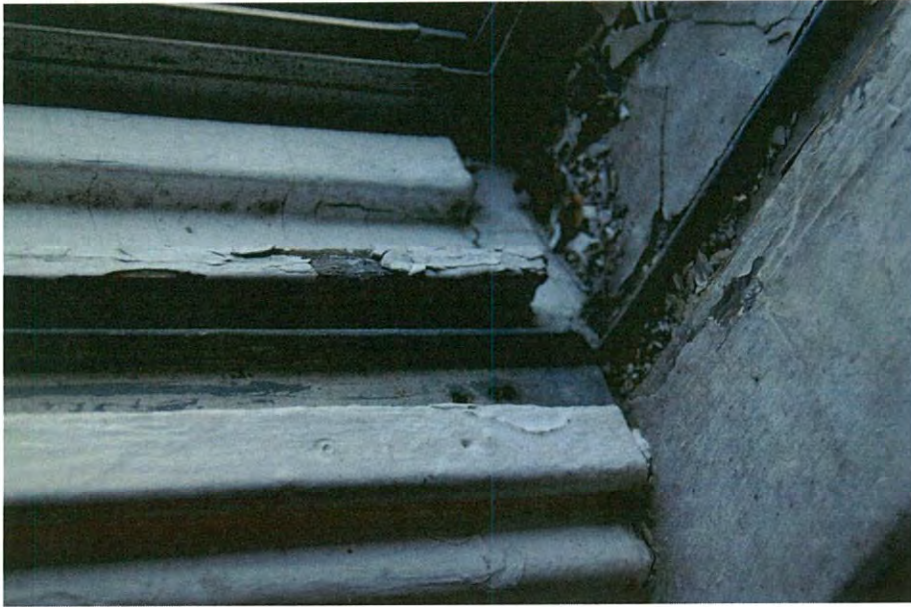
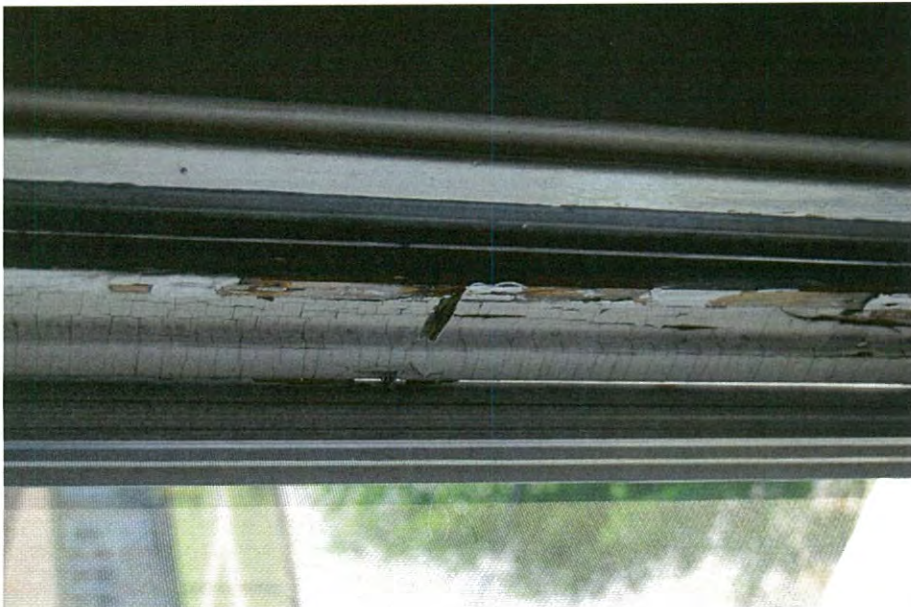
## 2. Windows

All windows are in severe disrepair. Wood around windows is rotten and should be replaced. Many of the glass pains have been vandalized. Many of the original windows have obviously been replaced. However, a few windows still have a two-over-one configuration which appears to have been original to the house.

**Windows have been leaking for years, most windows have either rotten boards or have mold growing on them. Leaks were so bad that the wall beneath have to be removed and replaced along with several of the interior framing boards.**

**Front Windows are 1 over 1.**

**Side Windows 2 over 1 or 2 over 2**

**Back Windows are 2 over 2**

We intend to replace all windows with the original two over one configuration, energy efficient Vinyl.

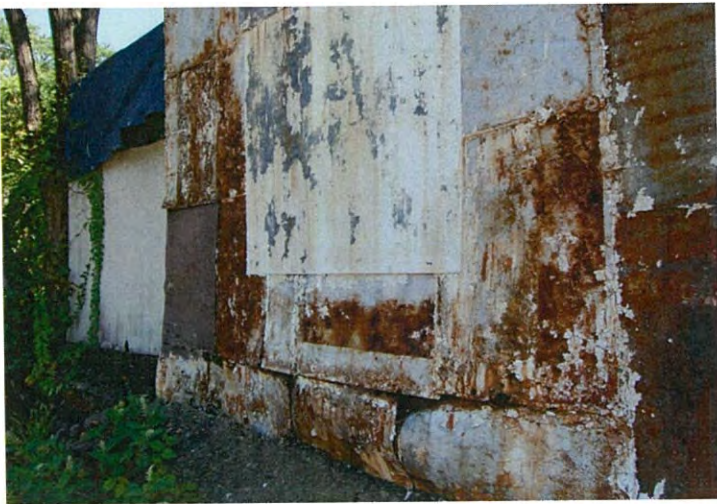
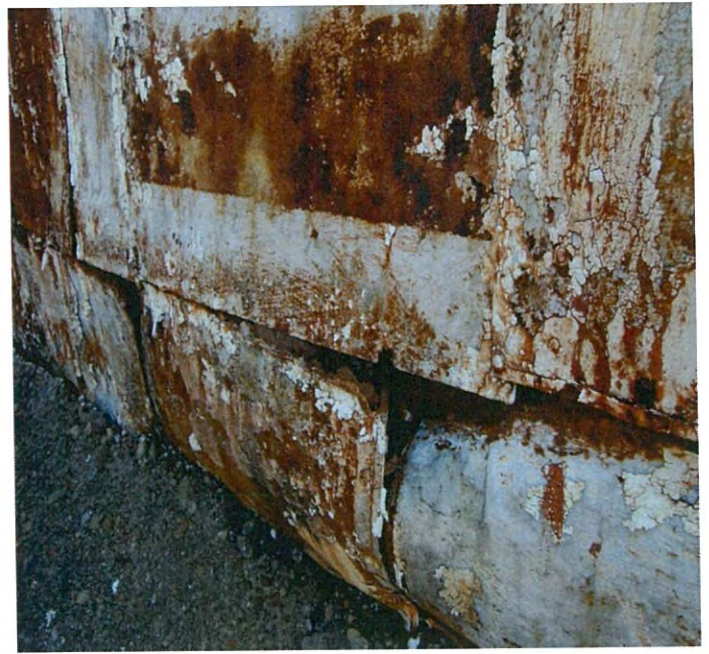
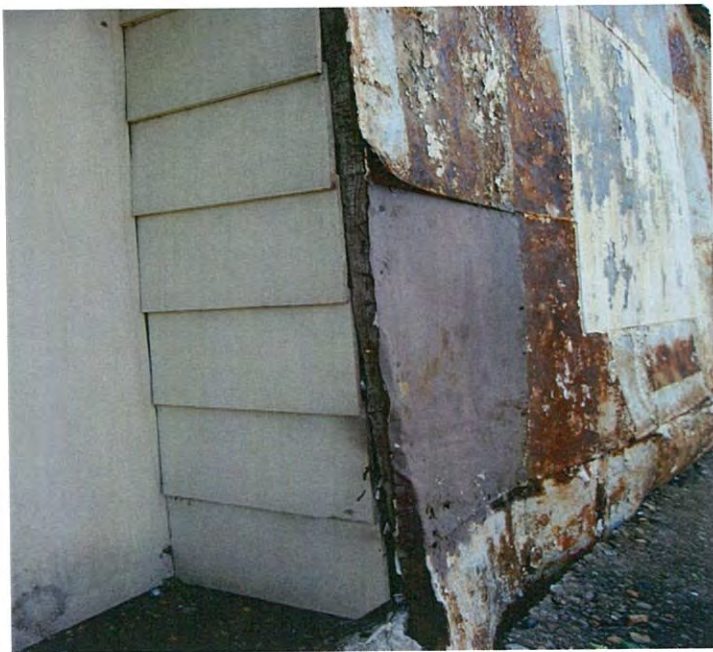
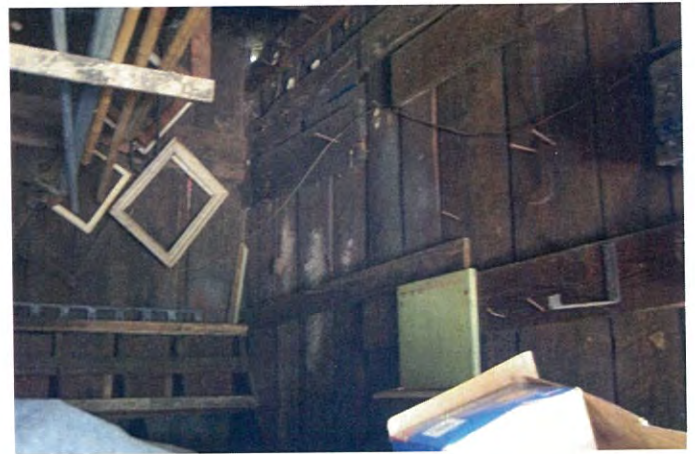
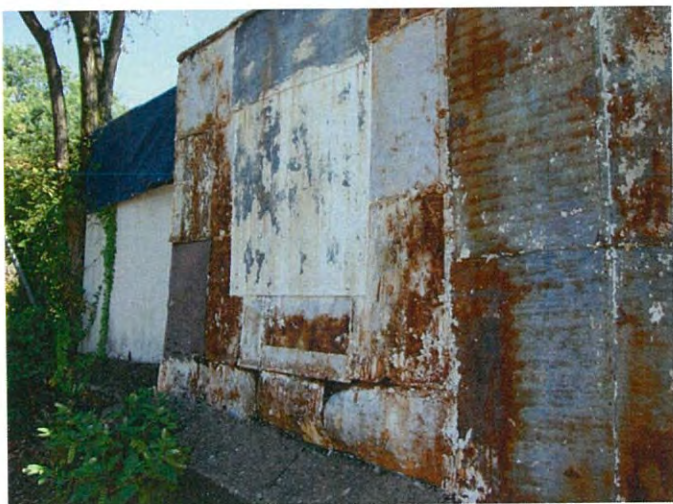
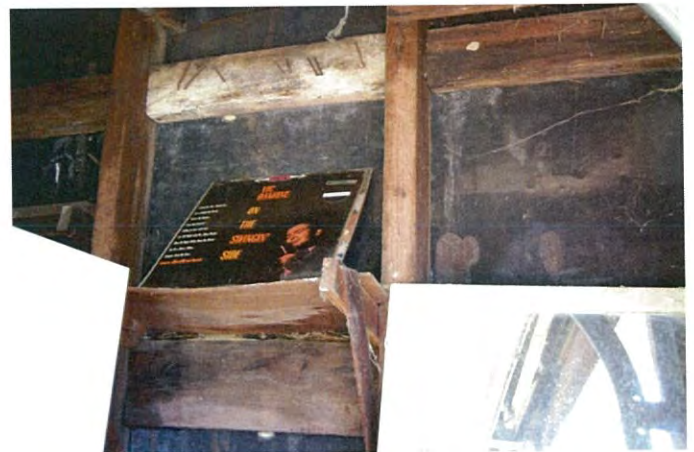
Garage: is on cinder block foundation, wood frame construction, and metal clad siding. Flat roof with metal sheeting that is leaking. Broken gutters causing flooding and rot on interior and exterior of the garage.

**Garage has several layers of board, tin and Plywood**
