I hope this email finds you well. I have spent quite a bit of time trying to master the window survey and put the rest of the pieces together so that we can move forward with the exterior renovations for 504 N. 29th St.

# Window Survey

504 N 29<sup>th</sup> St.

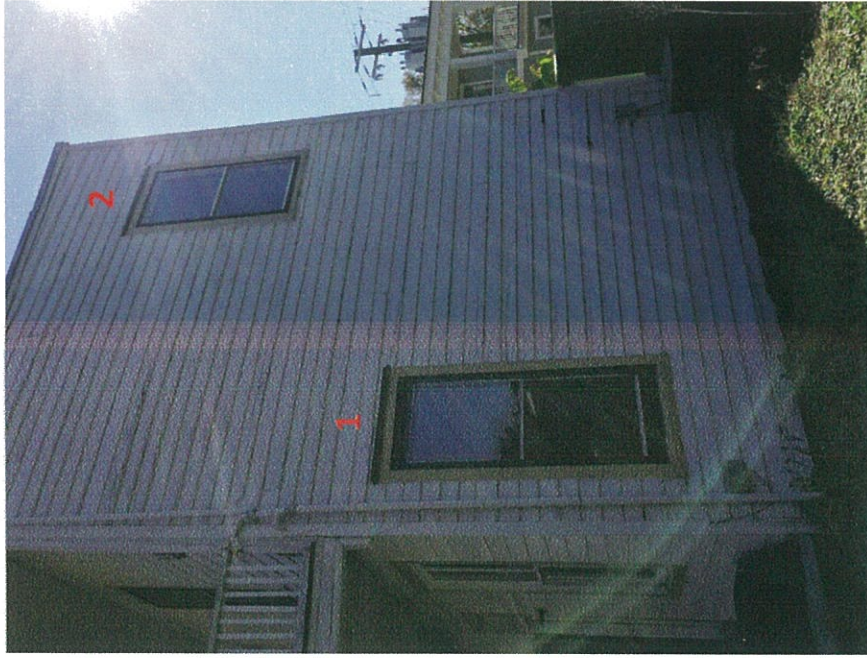
Rear window 1 has severe rot at the bottom pane and has been nailed shut with no latch in place, window 2 no longer has a weight system
