Commission for Architectural Review

Application for Certificate of Appropriateness

Address: 529 Mosby Street
Union Hill
Historic District: _____

Conceptual review to determine the status of the existing dwelling at 529 Mosby Street.

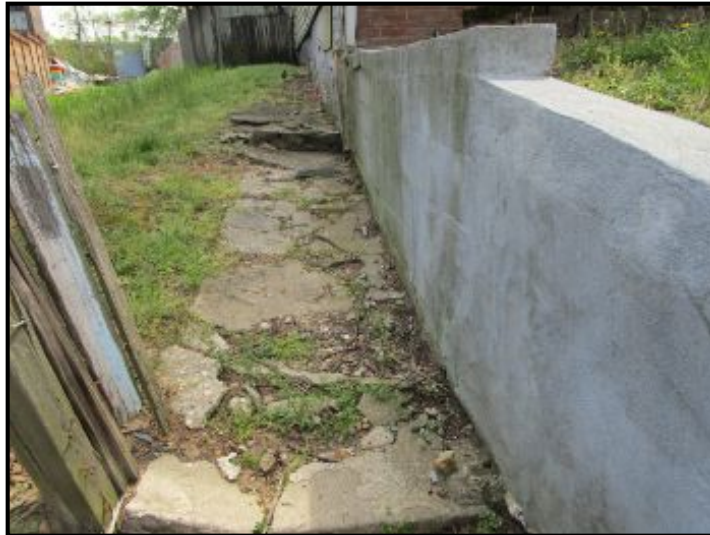
1. Driveway and Walkway Condition

- Gravel driveways need ongoing maintenance. Repair as needed.
- **There is significant cracks and damage to the concrete walkway at the side of the home and some settling observed. Recommend repair by a licensed contractor.**

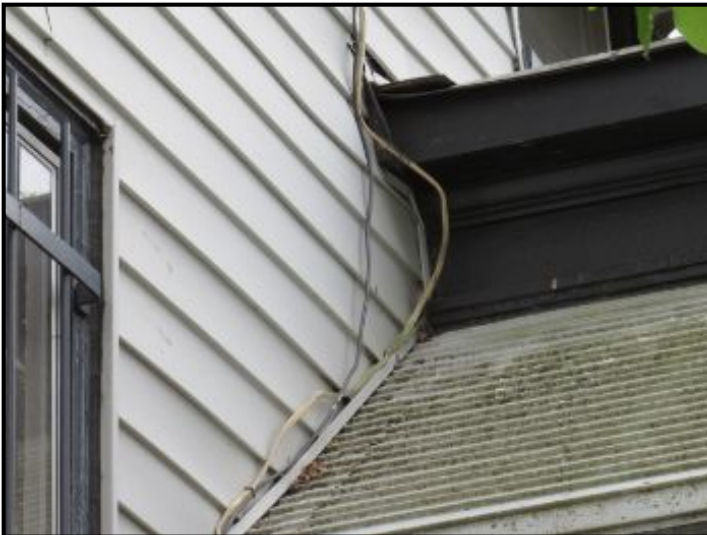
2. Grounds Electrical

- Interior grade Romex should be replaced with exterior-rated Romex and enclosed in conduit.
- Connections made outside of a Junction Box, which is a potential shock or electrocution hazard.

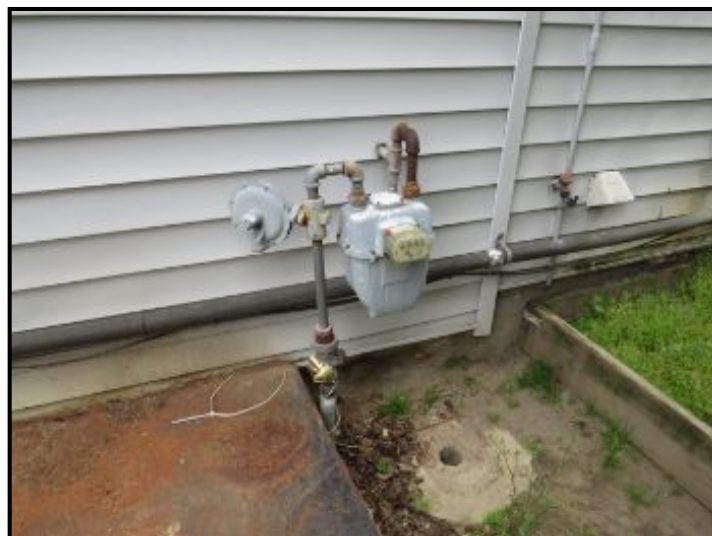
7. Main Gas Valve Condition

- The gas service is off to the structure. The inspector cannot inspect this system.

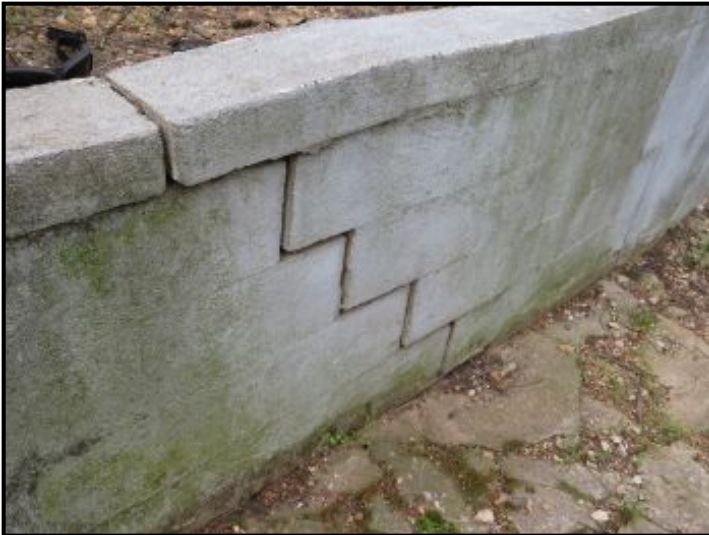
- **One or more retaining walls higher than 3 feet exists on this property and no guardrail is installed above. This is a safety hazard. Recommend having a qualified contractor install adequate guardrails above retaining walls higher than 3 feet where necessary and as per standard building practices (gaps no wider than 4", min. 36" high, vertical balusters so rail can't be used as a ladder, etc.)**
- **The retaining wall is leaning and there are large cracks noted. This is a potential safety hazard. Recommend repair by a licensed contractor.**

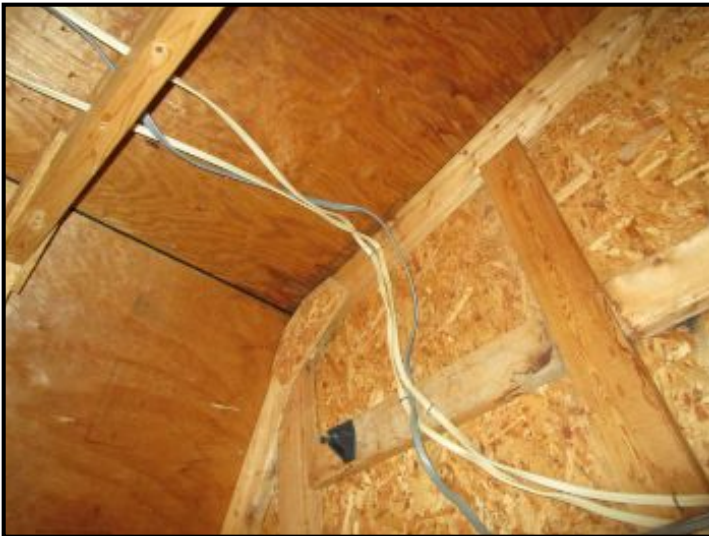
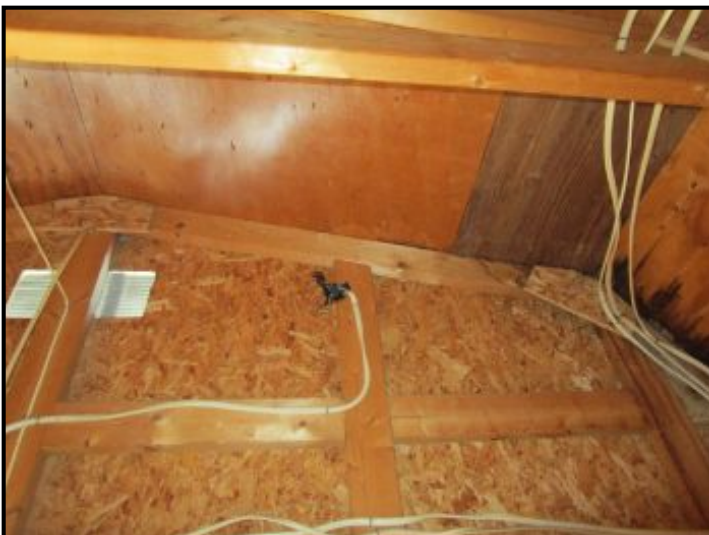
10. Shed

- The shed is in serviceable condition. There is moisture intrusion noted. Makeshift electrical and evidence of wood destroying insects. Sheds are typically sold as is.

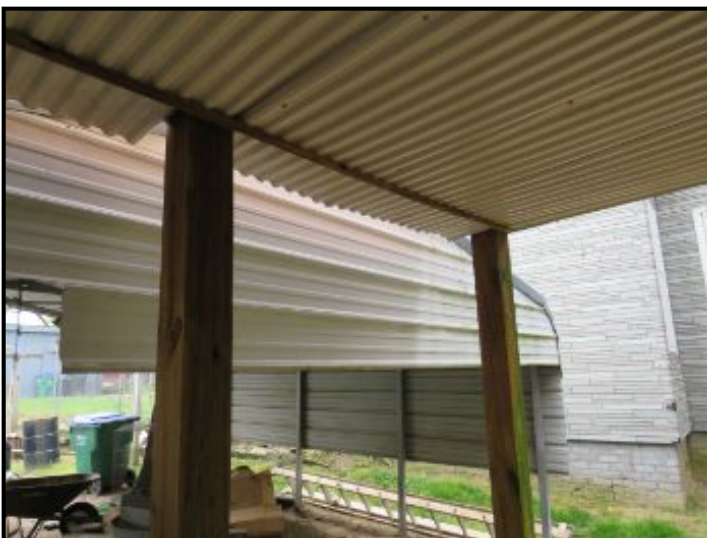
• Decks higher than 6 feet above grade that do not have diagonal decking should have diagonal bracing across the bottoms of the joists to keep the decking square. A deck that is not held square could permit the outer posts to lean to the right or left and parallel to the ledger board, and thus twist the ledger away from the home. Recommend repair by a licensed contractor.

• One or more deck ledger boards are nailed to the structure rather than being attached by adequate fasteners. This poses a significant safety hazard since the ledger board(s) may separate from the structure, causing the deck(s) to collapse. Recommend having a qualified contractor install lag screws or bolts as per standard building practices to securely attach the ledger board(s) to the structure. For more information on installing deck ledger boards visit:
http://www.hometime.com/Howto/projects/decks/deck_4.htm

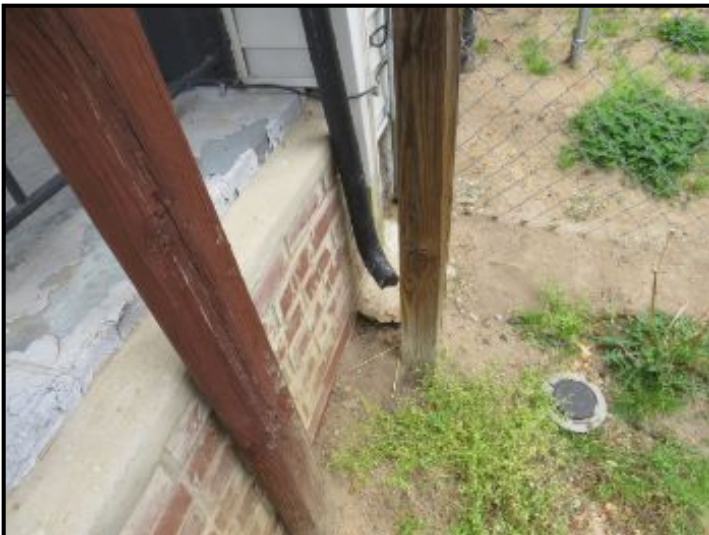
- One or more downspouts have no extensions, or have extensions that are ineffective. This can result in water accumulating around the structure's foundation, or in basements and crawl spaces if they exist. Accumulated water is a conducive condition to wood destroying insects and organisms, and may also cause the foundation to settle and possibly fail over time. Recommend making repairs as necessary such as repairing or installing splash blocks or tie-ins to underground drain lines so rain water is carried at least several feet away from the structure to soil that slopes down and away from the structure.

- One or more downspouts are loose or detached. This can result in water accumulating around the structure's foundation, or in basements and crawl spaces if they exist. Accumulated water is a conducive condition to wood destroying insects and organisms, and may also cause the foundation to settle and possibly fail over time. Recommend making repairs as necessary so downspouts are securely anchored and functional.

- There are damaged down spouts noted. Recommend repair by a licensed contractor.

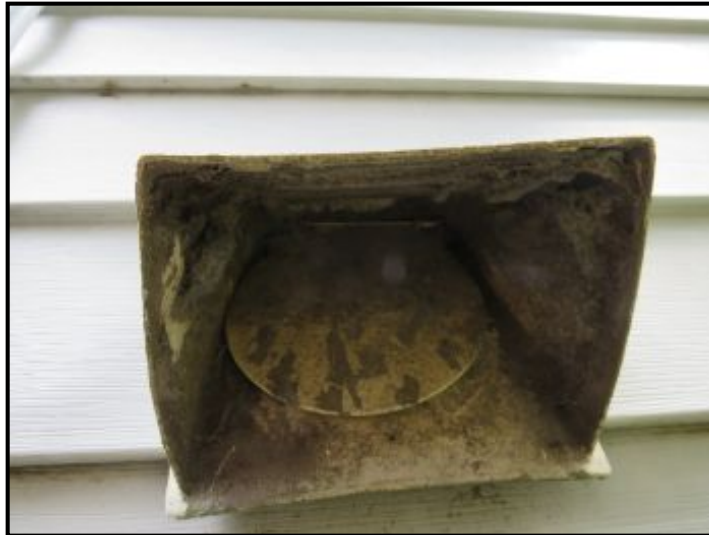
4. Dryer Vent

- The clothes dryer exhaust duct vent cap has significant amounts of lint and/or debris build up. This is a safety hazard due to the risk of fire. Recommend cleaning exhaust duct and cap now and annually, or more often if needed, in the future. Some chimney sweeps or heating and cooling duct cleaners perform this service. For more information, visit <http://chimneykeepers.com/dryerclean.html>

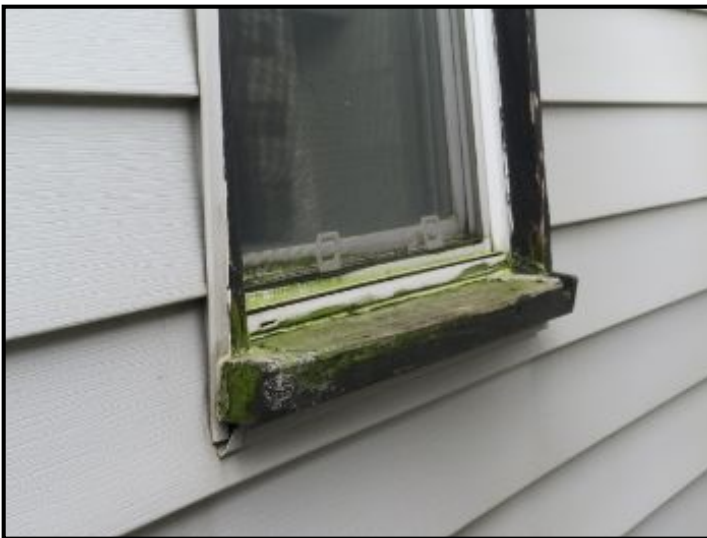
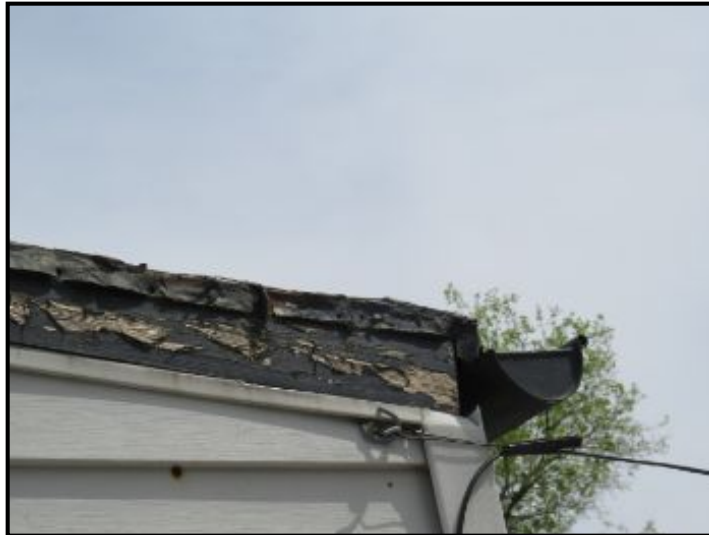
5. Exterior Paint

- Suggest sealing/caulking as part of routine maintenance to prevent deterioration.
- Approximately 3/4 of the homes built before 1978 (about 64 million homes) contain some lead-based paint. For more information, refer to the following EPA Fact Sheet:
<http://www.hud.gov/offices/lead/library/enforcement/fs-discl.pdf>
- There is paint/caulking deterioration at the window trim. Recommend repair by licensed painting contractor.
- There is paint deterioration at the soffit and eaves trim. Recommend repair by a licensed painting contractor.

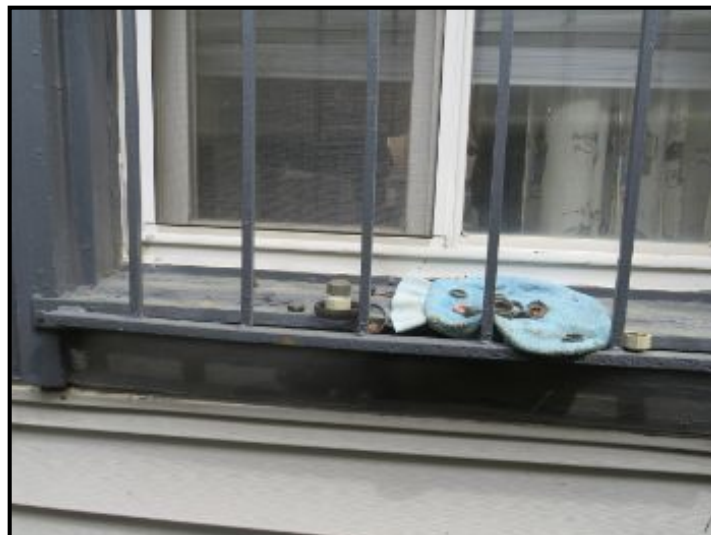
7. Window Condition

- **Some window screens are missing.**
- **Questionable Egress from apparent bars over windows. Check building and fire codes.**

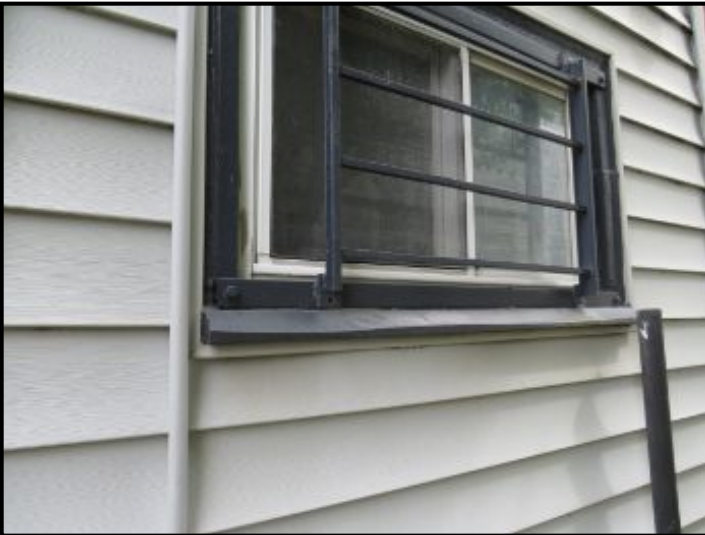
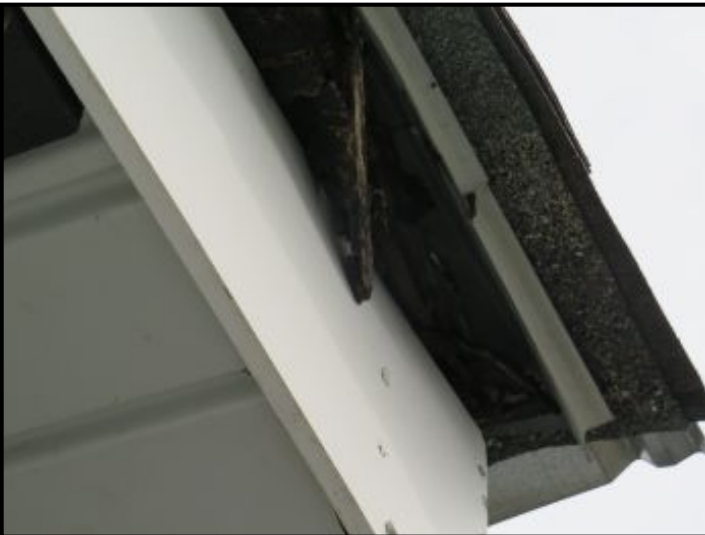
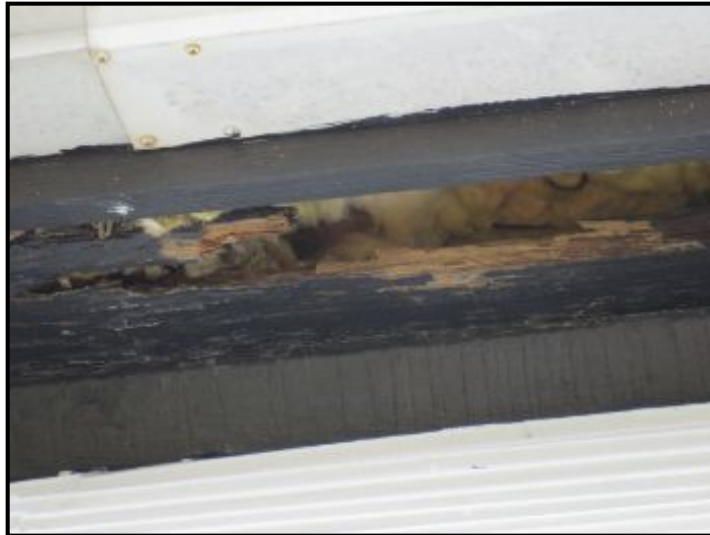
8. Wood Trim

- There is wood trim deterioration at the windows. Recommend repair by a licensed contractor.
- There is wood trim deterioration at the soffit, eaves and trim. Recommend repair by a licensed contractor.

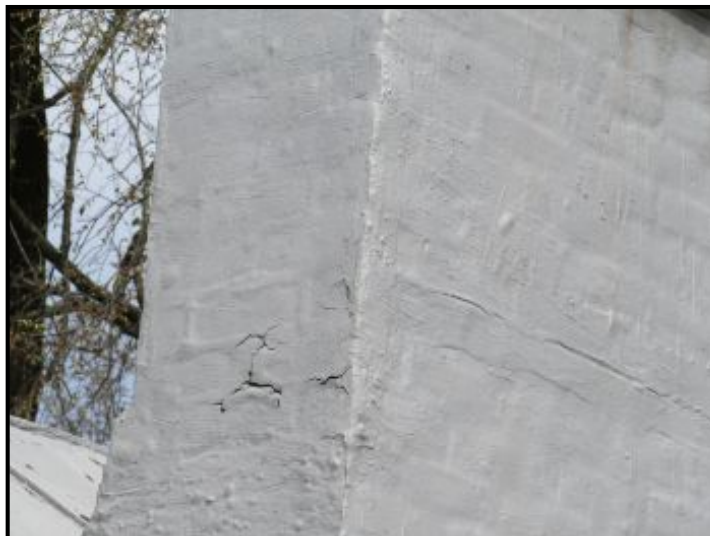
1. Chimney

- The masonry chimney's mortar is deteriorated and should be repaired to prevent further, significant deterioration. Recommend having a qualified chimney service contractor or mason evaluate chimney and repair as necessary. This will likely require repointing the mortar.

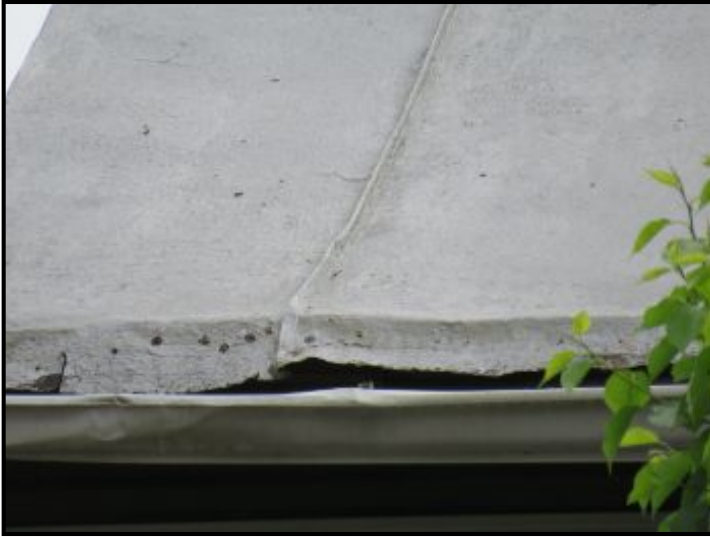
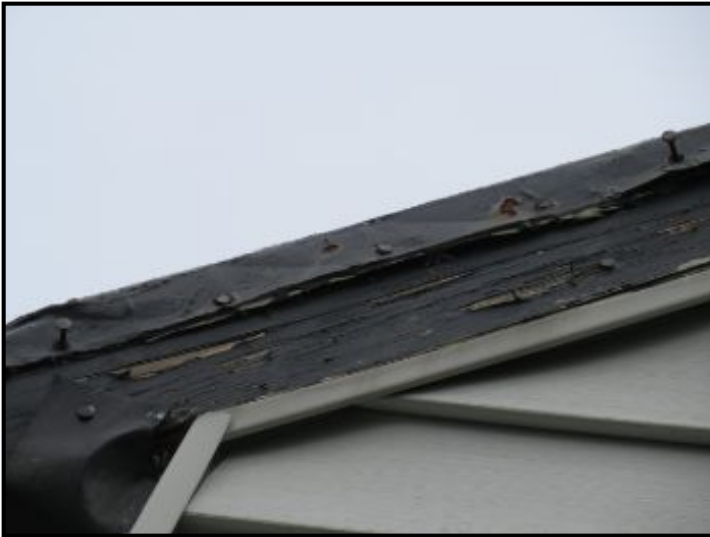
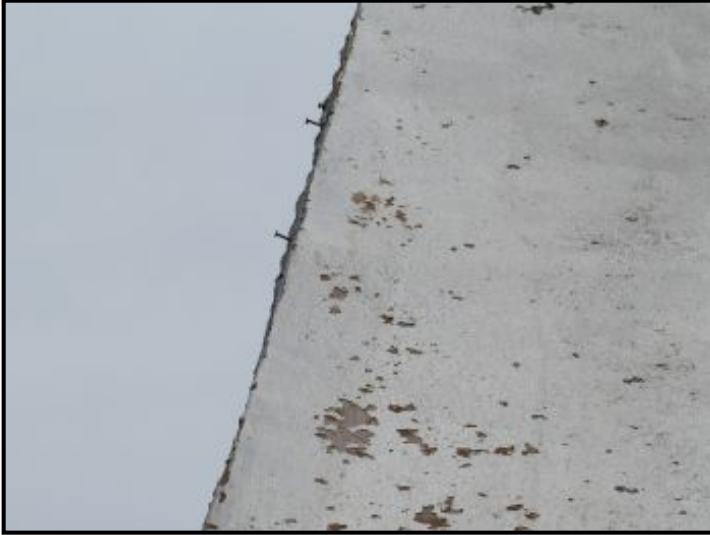
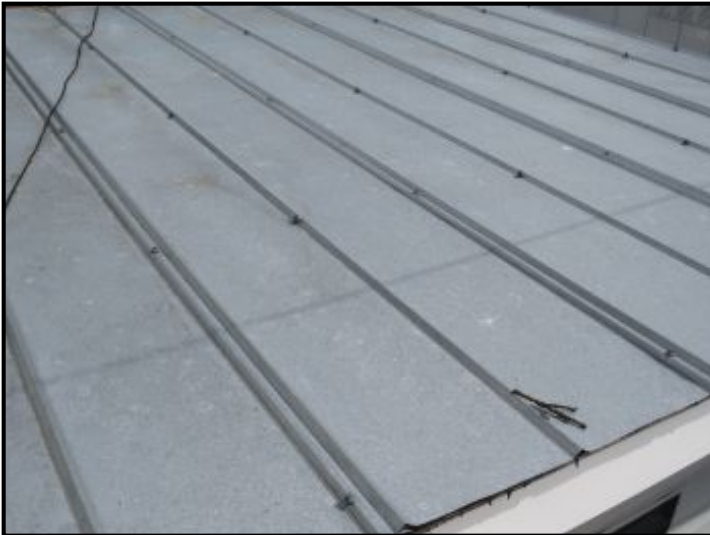
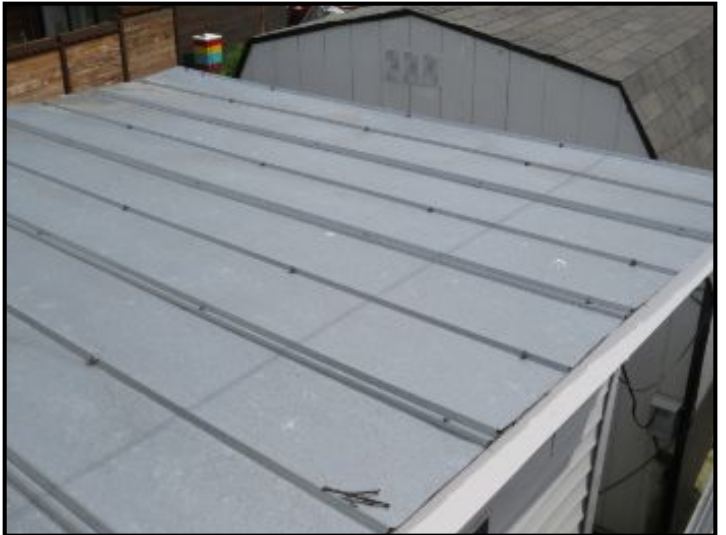
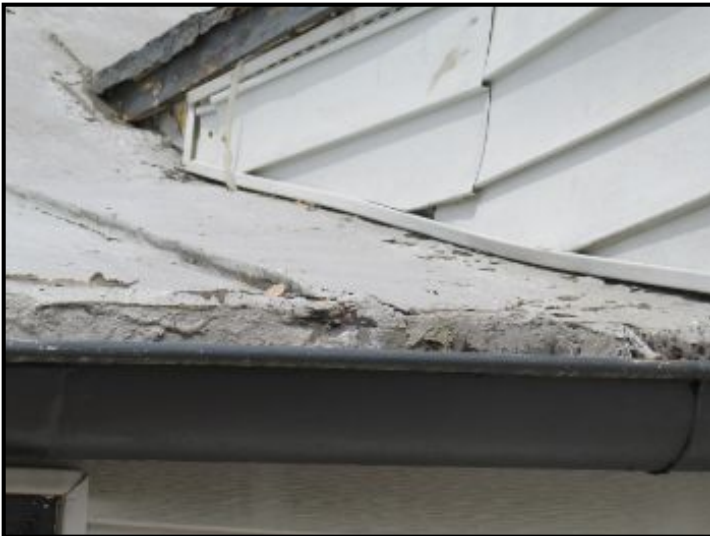
2. Roof Condition

- Note that experts recommend that any roof over 10 years old receive a roof certification by a local roofing specialist.
- **The roof is at the end of its useful life. There is splitting, rust and edges that are lifting. There is deteriorated paint and sealants. Recommend replacement/repair by a licensed roofing contractor.**

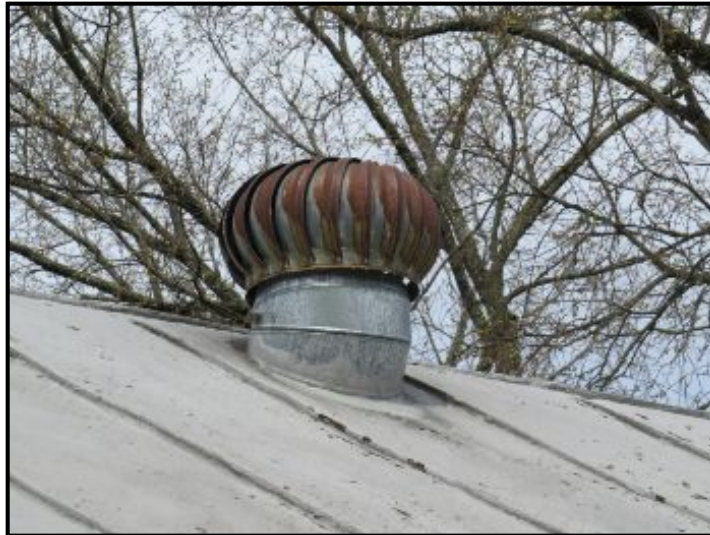
- The vent cap is rusted. recommend repairing/painting the vent cap.

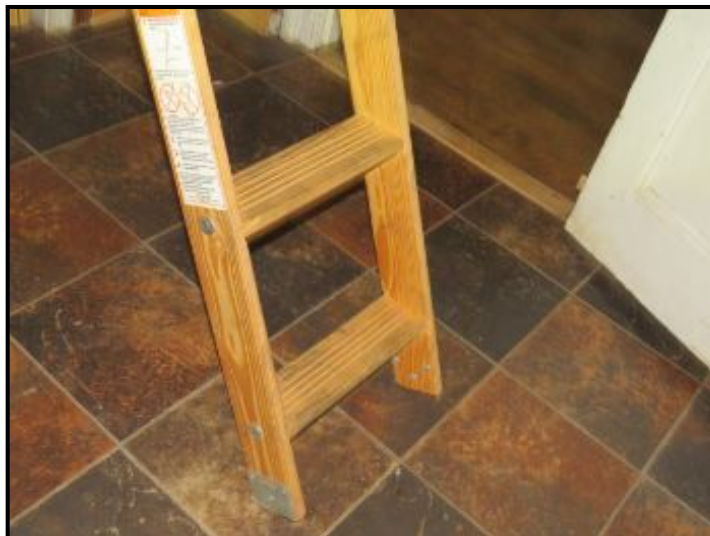
1. Access

- Pull Down Ladder located in: bedroom.
- Pull-down stairs are installed for the attic access. No insulation is installed above the stairs and no weatherstripping is installed around the hatch perimeter. To reduce air leakage, recommend installing weatherstripping and an insulated hatch cover. An example of one can be seen at <http://www.batticdoor.com/>

- The Attic pull down stairs are damaged or the hinges are bent/broken. recommend repair/replace by a licensed contractor.

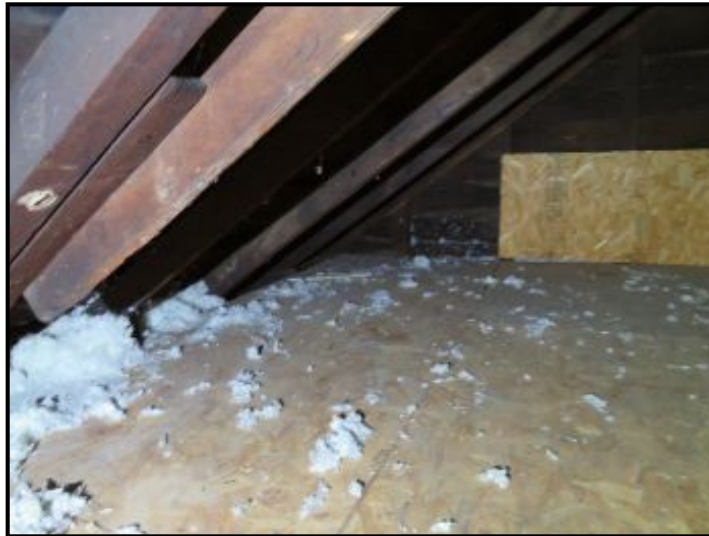
3. Insulation Condition

- The ceiling insulation's R rating significantly less than what's recommended for this area. Recommend having a qualified contractor install additional insulation as per standard building practices for better energy efficiency.

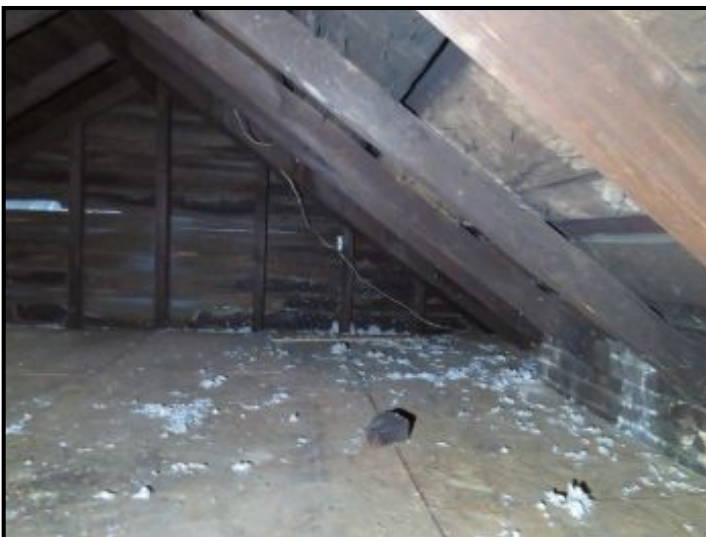
4. Moisture Intrusion

- There is evidence of past moisture intrusion in the attic. The areas were dry at the time of the inspection.

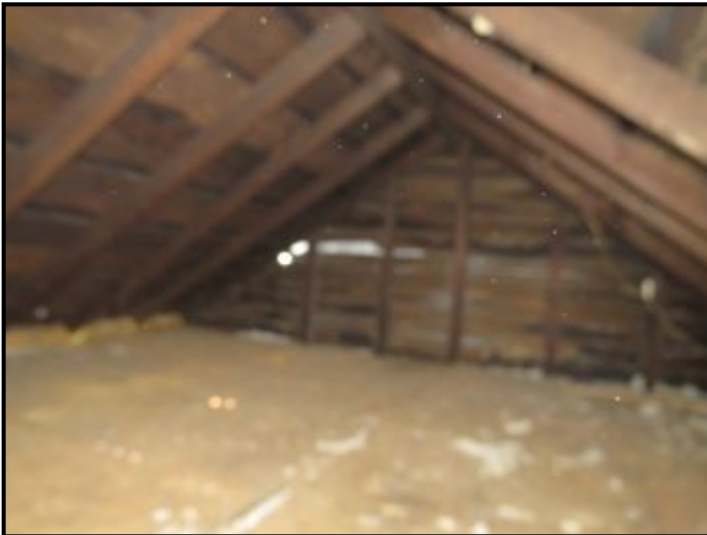
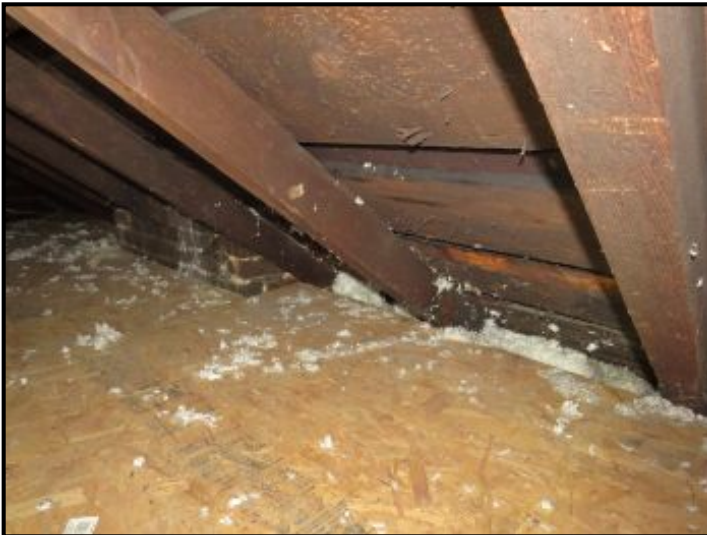
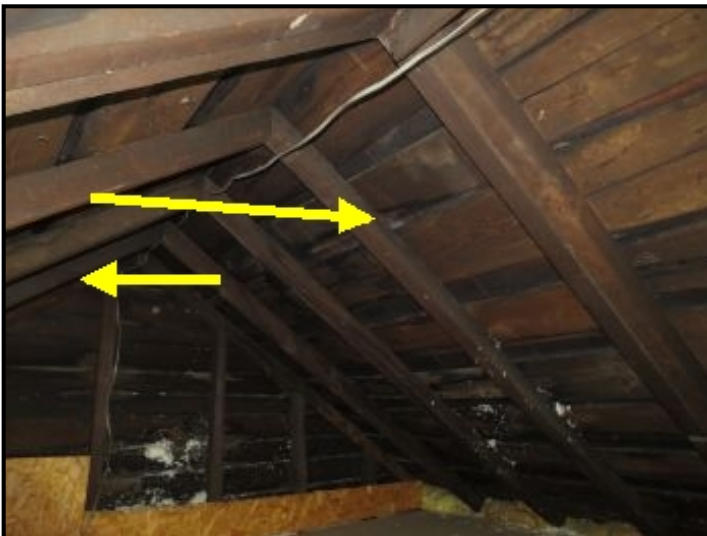
- **Framing is poorly braced. Recommend adding collar ties.**

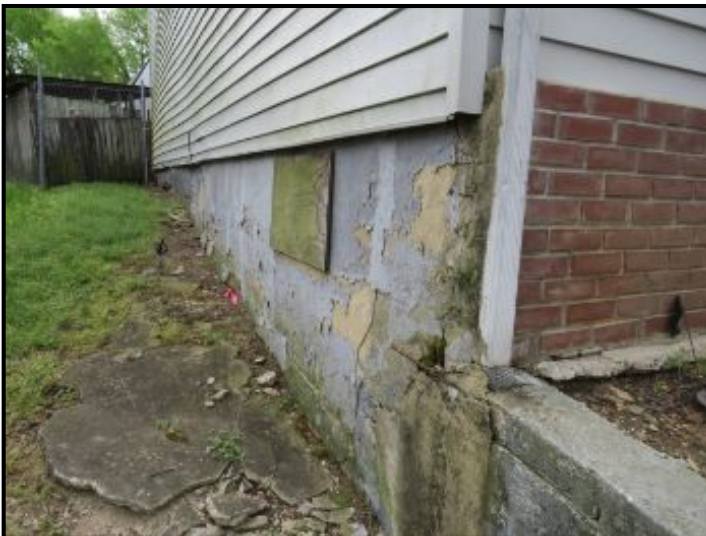
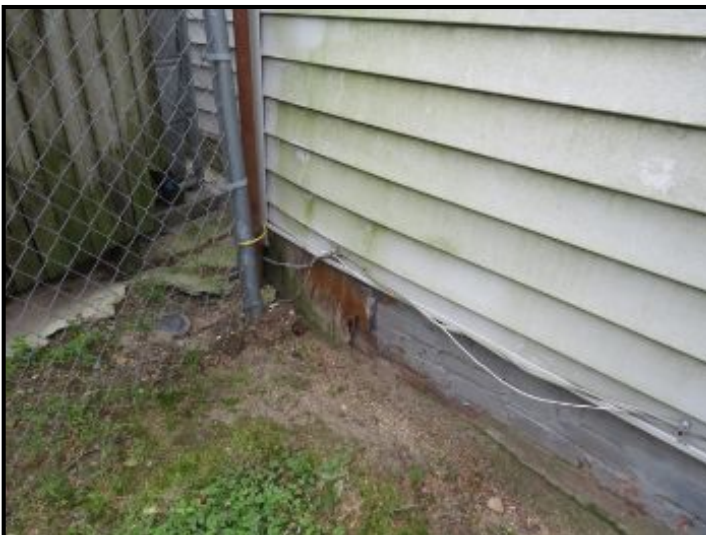
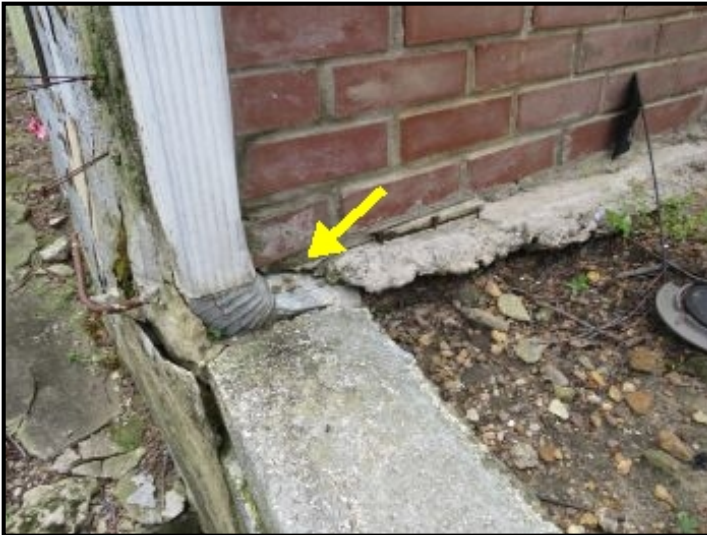
- There are holes in the foundation large enough for rodent intrusion. Recommend filling or closing any holes with mortar or grout.
- Pressure bulge in wall indicates excessive forces are being applied to the exterior side. It also appears that the front exterior downspout is dumping water into the foundation and there is washout at the front corner piers. Recommend repair by a licensed structural contractor.

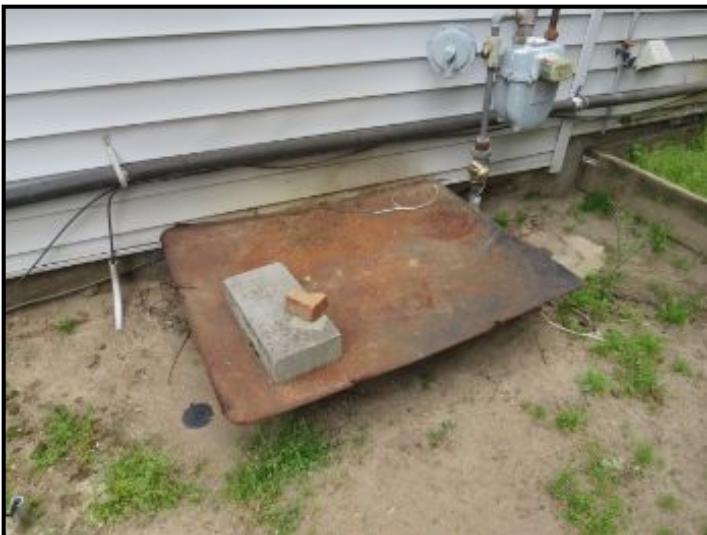
- **The crawlspace door is in poor condition and there is limited access to some areas. Recommend repair or replace by a licensed contractor.**

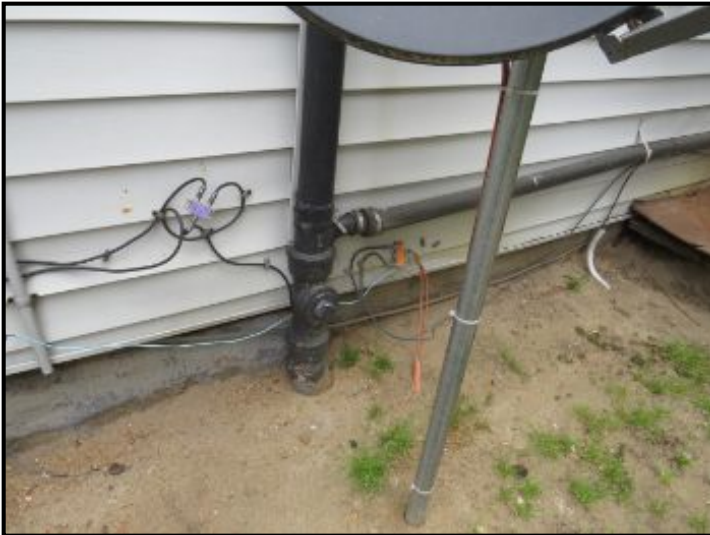
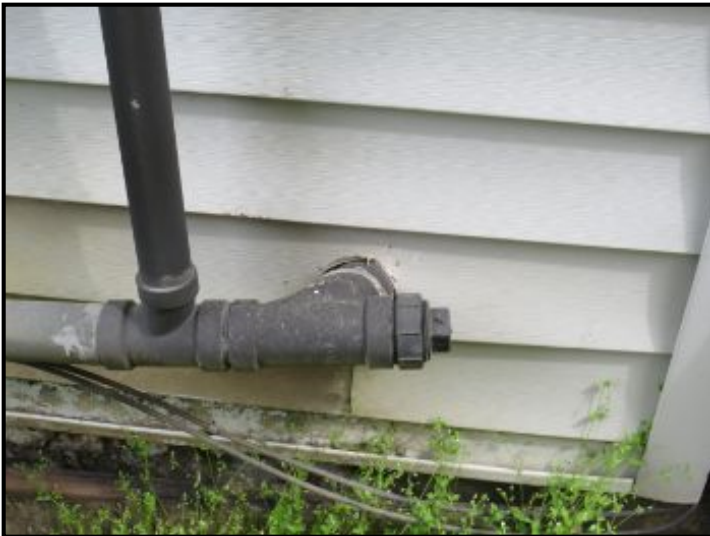
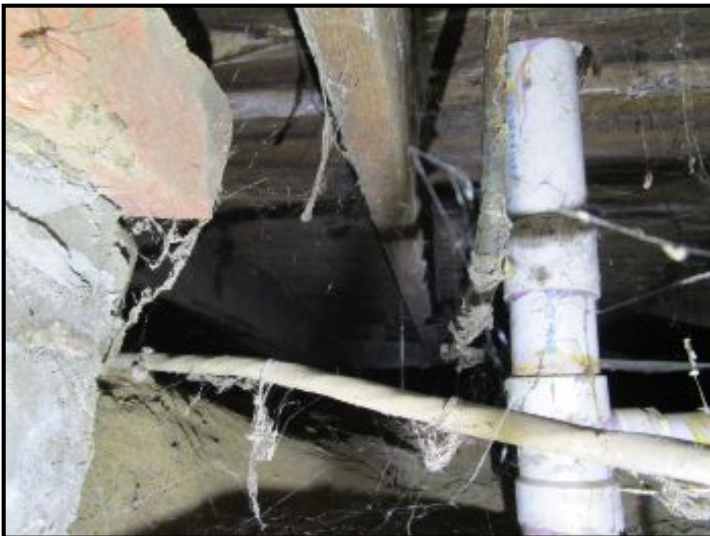
- **ABS**
- Cast Iron
- Copper
- **PVC**
- Cast iron and galvanized drain lines have a life expectancy of 50 to 70 years. Recommend budgeting for replacement in the future.
- Most of the plumbing lines expose on the exterior of the home for the drain system. The water was off to the structure and could not be tested. There does not appear to be proper support at these drain lines and some areas need additional insulation to protect them. Recommend repair by a licensed plumbing contractor.

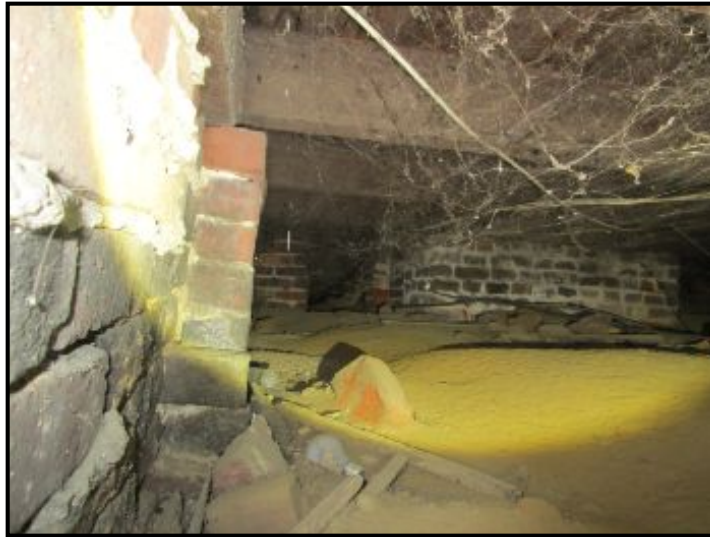
- **Cellulose-based debris such as wood scraps, form wood, cardboard and/or paper were found in crawl space. Recommend removing all cellulose-based debris to avoid attracting wood destroying insects.**
- **Wood scraps noted in the crawl space. This can draw wood destroying insects. Recommend removing any wood scraps or cellulose based materials.**

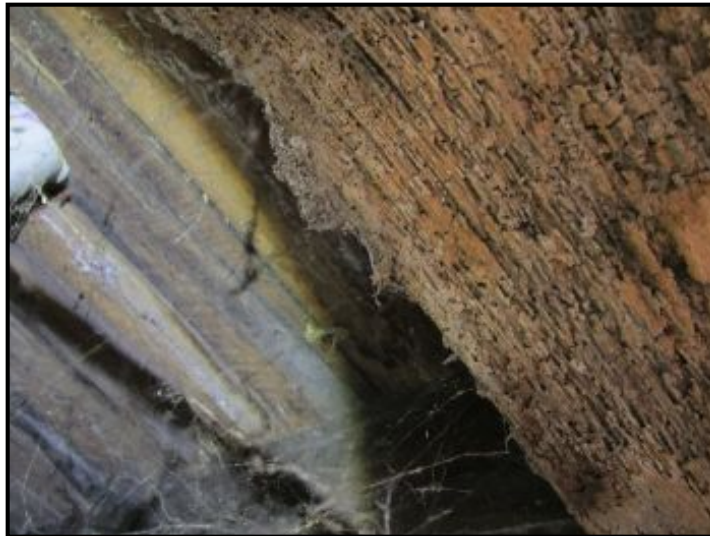
11. Wood destroying Insects

- **Evidence of wood destroying insects. Recommend evaluation, treatment and repair by a licensed pest control contractor.**

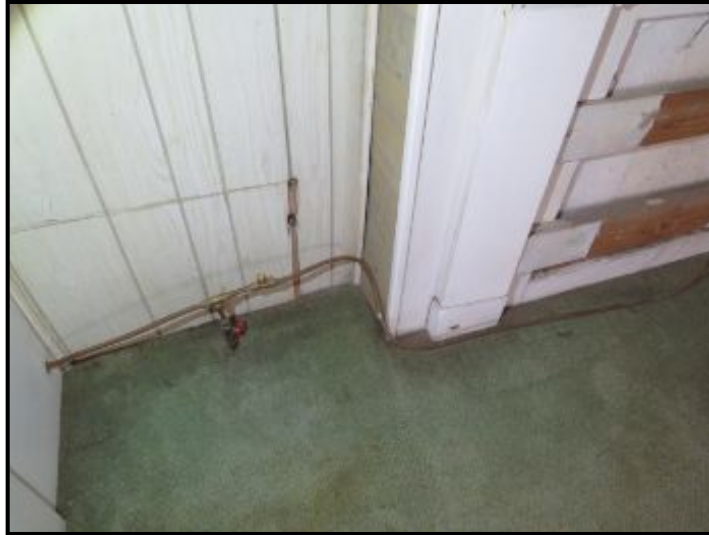
- There is no drip leg noted at the gas supply line. Current standards recommend drip legs to be installed in a manner that meets or exceeds fuel piping requirements for appliances and devices. The drip leg requirements are the same for both natural gas and propane. A drip leg can be installed anywhere at the low point in the piping system, if there is moisture in the gas this will allow for the removal of the condensation.

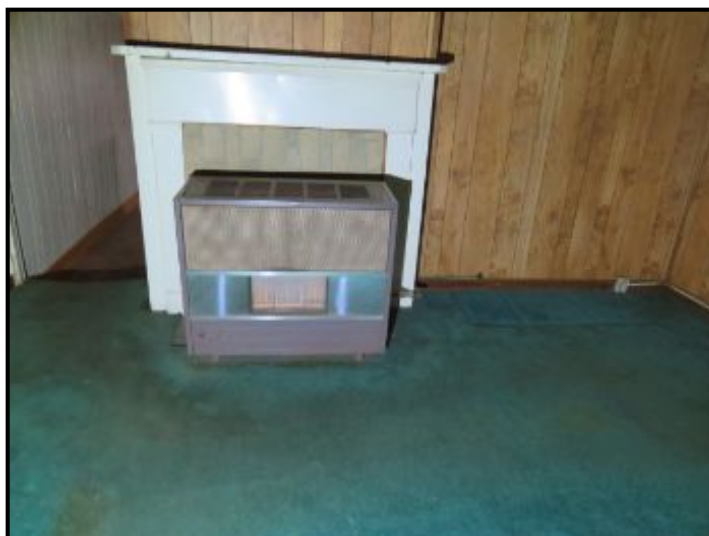
2. Heater Condition

- Because of the age and/or condition of this furnace, recommend that a qualified heating and cooling technician inspect the heat exchanger and perform a Carbon Monoxide test when it's serviced.
Replace if needed

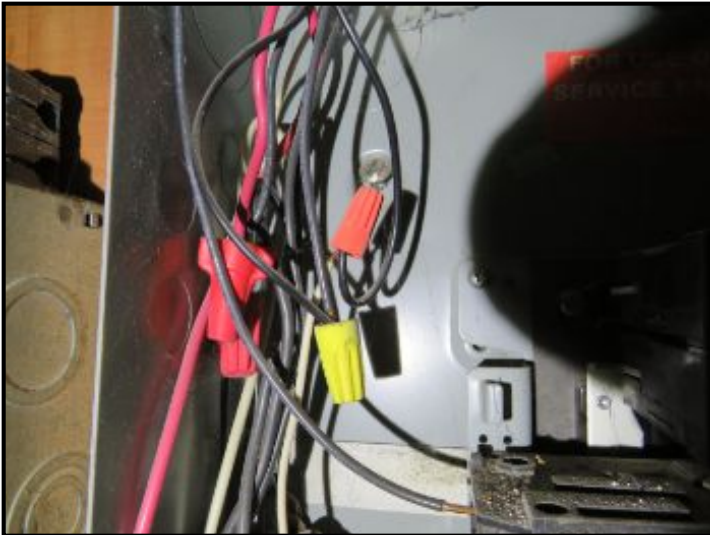
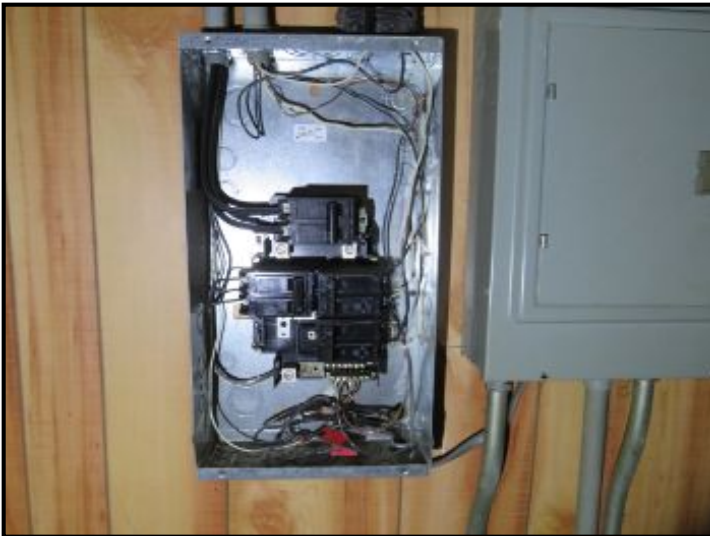
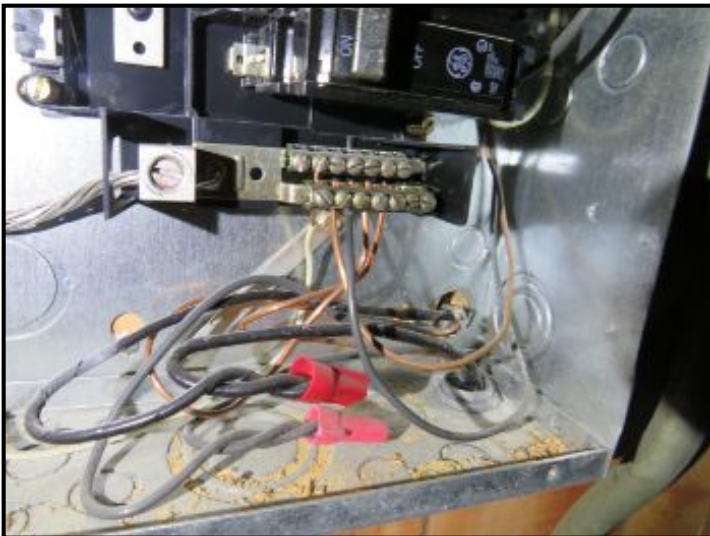
- **One or more screws are missing from the main service panel cover. Recommend replacing missing screws.**

- **There is a sub panel in the shed. The ground wires and neutral wires are connected to the same buss bar. Grounds and neutrals should be separated in sub panels. Recommend repair by a licensed electrical contractor.**

- **Knockouts need snap-in caps inside panel box. Should be installed to keep mice out of panel box and to avoid potential electrocution hazard.**

- **There are some questionable splices inside the electrical panel. It appears that the main 100 amp wire is split for two separate boxes. Recommend evaluation by a licensed electrician.**

Because live wiring may exist behind the holes with the missing screws, recommend that a qualified, licensed electrician replace these screws, or that care be taken to ensure that the new screws don't come in contact with wiring inside the panel when they're installed.

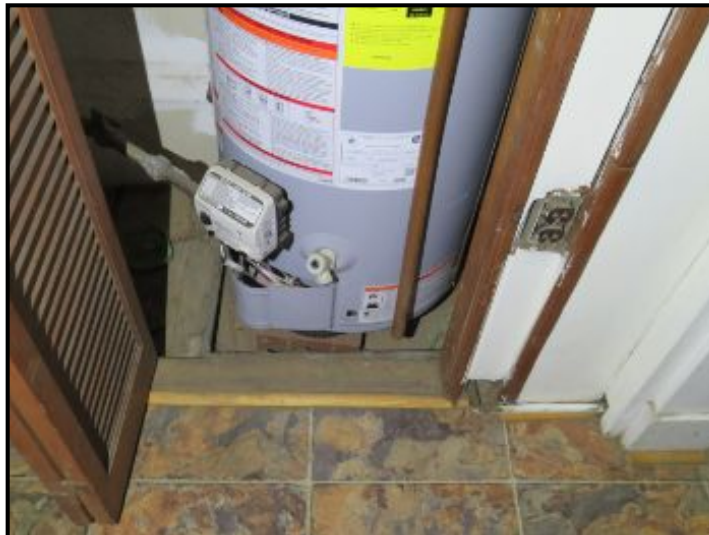
- Recommend installing a catch pan under the water heater.

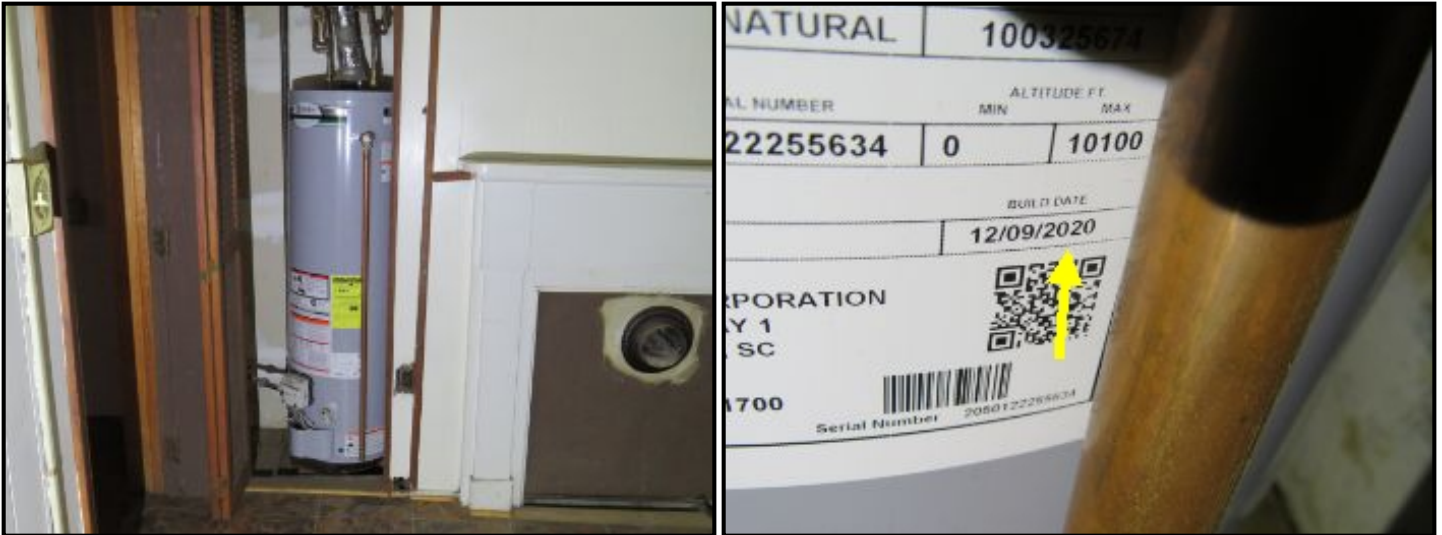
- The home is equipped with a gas water heater that could not be operated at the time of the inspection.

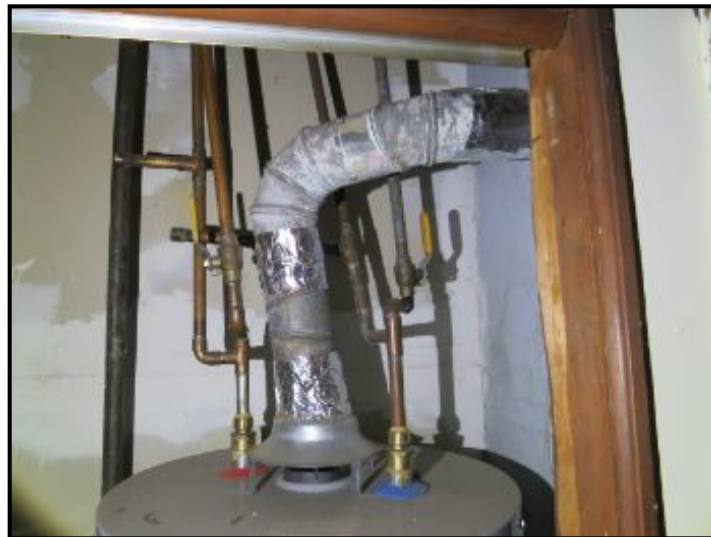
- Minimum water heater single-wall vent pipe clearance from combustible material is 6".

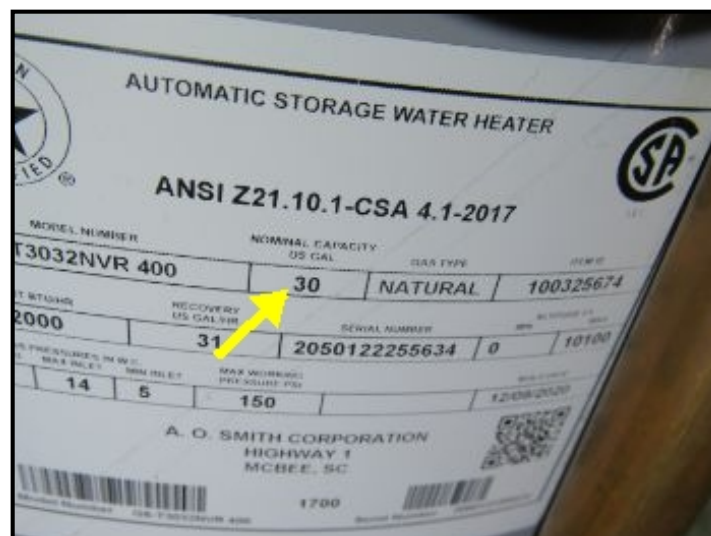
11. Number Of Gallons

- 30 gallons

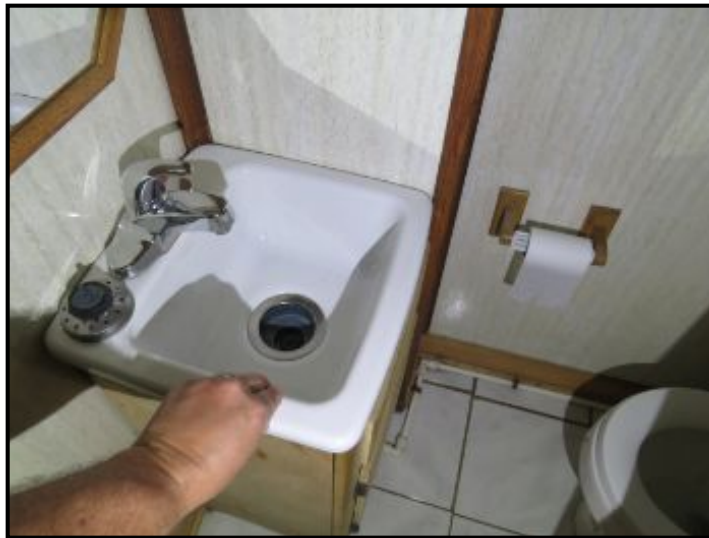
- Solid Surface tops noted.
- Granite tops noted.
- **The counter tops appear to be loose on the cabinet. We recommend having a qualified contractor re-fasten them.**

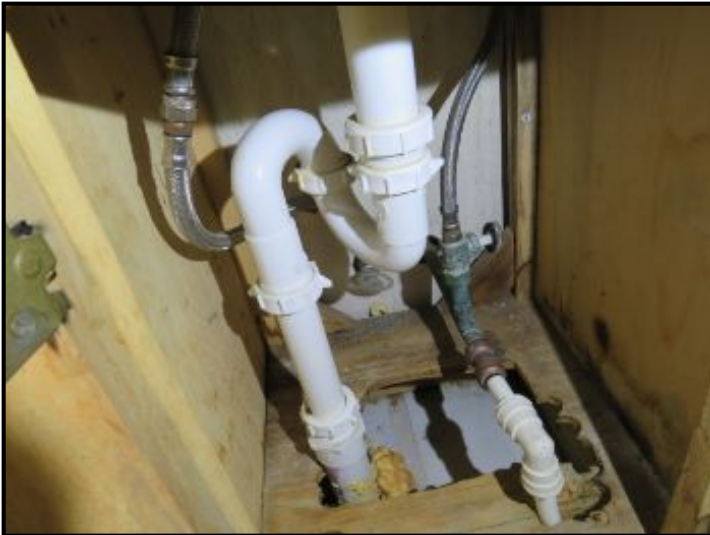
• **Improper "S" trap noted.** This trap configuration may cause the trap to siphon dry, allowing sewer gas and odor to enter the dwelling. This situation may be rectified by the installation of an anti siphon device (cheater vent). Suggest repair by a qualified professional. In the alternative, run a little bit of water into the sink to reseal the trap if odor is detected.

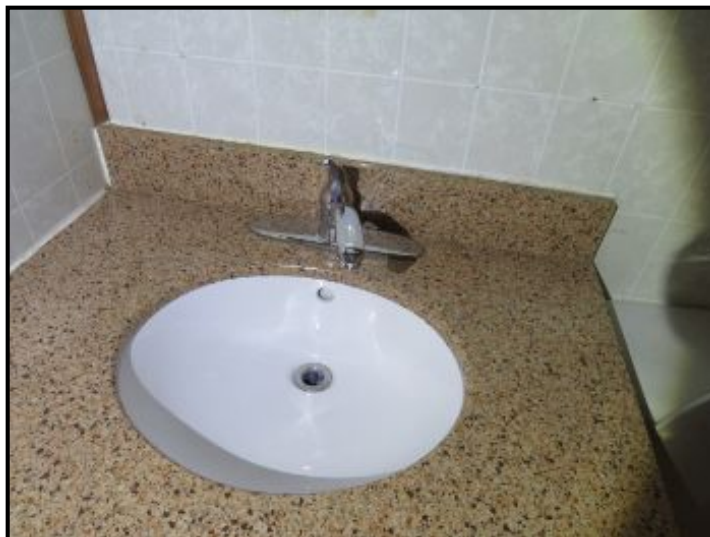
- Note that without water the sink(s) and dishwasher could not be evaluated.
- **The sink stopper linkage is damaged or disconnected and does not function properly. Recommend repair by a licensed plumbing contractor.**
- **There is PVC supply lines laying on the floor in the bathroom area. Recommend repair by a licensed plumbing contractor.**

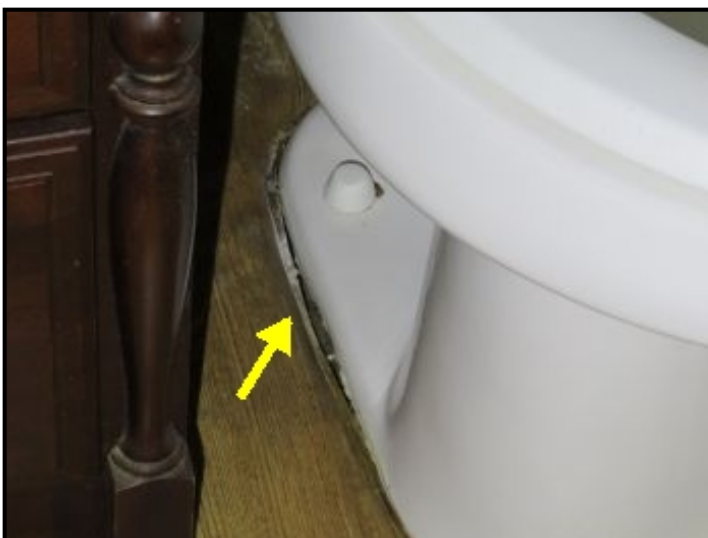
10. Toilets

- The toilet is loose at the floor. Recommend repair by a licensed plumbing contractor.
- The floor is sunk down at the back of the toilet. Recommend repair by a licensed contractor.
