Commission for Architectural Review

Application for Certificate of Appropriateness

Address: 529 Mosby Street
Union Hill
Historic District: _____

Conceptual review to determine the status of the existing dwelling at 529 Mosby Street.

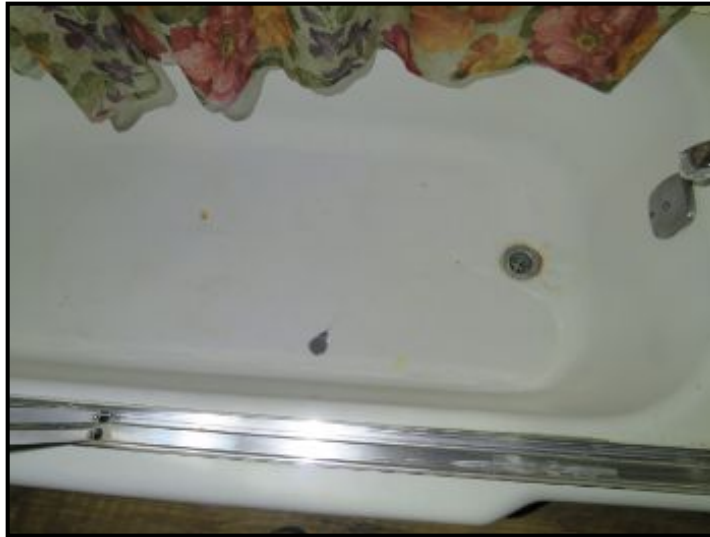
11. Bath Tubs

- There is a chip in the bath tub finish noted.

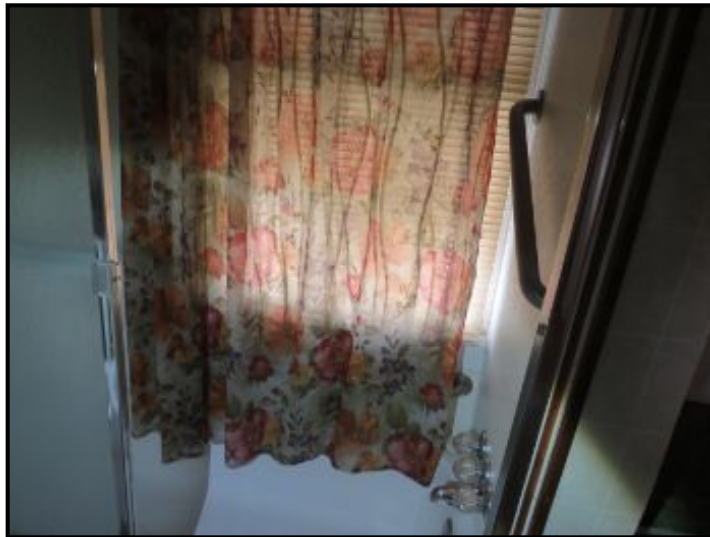
- **The window in the shower at the bathroom is not tempered glass. This window is accessible from the bathroom tub. This is a safety issue. Recommend repair/replace by a licensed contractor.**

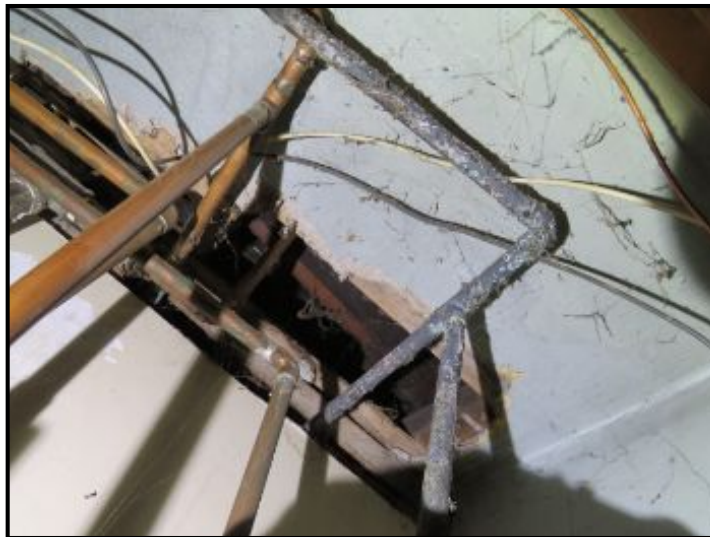
• **There is missing drywall or plaster noted in the hall closets. Recommend repair by a licensed contractor.**

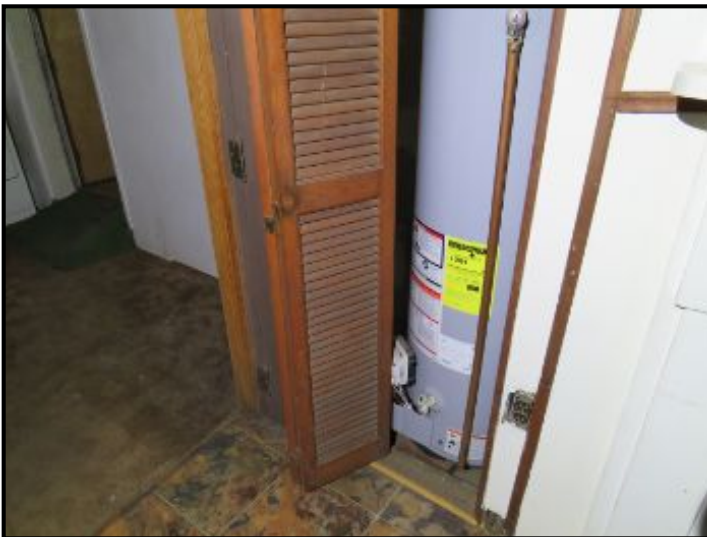
- Some doors do not latch properly or stick in the frame when closed. Recommend repair by a licensed contractor. 200.00 - 300.00
- Some doors drag the floor when opening. Recommend repair by a licensed contractor.
- Some bi-fold doors are out of the track. Recommend repair by a licensed contractor.
- Bedroom door is missing doorknob & hardware.

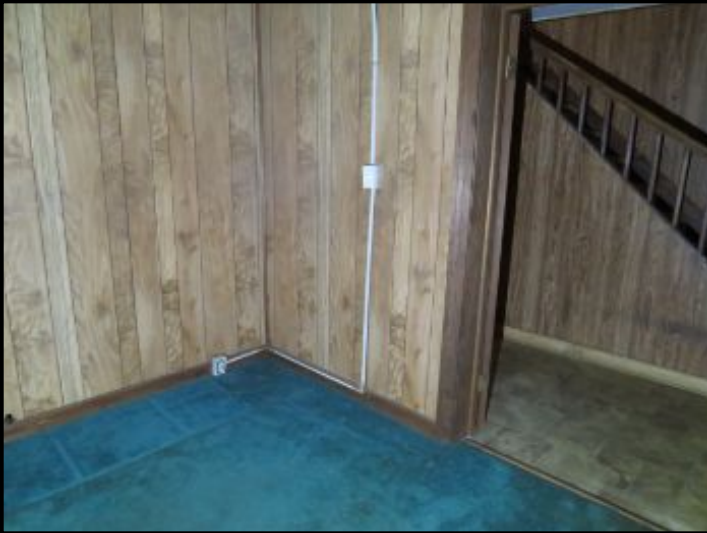
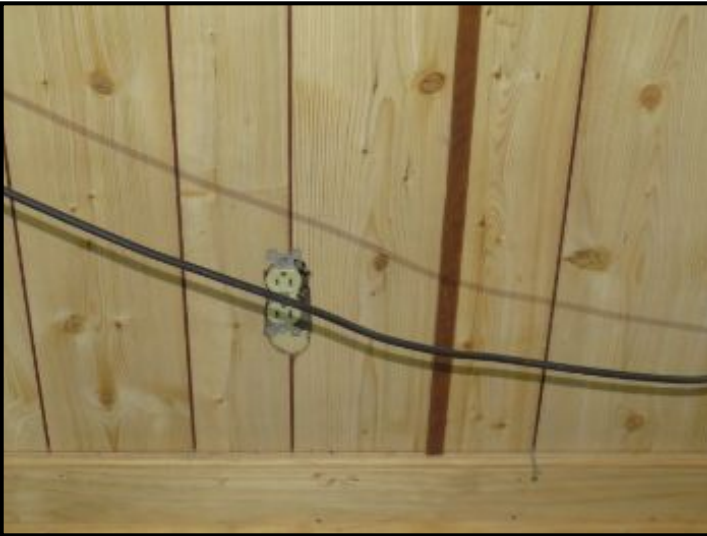
- **Cover plate(s) are missing from one or more electric receptacle boxes. They are intended to contain fire and prevent electric shock from exposed wires. This is a safety hazard and poses a risk of both fire and shock. Recommend installing cover plates over receptacle boxes where missing.**
- **Electrical connections made out side of a covered junction box. This is a safety fire hazard. Recommend repair by a licensed Electrical contractor.**

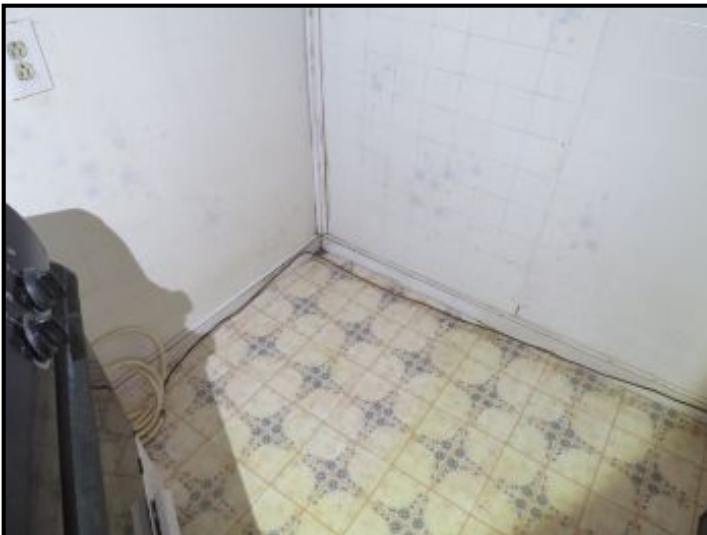
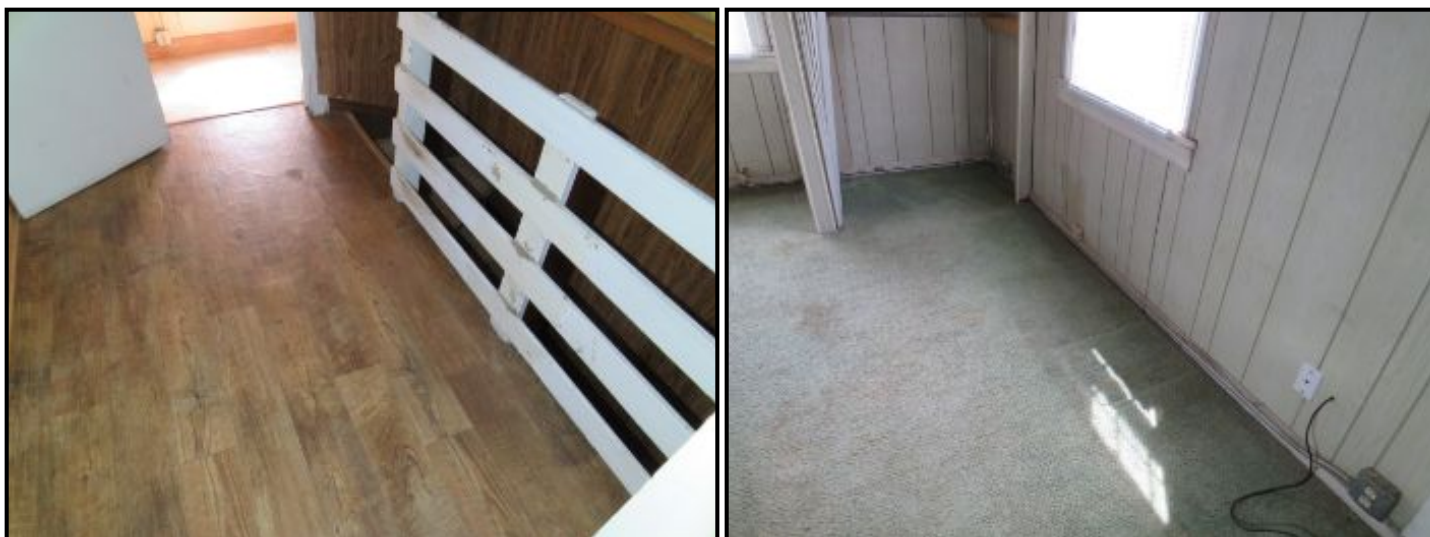
- Some stained or faded carpets noted.
- The hardwood flooring is scuffed and stained in some areas..
- Walking on some sections of the floor results in squeaking or creaking noises. This is usually the result of substandard construction practices where the subfloor decking isn't adequately fastened (insufficient glue) to the framing below. In most cases, this is an annoyance only rather than a structural problem. Various solutions such as [[url="http://www.oberry-enterprises.com"](http://www.oberry-enterprises.com)]Squeeeeeek No More and Counter Snap fasteners[/url] exist to correct this. Repairs to eliminate the squeaks or creaks may be more or less difficult depending on there being finished hardwood floors, carpeting over the subfloor, and/or clear access to the underside of the subfloor. Recommend having a qualified contractor evaluate and repair as necessary.

- Some of the floors in this building are a vintage 9" x 9" size; be advised that these tiles may be the type that had an adhesive containing asbestos. Asbestos is a health risk when it is made friable - in other words, when its fibres and dust can be breathed in by the lungs. To be safe, please refrain from removal and damaging these tiles until it is certain they are not asbestos containing material.

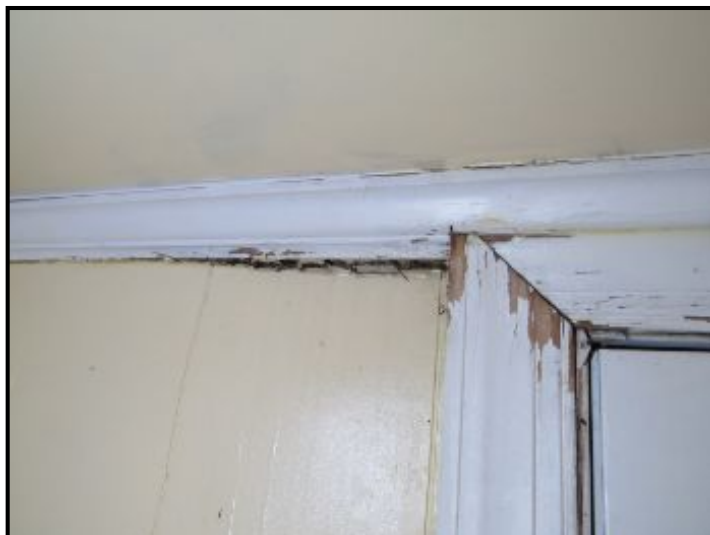
- **There is evidence of moisture in the second floor wall at the back of the home. Recommend evaluation for repair by a licensed contractor.**

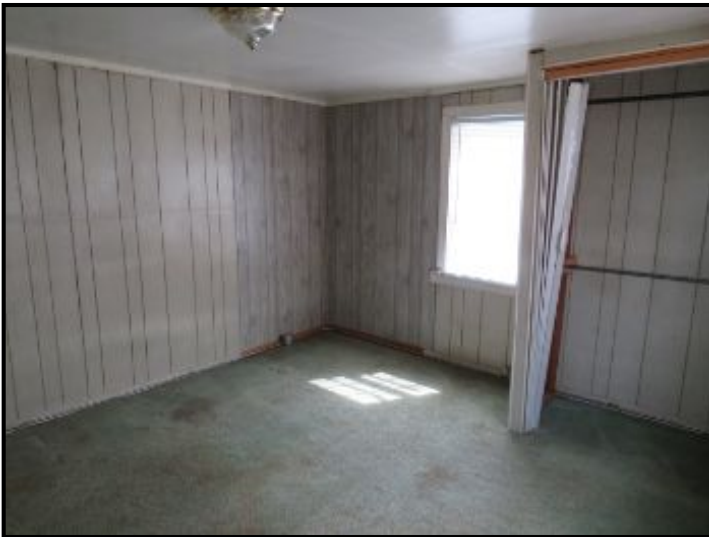
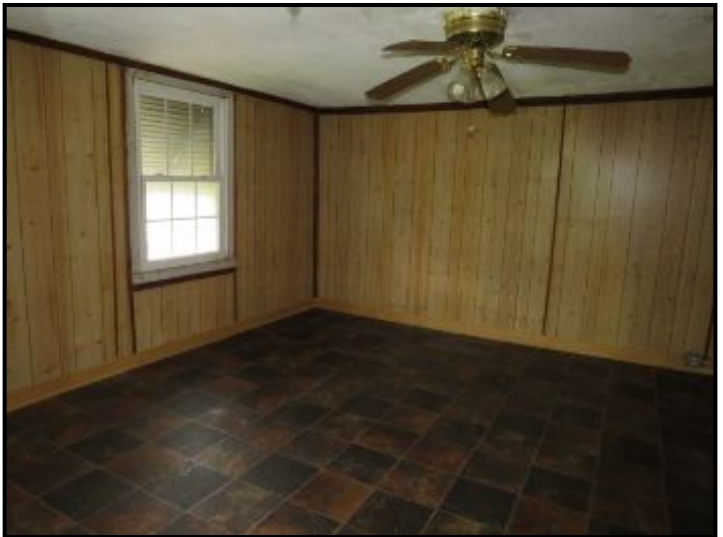
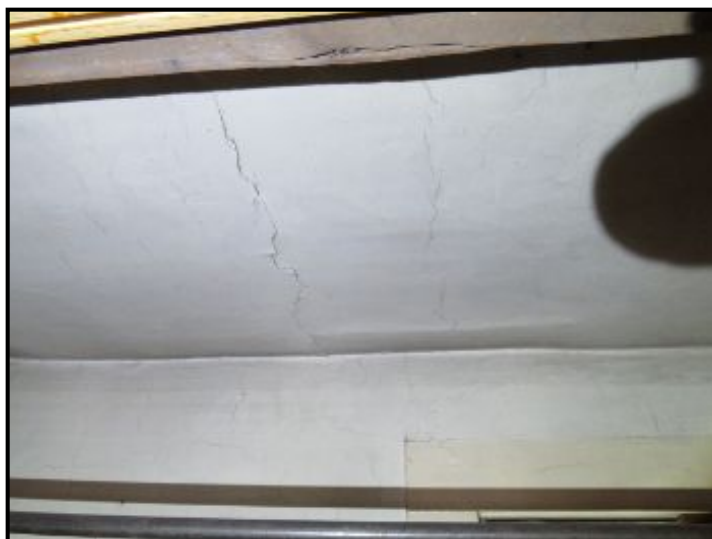
• This home was built before 1978, when laws were enacted in the US preventing the use of lead paint in residential structures. Lead paint may be present, and is a known safety hazard, especially to children but also to adults. It may cause brain damage and retarded mental and physical development, among other things. The paint found in and around this structure appeared to be intact and most likely encapsulated by more recent layers of paint that's not lead-based. However, recommend following precautions as described in the following links to Consumer Products Safety Commission website articles regarding possible lead paint.

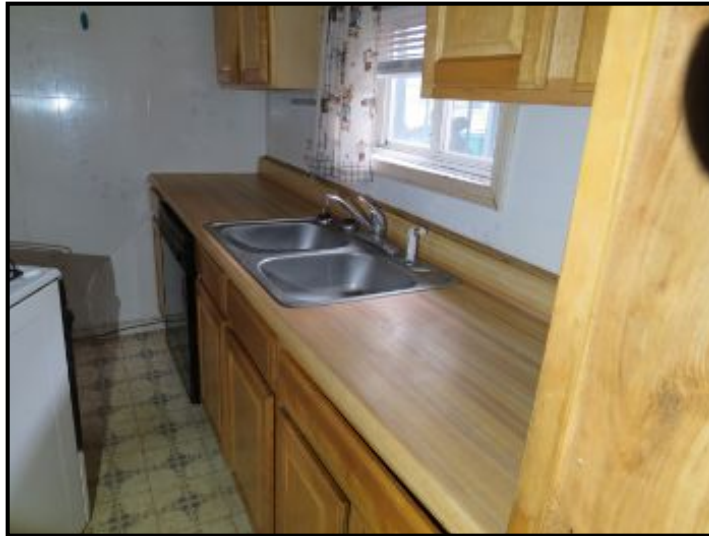
- Plastic laminate tops noted.

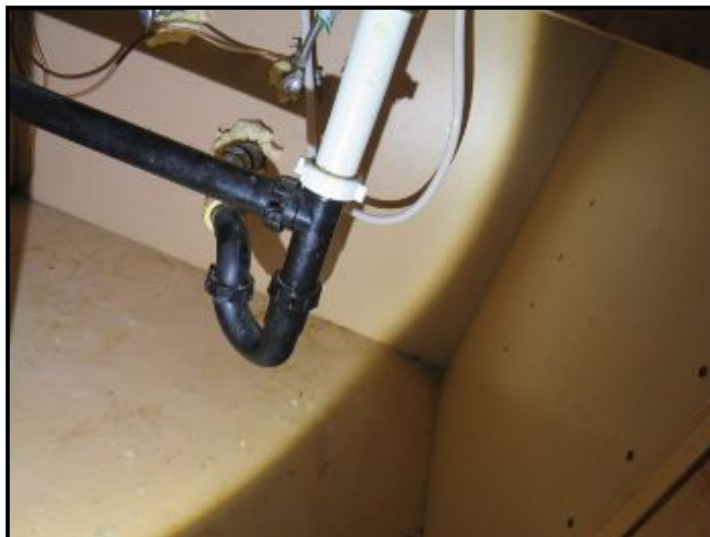
- **Flex drain observed, these are subject to frequent clogging.**

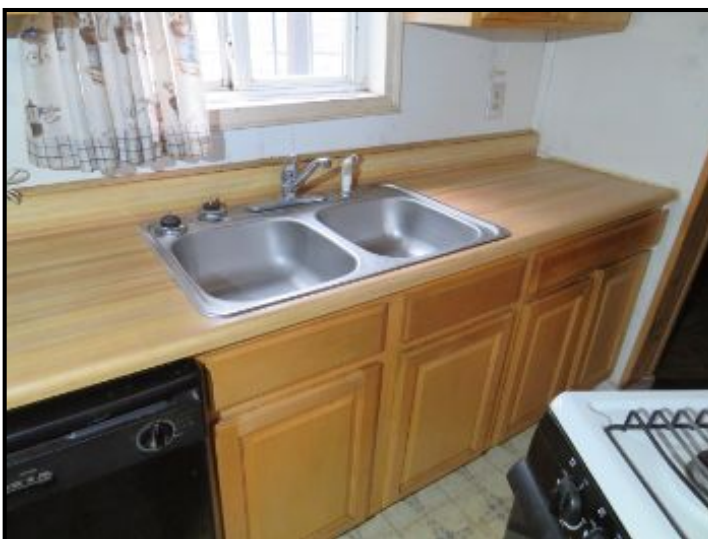
- **The sink could not be tested. The water is not turned on at the meter.**
