## 2. COA-077142-2020

2216 Venable Street

# Commission of Architectural Review

**Rehabilitate a semi-attached brick home and construct a small addition in the rear.**

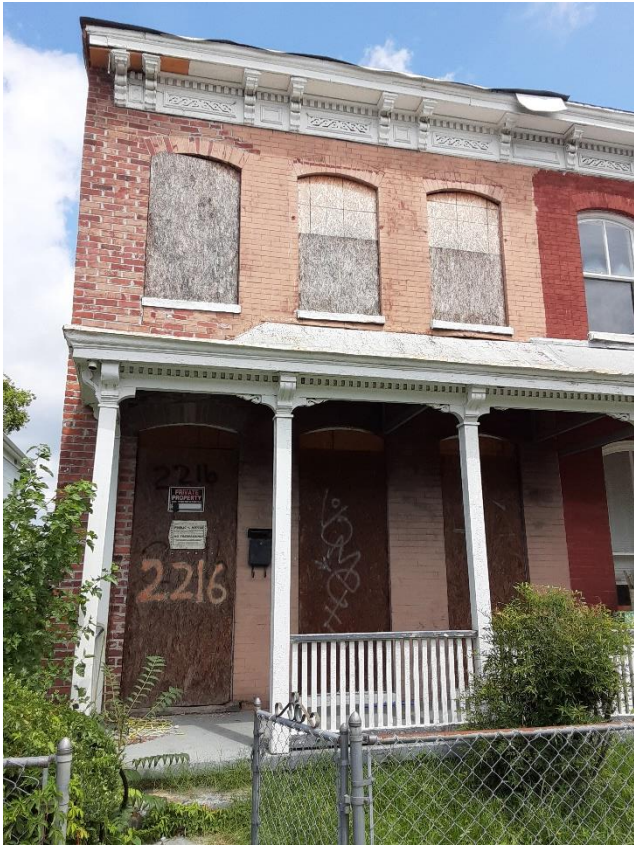
Figure 1. 2216 Venable Street, façade

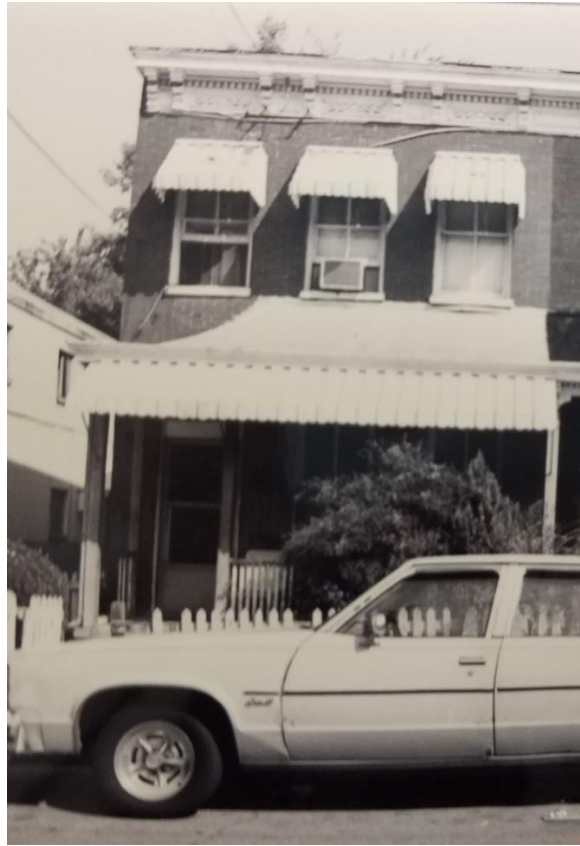
Figure 2. 2216 Venable, 1993

<p>Photographs of the building indicate that the second story façade windows were historically 2/2. <u>Staff recommends the applicant work with staff to restore the historic 2/2 light configuration.</u></p>
<p>Windows, #4 pg. 69</p>	<p><i>Boarded windows should be uncovered and repaired. If the resulting window opening is no longer functional, the glass should be retained and frosted, screened or shuttered from the interior. The window should appear to be functional from the exterior.</i></p>	<p>The second-story floor plans indicate a window in the rear will be bisected by a new closet wall. <u>Staff recommends this window be enclosed from the interior only, preserving the exterior appearance of the window.</u></p>
<p>Roof Repair #3, pg. 66</p>	<p><i>Substitute materials may be used if the same kind of material is not technically feasible because the material is no longer being made. Substitute materials should match the original style and form as much as possible.</i></p>	<p>The application does not indicate whether any roofs will be replaced, however existing conditions indicate that some roof replacement will be necessary. <u>Staff recommends details for the roof replacement, including materials specifications, be submitted for administrative approval.</u></p>

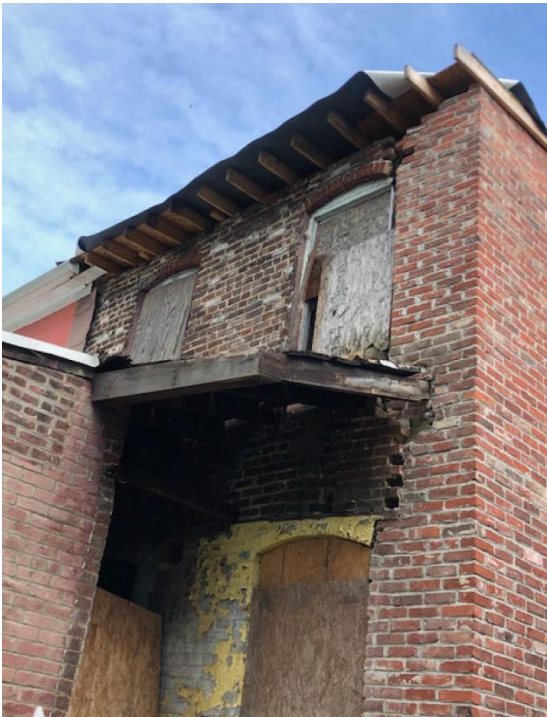
Figure 3. Structural damage at rear wall

- The rear wall be rebuilt to match the existing brick wall, including replicating the brick pattern and window arches and openings.
- The new front door be of a simple design.
