## 4. COA-053436-2019

# Commission of Architectural Review

## STAFF REPORT

**Rehabilitate two semi-attached, single-family residences.**

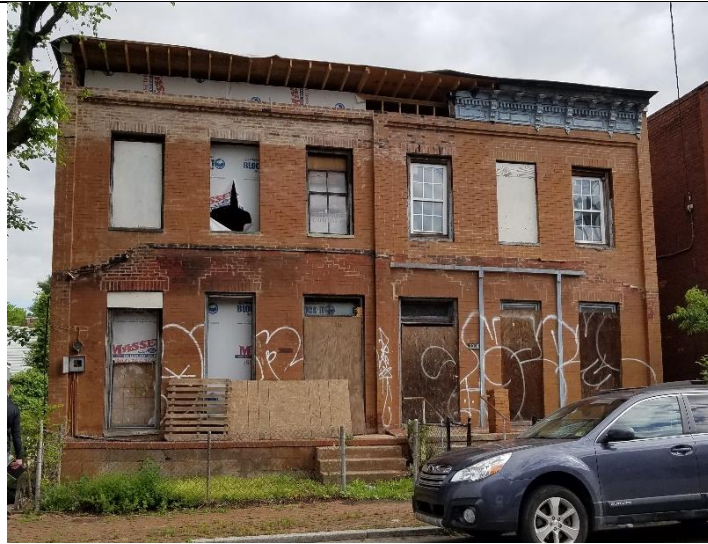
Figure 1. 2304-2306 Venable Street, May 2019

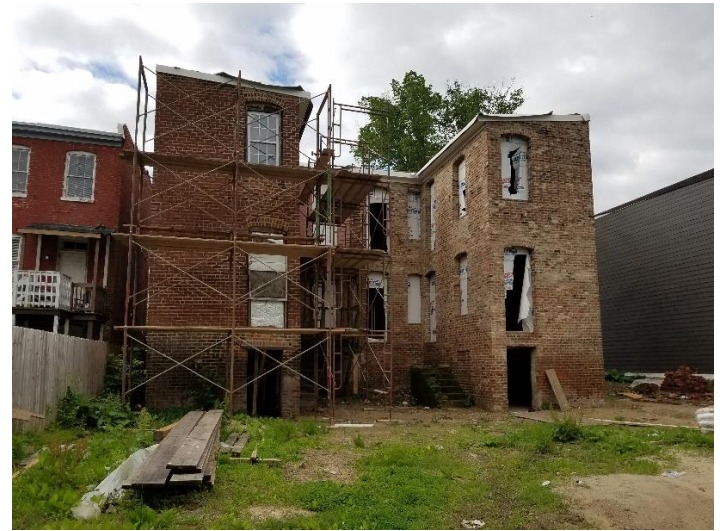
Figure 2. Rear, May 2019

The applicant is proposing to infill two doors on the second story of the rear wall of each building. Sanborn maps do not show a rear porch in this location. Though the Guidelines discourage the infilling of existing masonry openings, photographic evidence shows that the opening at 2306 had previously been converted to a window. Staff recommends the existing arches and jambs of the doors be maintained and the new windows fit between the jambs of the existing opening.

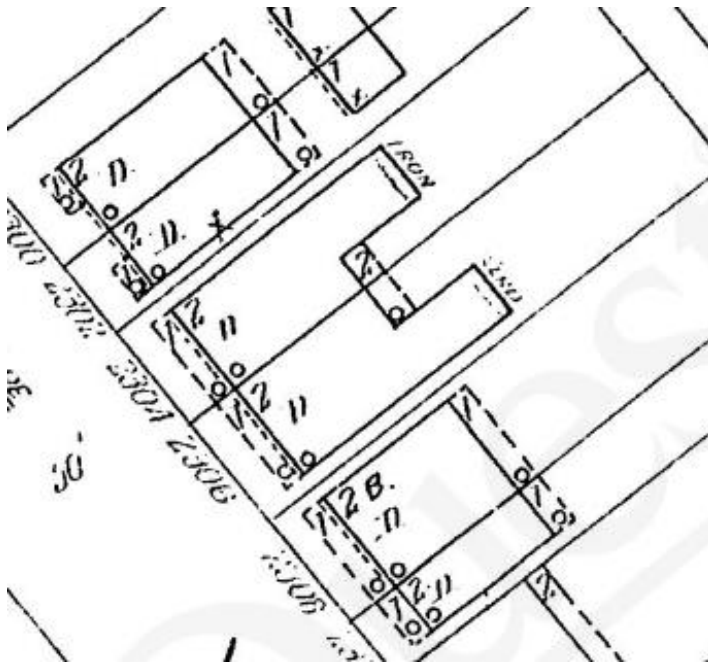
Figure 3. 1905 Sanborn Map

The applicant is proposing to construct a small frame addition at the rear of both buildings. Sanborn maps indicate that historically there was a two story porch in this location. Though no physical evidence of the porch remains, the new addition should reflect the appearance of a porch to create an understanding of the historic construction. Staff recommends the design of the addition be modified in a manner to be administratively reviewed and approved by staff to limit the use of solid panels by including additional glazing and shutters if the addition of glazing does not accommodate the desired floor plans.

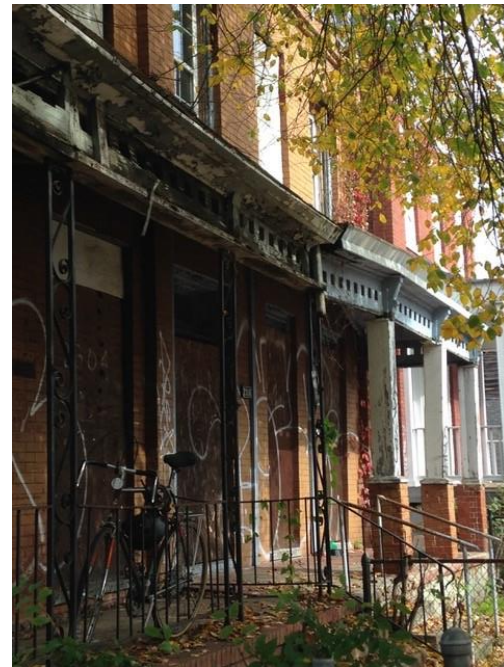
Figure 4. Front porches, November 2017

The applicant proposes to rebuild the front porches, using the design of the front porch at 2306 for both units. Staff has located photographic evidence which shows that the brick piers are not the original front porch design. Historic photographs show turned posts which align with the cornice brackets. The railing designs shown in the photographs are not clear. As the Guidelines recommend replacement porches match the original as much as possible, staff recommends the front porches have turned wooden posts which align with the porch cornice brackets, and a Richmond rail. Revised elevations should be submitted to staff for administrative review.

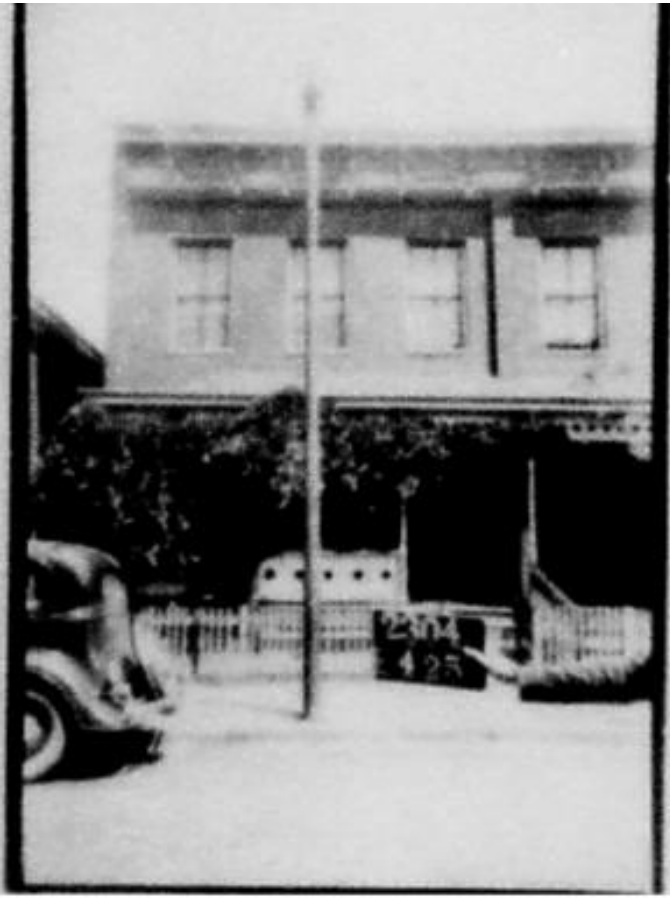
Figure 5. 2304 Venable Street, ca. 1934-1956

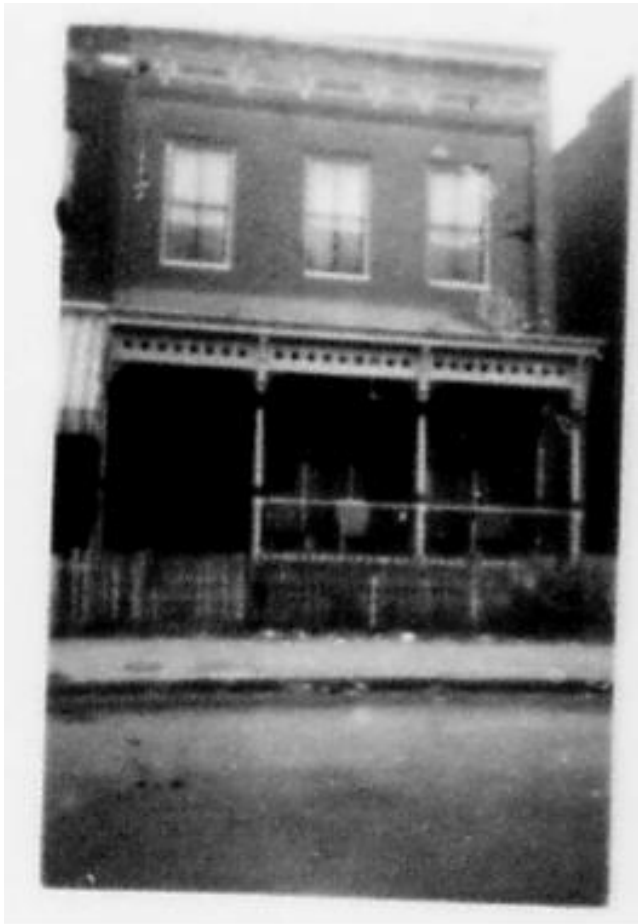
Figure 6. 2306 Venable Street, ca. 1957-1977
