Staff Report
City of Richmond, Virginia

Commission of Architectural Review

10. COA-166151-2025	Final Review	Meeting Date: 5/27/2025
Applicant/Petitioner	Allan Rosenbaum	
Project Description	Replace various components of an existing storefront.	
Project Location		
Address: 3301 East Marshall Street		
Historic District: Chimborazo Park		
<p>High-Level Details:</p> <p>The applicant requests various alterations to an existing storefront on a two story, masonry, corner mixed-use building circa 1905.</p> <p>The applicant proposes to replace the existing storefront system with a new aluminum storefront assembly.</p> <p>The primary entrance door will be reconstructed to match the original door.</p>		
Staff Recommendation	Partial Approval	
Staff Contact	Alex Dandridge, alex.dandridge@rva.gov, (804) 646-6569	
Previous Reviews	None.	
Staff Recommendations	<p>Staff recommends Partial Approval of the application with the following conditions:</p> <ul style="list-style-type: none"> Staff recommends that the concrete be repoured to match the existing in height and footprint. Staff recommends that the knee wall be reconstructed to match the existing in height and design. <p>Staff recommends Deni

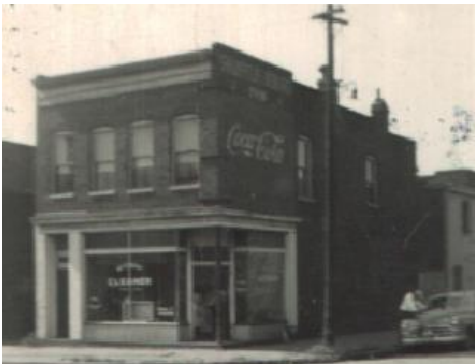
Figure 1. 3301 E. Marshall, City Assessor, 1950s.

Guideline Reference	Reference Text	Analysis
Standards for Rehabilitation, Commercial Construction, pg. 58	<p><i>1. Conduct pictorial research to determine the design of the original building. The Valentine Museum has an extensive collection of photographs of Richmond's 19th-century building stock to aid in this research. If no pictorial documentation is available, any new additions to the storefront design should respect the character, materials and architectural style of the entire building. If possible, careful exploratory demolition should be conducted to determine the extent and condition of all original materials. Consult a knowledgeable professional before beginning work.</i></p> <p><i>4. Materials and modifications typically considered inappropriate for use on most historic structures include: replacing historic wood storefront with aluminum storefront, enameled panels, stone veneer, textured wood siding, artificial siding, wood shingles, mansard roof, metal awnings and plastic shutters.</i></p>	<p>The applicant proposes to replace the existing storefront system with a new aluminum storefront system. The existing storefront wraps the corner of the building and features traditional storefront elements like transparent glass, a knee wall, and transom windows above the main storefront window, which are separated by a prominent band of horizontal molding.</p> <p>3301 East Marshall Street is a contributing resource to the Oakwood-Chimborazo National Register Historic District, and while not currently a commercial space, the building is associated with the small-scale commercial development on this block in the late 19th and early 20th century.</p> <p>Based on historic documentation, the storefront has been altered over time. A photograph from the City Assessor's office dating to the 1950s shows the storefront windows having fewer vertical divisions and a different knee wall. This would suggest that the windows have been replaced and are not original. The transoms and horizontal trims appear to be original to the storefront.</p> <p>While the extant storefront has some replacement materials, the materials have a profile and appearance more in-keeping with the district's storefronts than that of the proposed aluminum.</p> <p>New aluminum storefront system will have 2 ¼" mullions.</p> <p>Given that the guidelines consider modern aluminum storefront inappropriate replacements, <u>staff recommends denial of the replacement of the storefront with the aluminum system.</u></p> <p>If staff's condition carries, it is suggested that the owner rebuild the storefront with new wood or another material that better replicates the profile of the existing storefront, wood trim be added to the new storefront, or interior/exterior storms be added to the interior for double insulation.</p>

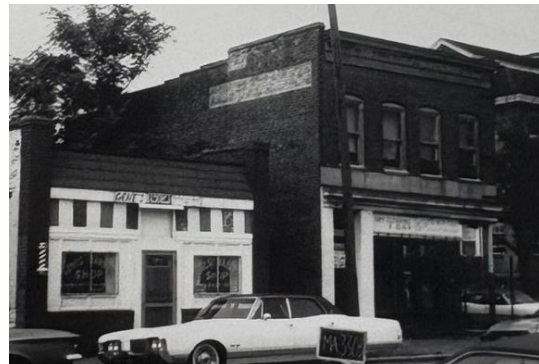
Figure 2. 3301 E. Marshall, HRF Survey 1970s

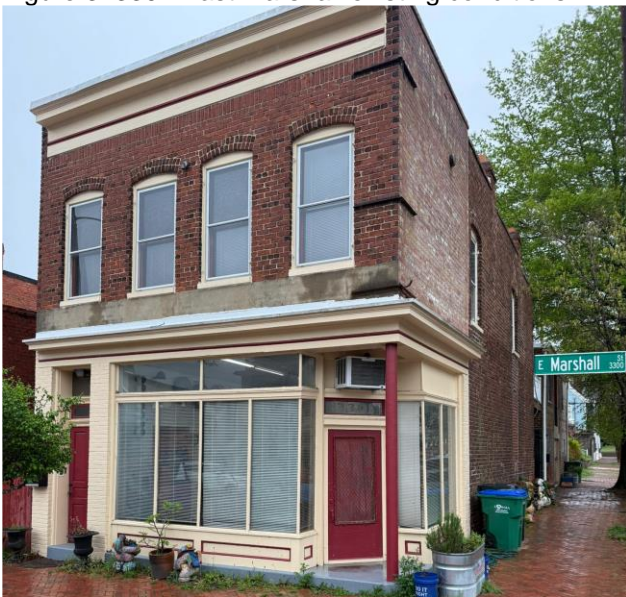
Figure 3. 3301 East Marshall existing conditions.

<p>The applicant proposes to remove and replace the existing concrete foundation/floor at the corner entrance and underneath of the storefront's knee wall, as well as the knee wall, itself. In the application, it is stated that the existing concrete is cracked and may be deficient, and the knee wall has rot. Based on historic photographs, the knee wall appears to have been replaced and is not the original. <u>Staff recommends that the concrete be repoured to match the existing in height and footprint.</u></p> <p><u>Staff recommends that the knee wall be reconstructed to match the existing in height and design.</u></p>
--	--	---
