3. COA-068521-2020

2017-2021 Monument Avenue

STAFF REPORT

Construct a three-story rear addition and porch; alter fenestration.

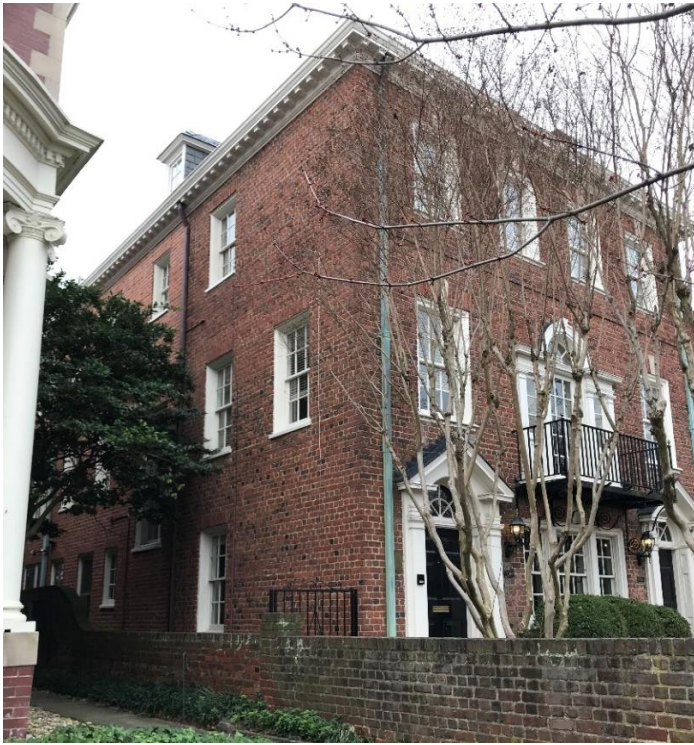
Figure 1. Façade and east elevation.

On the east elevation staff finds that the proposed arched window is not appropriate as it is not consistent with the design of the existing windows and is visible from Monument Avenue. Staff notes that the existing east elevation drawing is inaccurate as there is currently a window in this location. Staff recommends denial of the proposed arched window on the east elevation. Staff finds that the proposed alteration to the double window on this elevation is minimally visible from the public right-of-way, and is supportive of this change with the condition that the northern window of the pair remain and the brick in the opening to the right be inset.

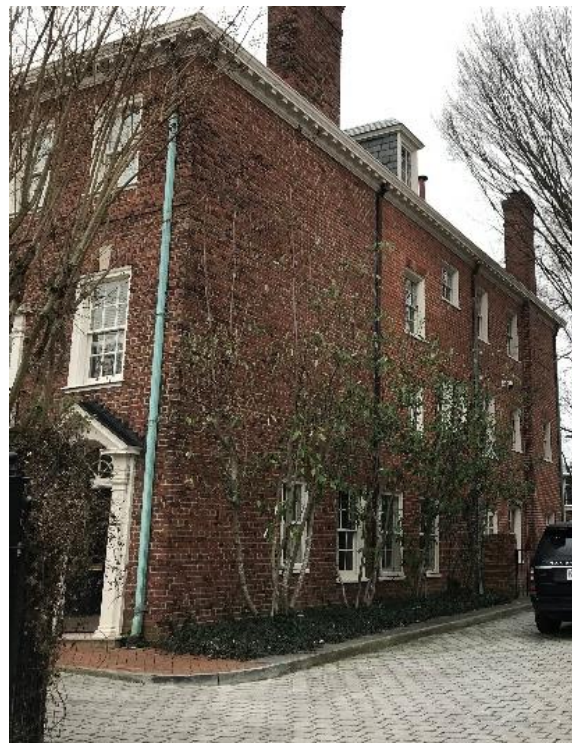
Figure 2. West elevation.

- Enlarge two existing windows to match other windows on this elevation.
- Change a double window to a single window.
- Reopen a previously enclosed window opening on the first story.
- Restore an original door opening on the first story.

The west elevation is highly visible from Monument Avenue as the building is located on a double lot with an open yard and parking area on this side. Some of the proposed changes attempt to recreate this façade as it was originally drawn by Duncan Lee. The 1927 plans do show a larger window on the third story, and a window on the first story beside a

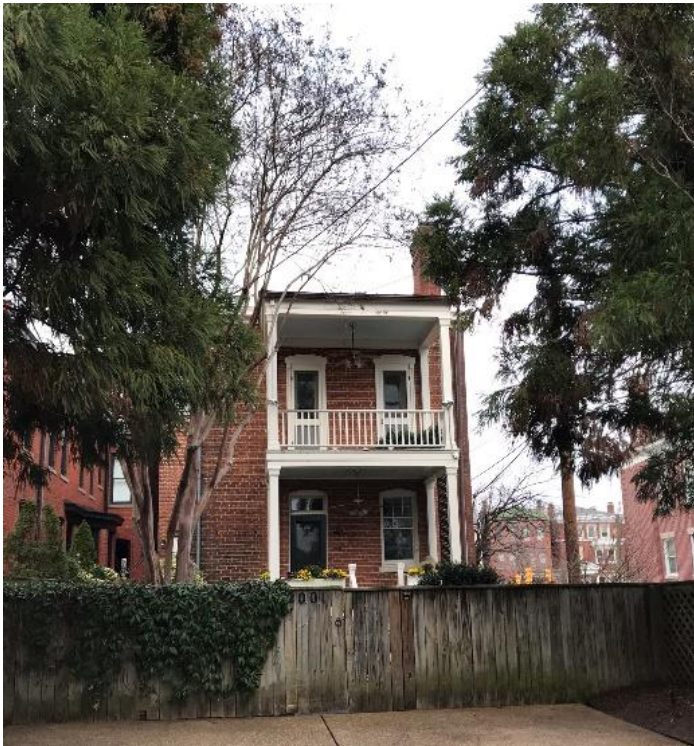
Figure 3. 2001 Monument Ave, rear porch.

<p>Porches, Entrances & Doors, pg. 71 #4</p>	<p><i>Front and side porches are architecturally more ornate than utilitarian back porches.</i></p>	<p>Staff finds that the proposed ornate double columns on the rear porch are not in keeping with the Guidelines, which state that rear porches are more utilitarian. Staff also notes that the façade of the building is understated, making an ornate rear porch incongruent with the overall design. Other rear porches and enclosed porches along this block of Monument Avenue are modest porches with simple square posts. <u>Staff recommends the rear porch design be simplified by utilizing single square posts, rather than the double round posts proposed.</u></p>
<p>Standards for Rehabilitation, pg. 59, #10</p>	<p><i>...adding features or salvaged architectural elements that suggest an inaccurate or undocumented sequence of construction should be avoided because this confuses our understanding of the evolution of Richmond's historic built environment.</i></p>	<p>Staff finds that the third-story solid addition reads as a porch enclosure, which confuses the sequence of construction as this area is new construction and not an enclosure of a porch. <u>Staff recommends this section be redesigned to not read as a porch enclosure.</u> This could be achieved by using a solid material that does not replicate columns and railings.</p>

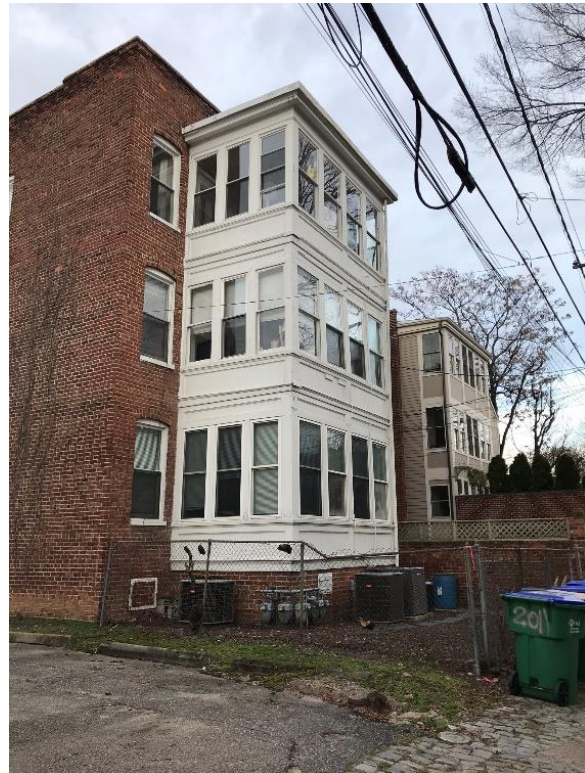
Figure 4. 2011 Monument Ave, enclosed rear porch.

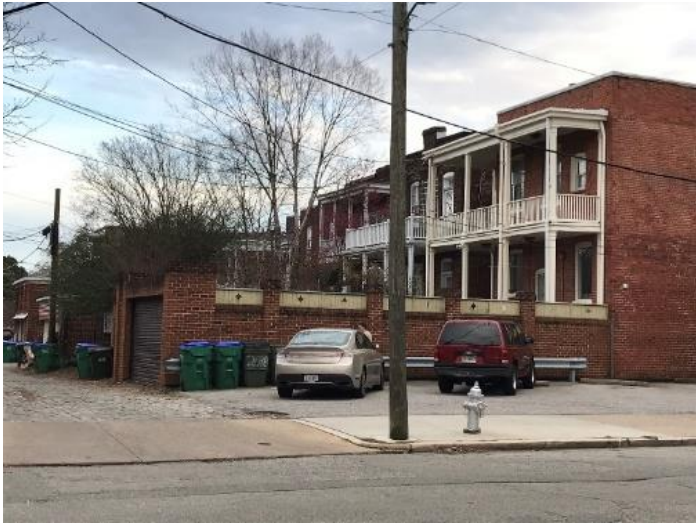
Figure 5. 2000 Block Monument Avenue, even side, rear elevations.

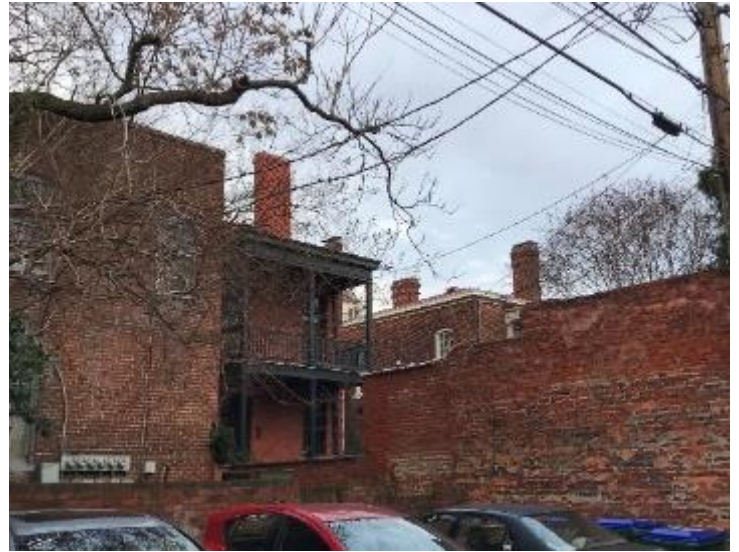
Figure 6. 2003 Monument Avenue, rear porch.
