St. Luke Building

900 St. James Street
 North District
 City of Richmond, Virginia

SHEET:
Layout & Utility and Grading & Drainage Plan
SHEET NO:

ST LUKE BUILDING
RICHMOND, VA 23220

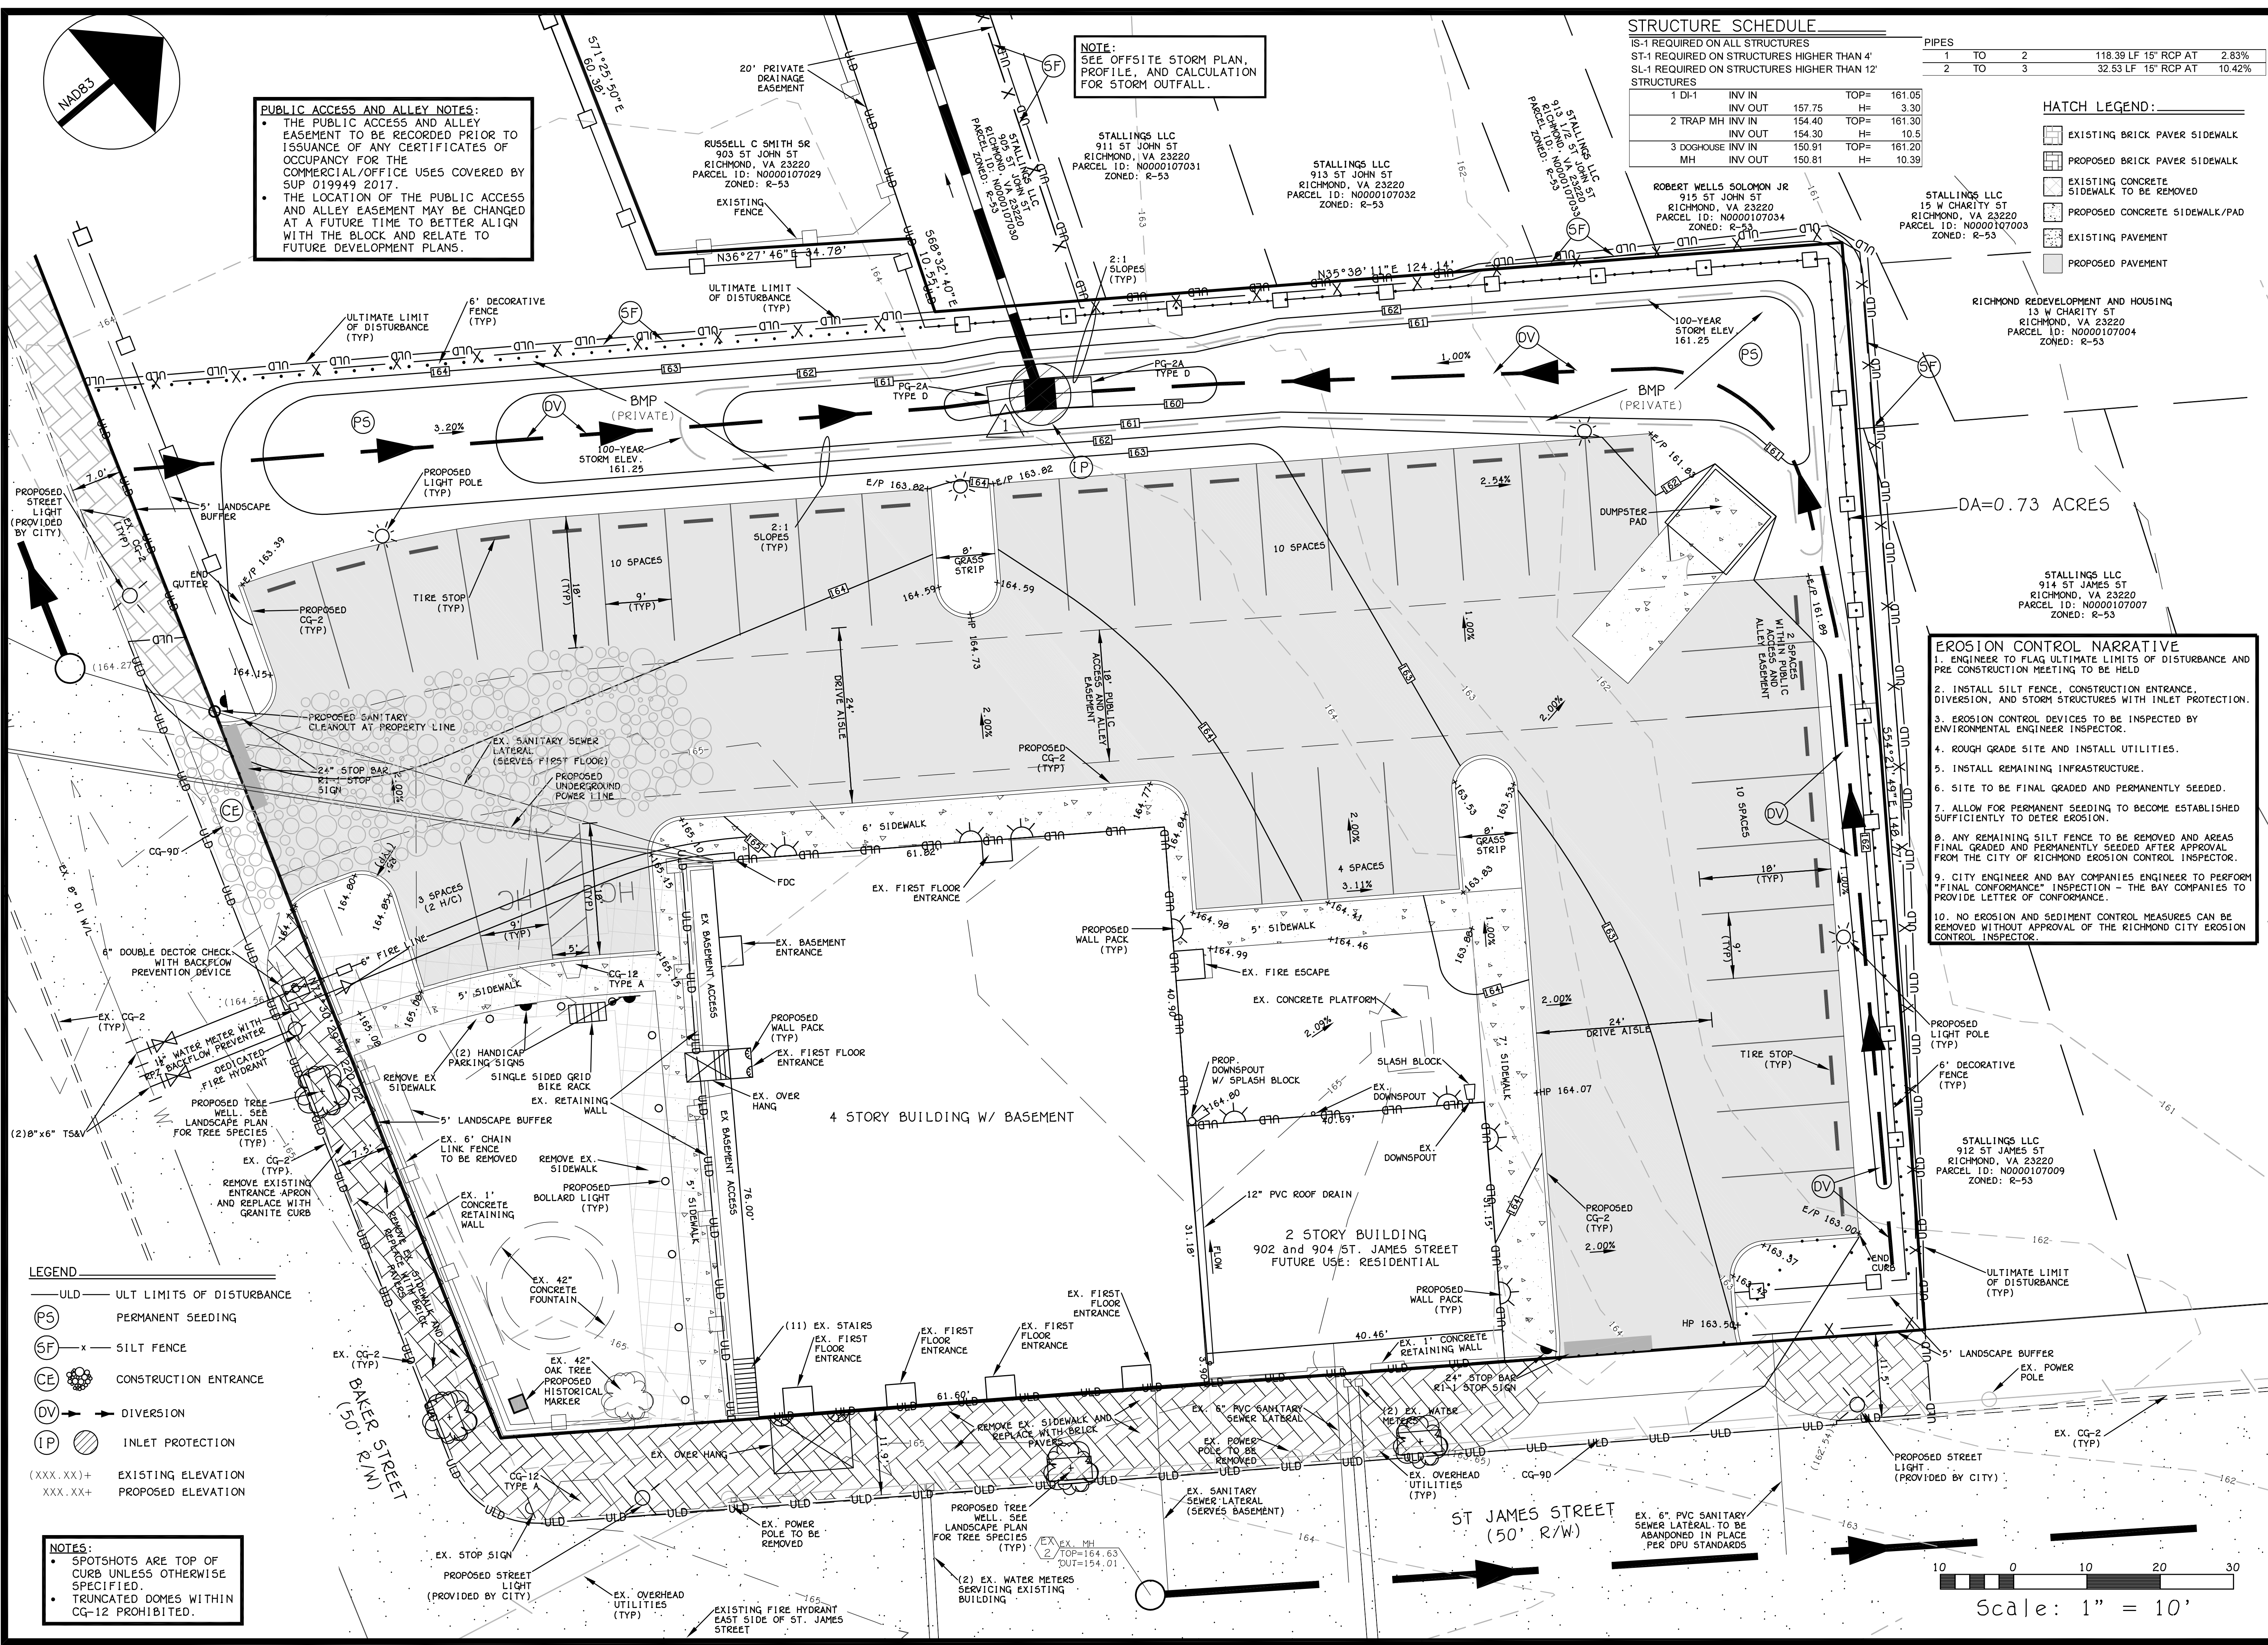
C2
JOB NO. 16038

- SPOTS ARE TOP OF CURB UNLESS OTHERWISE SPECIFIED.
- TRUNCATED DOMES WITHIN CG-12 PROHIBITED.

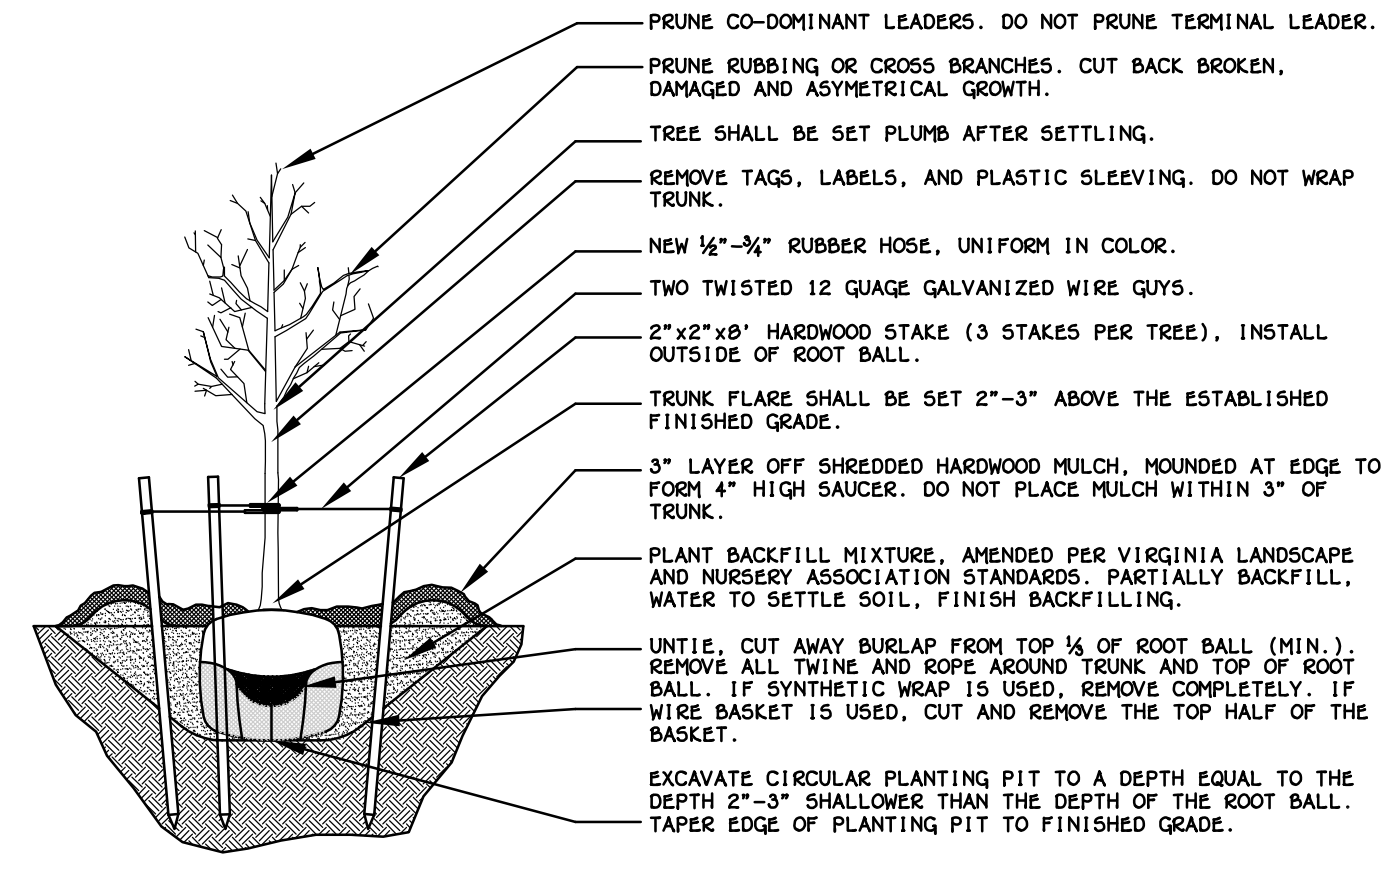
TREE PLANTING DETAIL

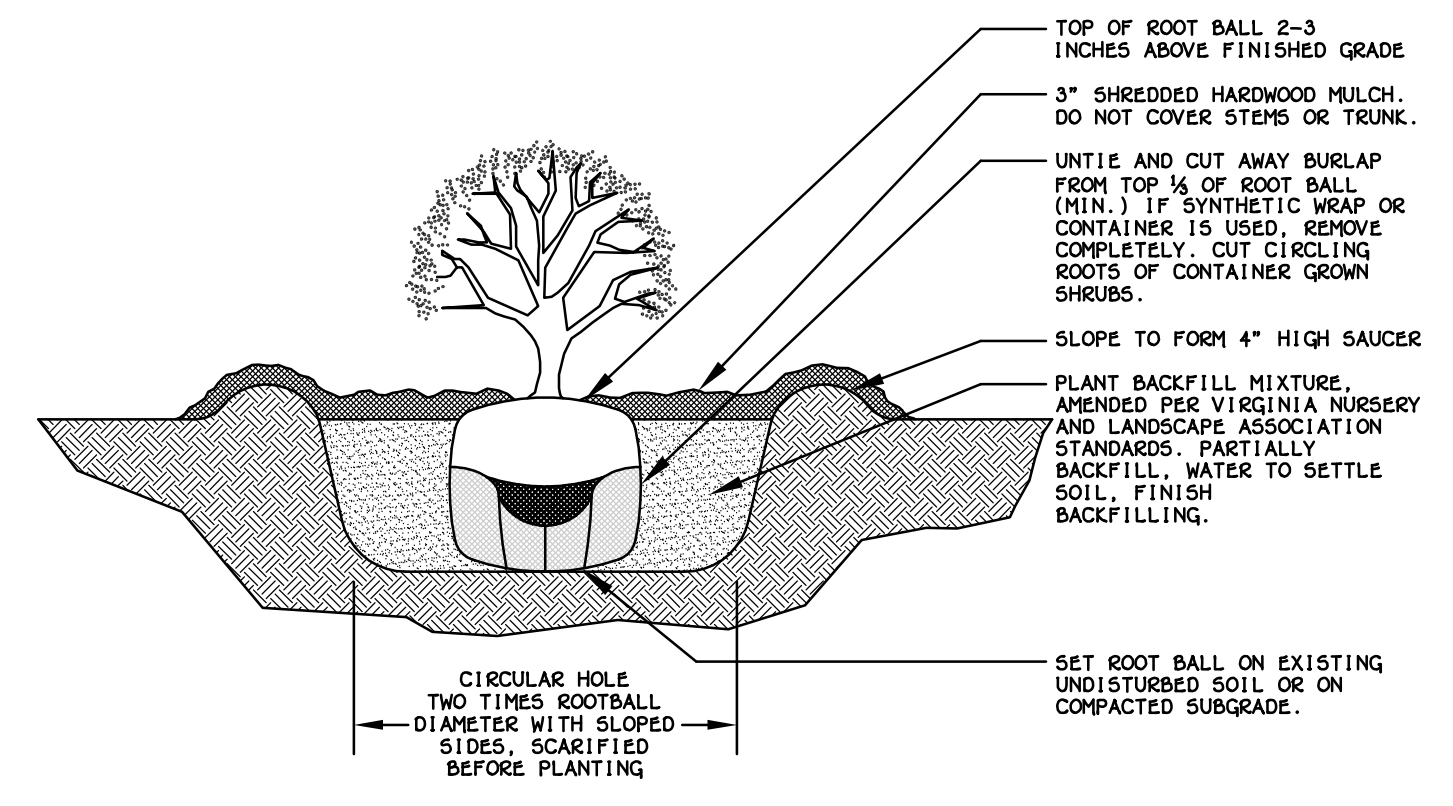
SHRUB PLANTING DETAIL

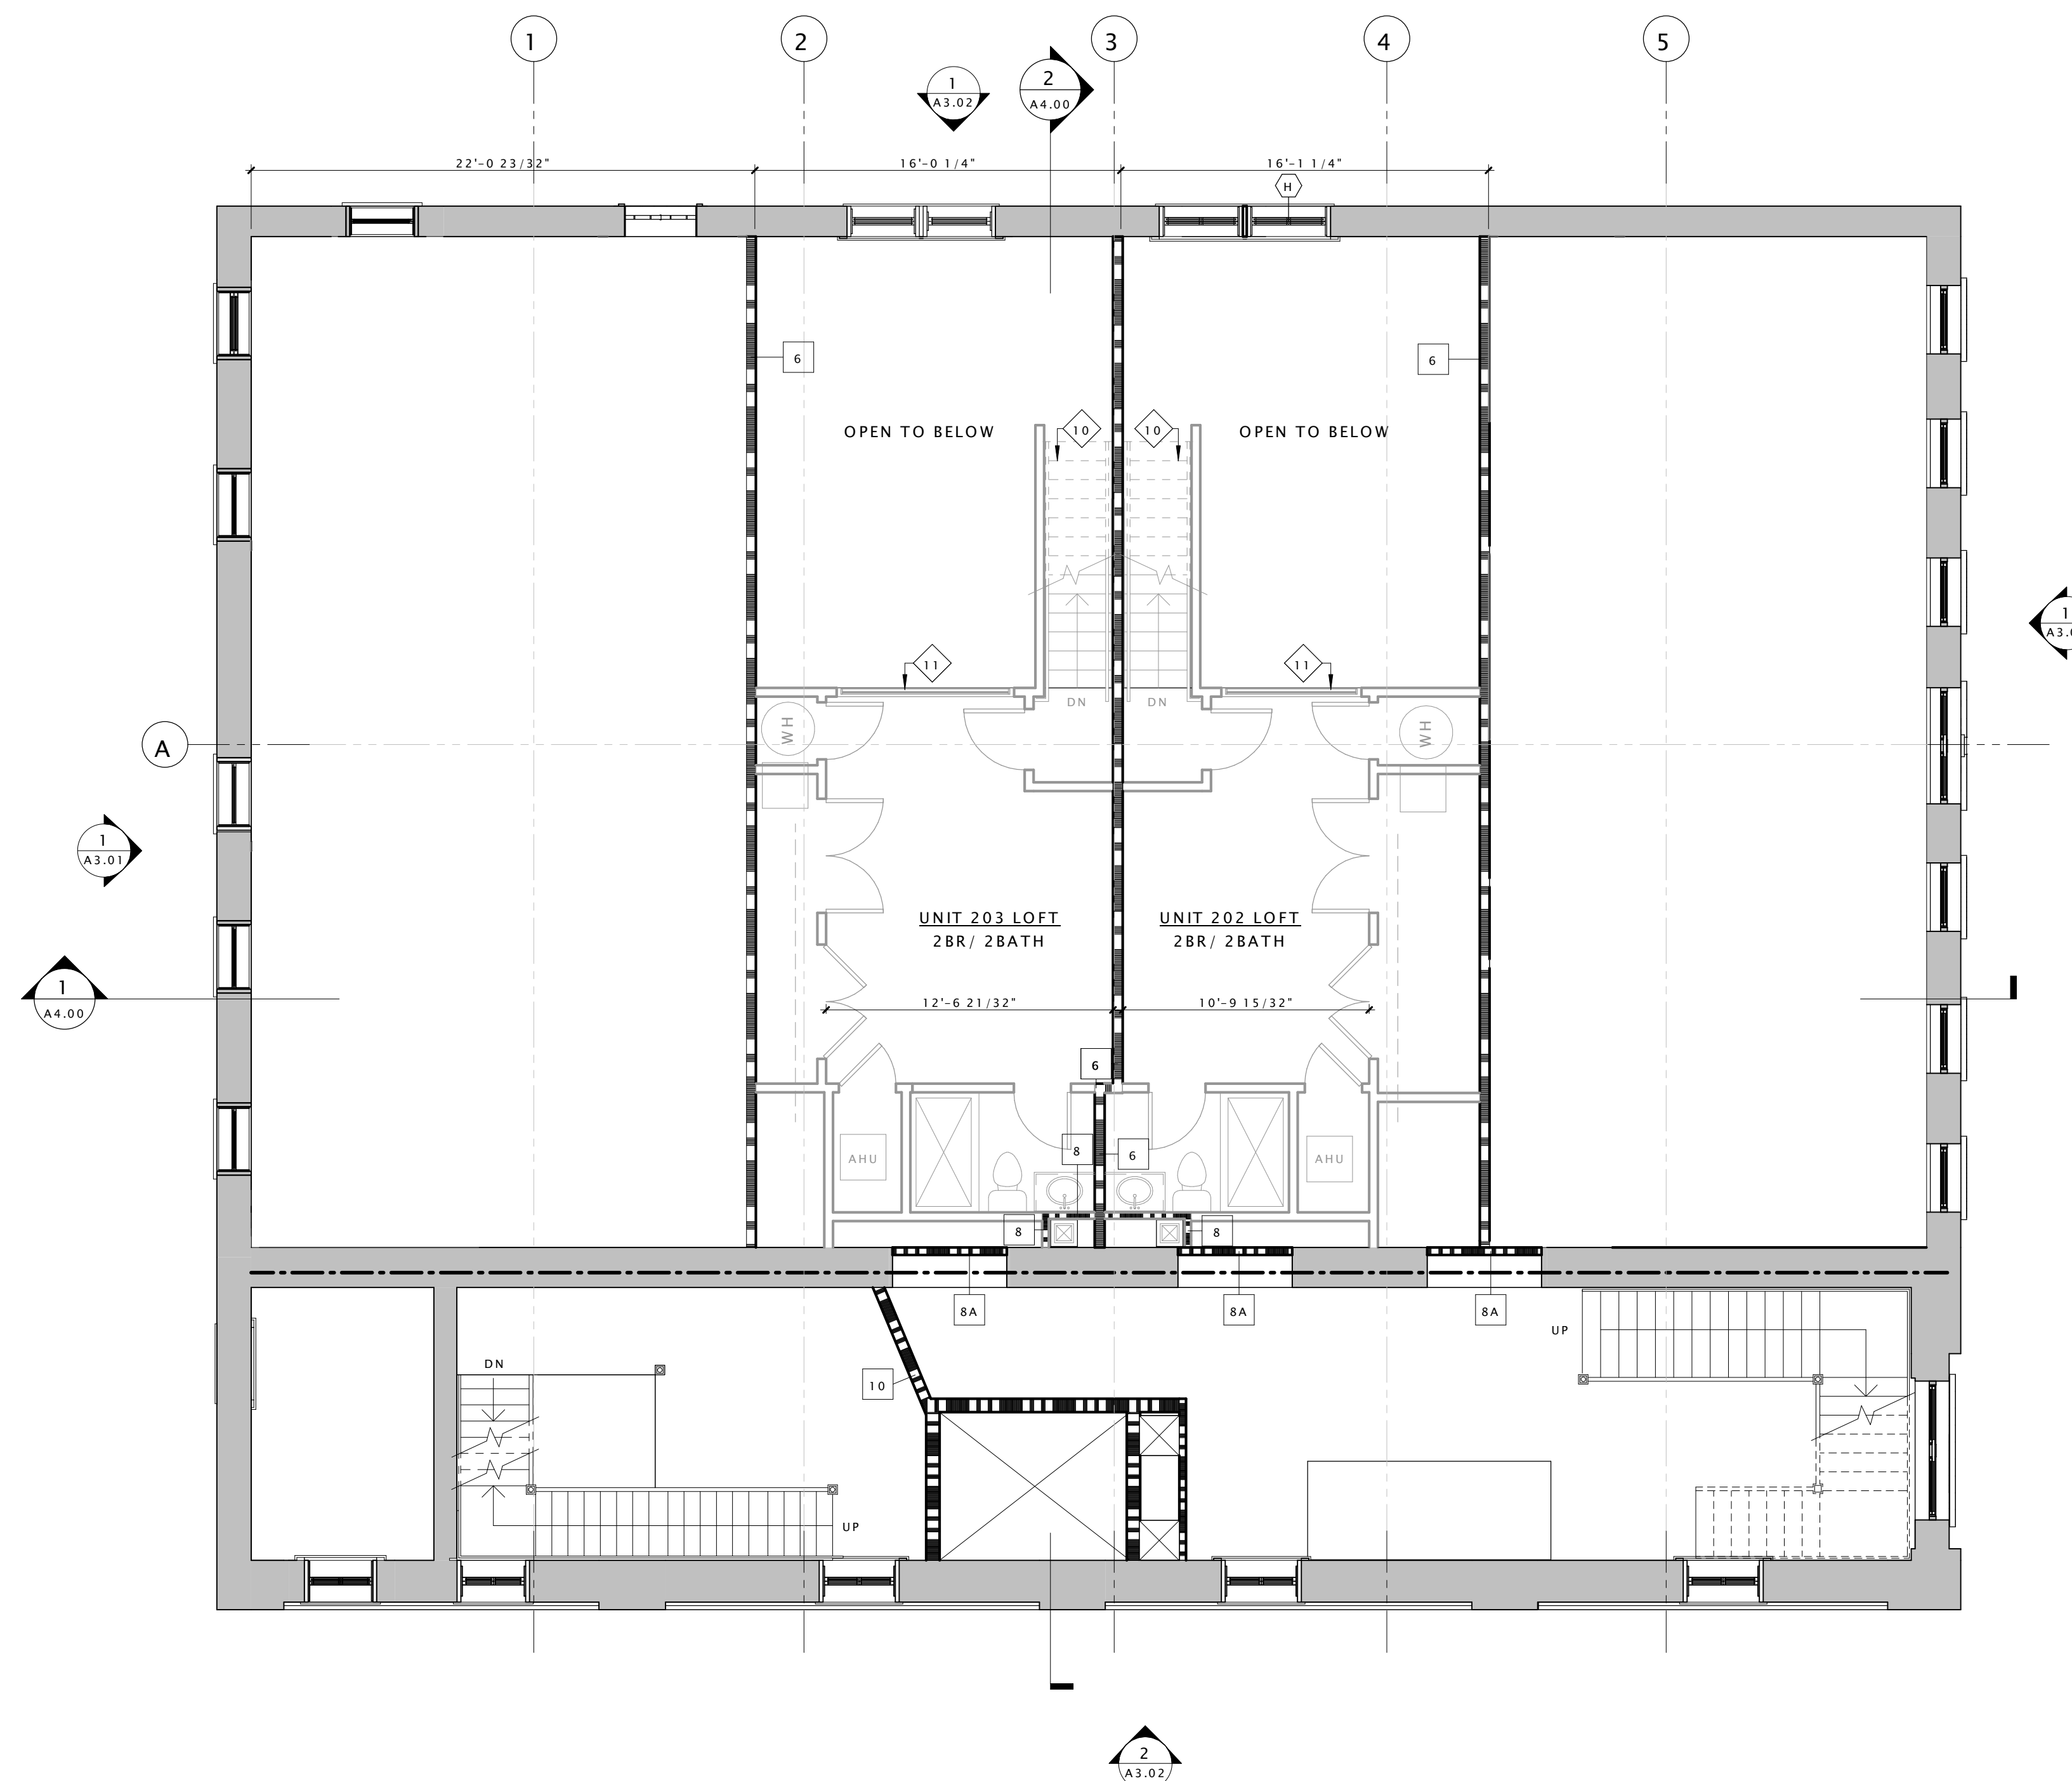
- EXISTING VAULT TO REMAIN
- REPAIR AND PAINT EXISTING WAINSCOTING AT EXTERIOR WALLS AND HISTORIC PLASTER INTERIOR WALLS TYP. THROUGHOUT
- REPAIR EXISTING WOOD JOISTS TO MAKE FLOOR STRUCTURALLY SOUND - SEE STRUCTURAL

- NEW CONCRETE STAIR AND LANDING AT EXISTING ENTRY - SEE STRUCTURAL FOR DETAILS
- REPAIR EXISTING CANOPY
- NEW METAL GUARD RAIL AND HANDRAIL AT ENTRY
- RAISE EXISTING HISTORIC HANDRAIL TO CODE COMPLIANT HEIGHT

- REPAIR AND PAINT EXISTING HISTORIC RAIL/GUARDRAIL
- NEW LOFT FLOOR AT CONSTRUCTED OUT OF LIGHT GAGE FRAMING - SEE STRUCTURAL FOR DETAILS
- NEW STAIR IN THIS LOCATION.

Drawing Title
SECOND AND SECOND FLOOR LOFT PLANS

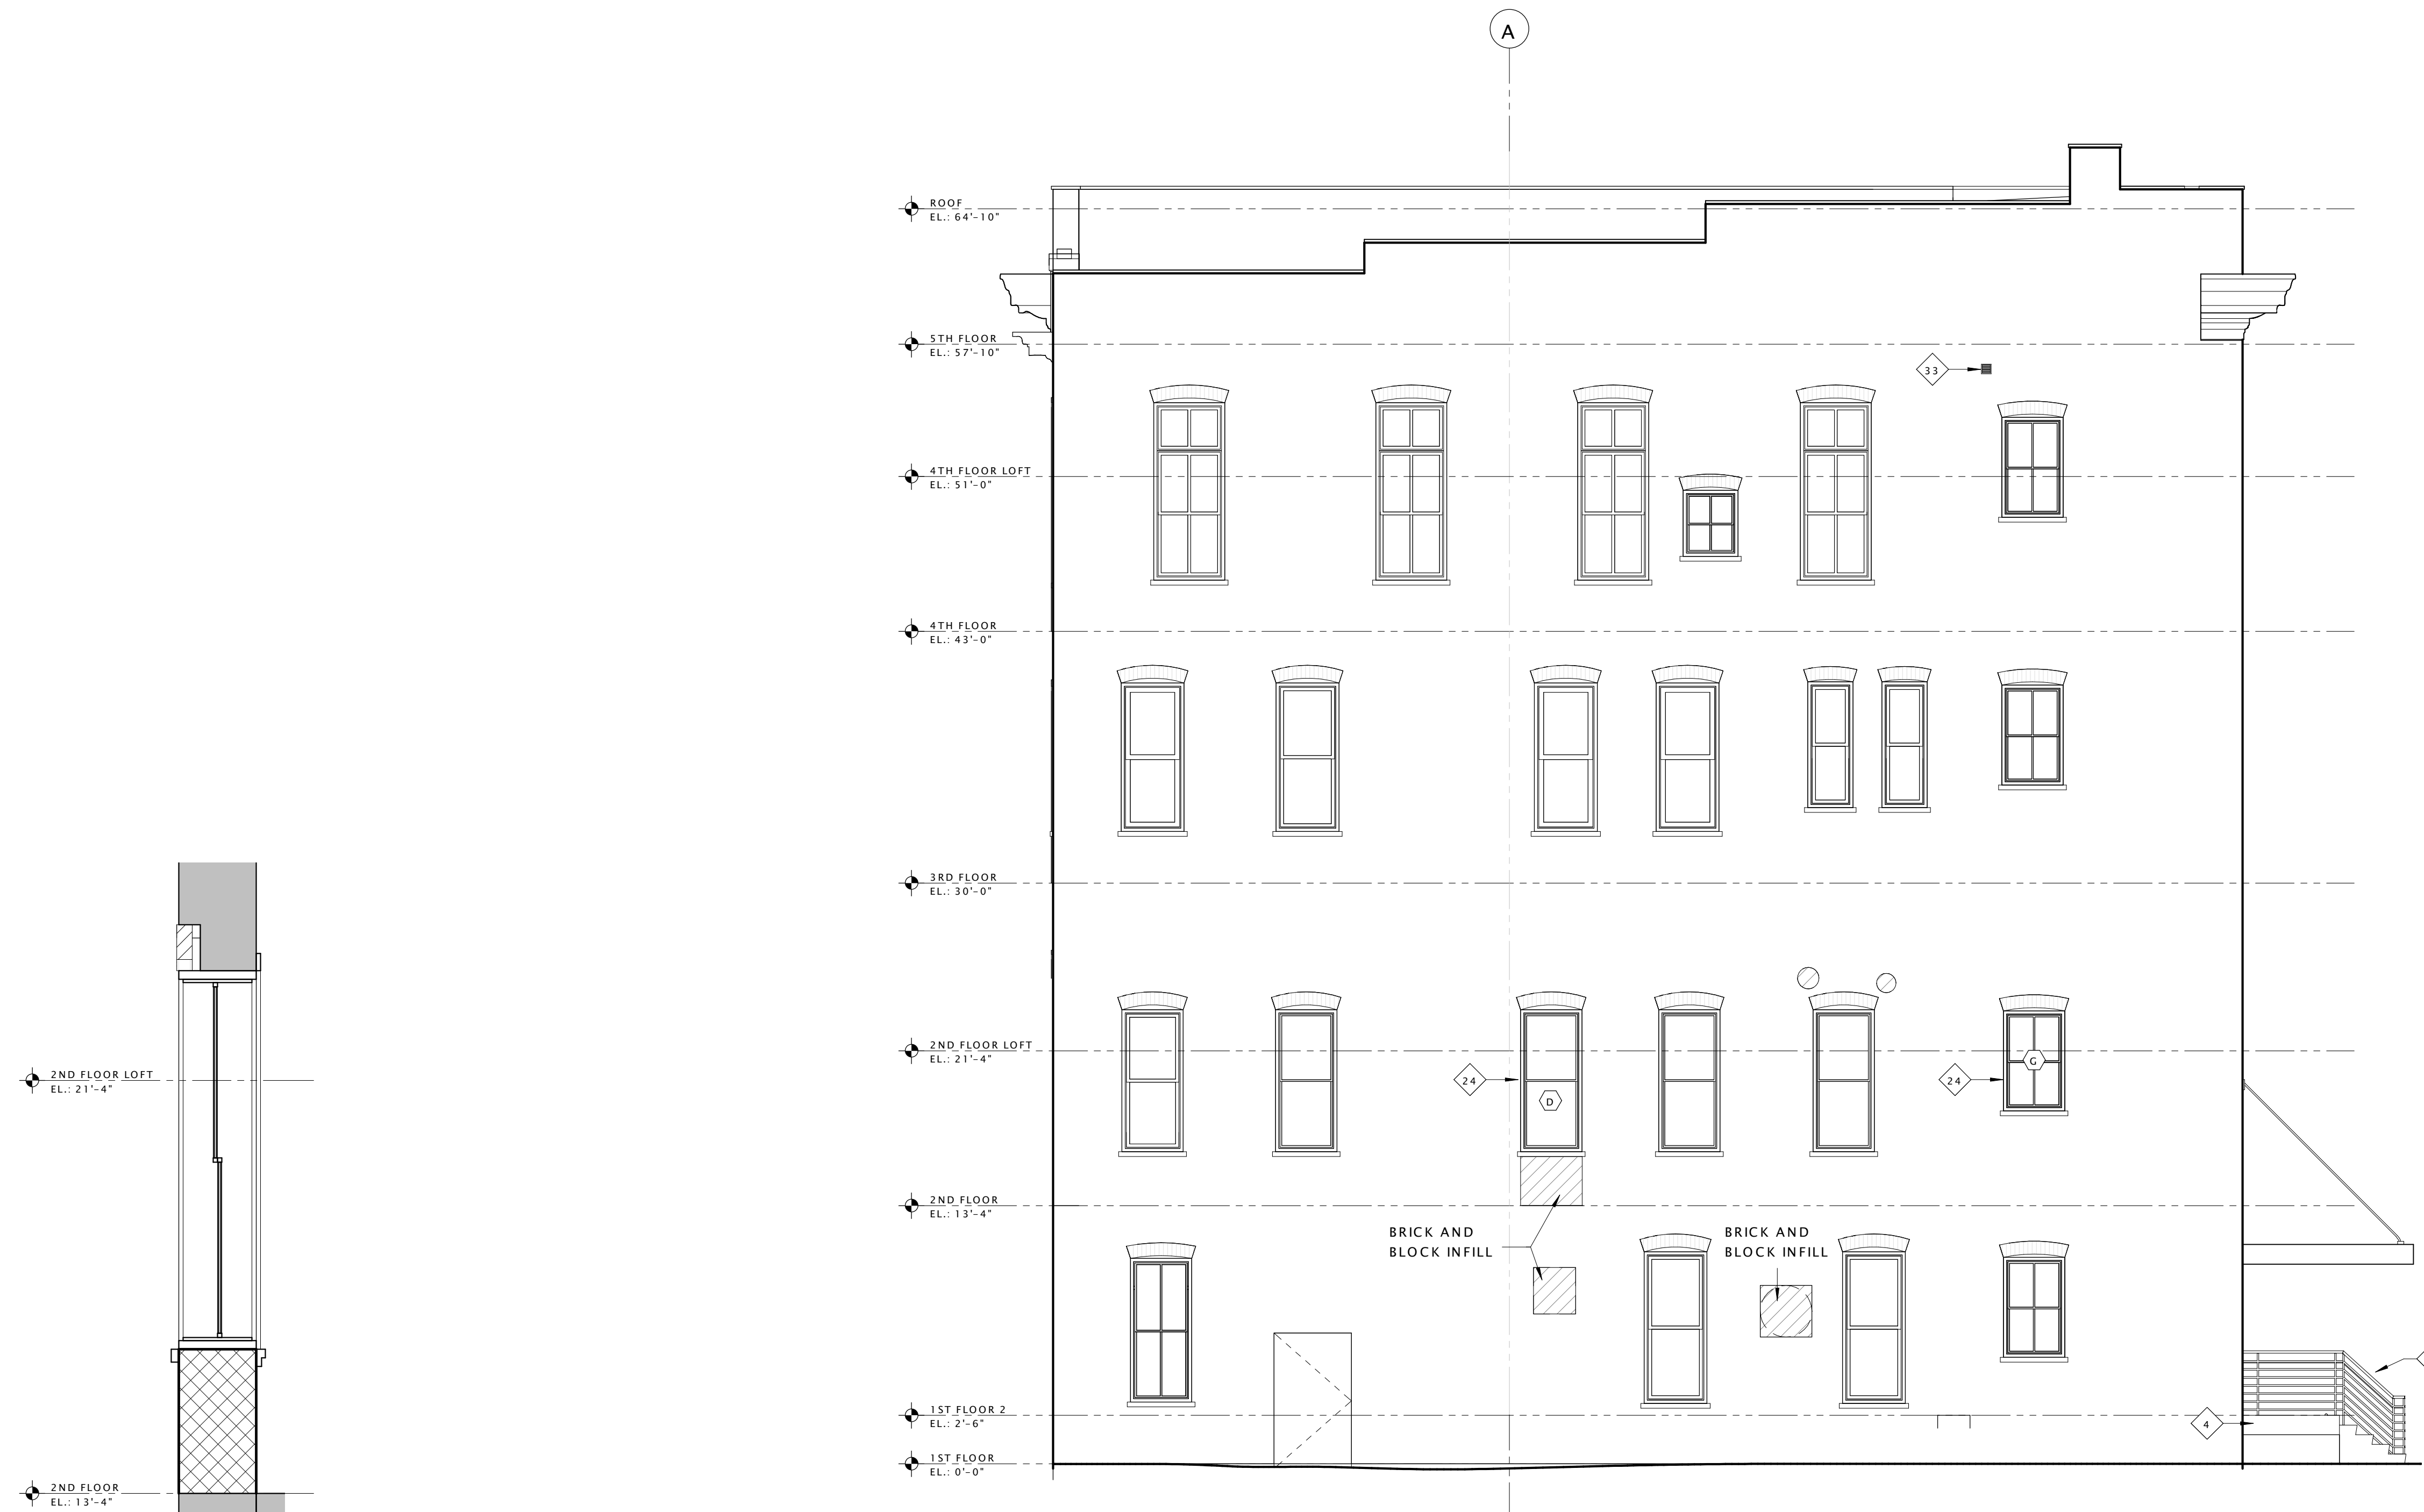
2 WEST ELEVATION - WALL INFILL DETAIL
SCALE: 1/2" = 1'-0"

1 WEST
SCALE: 3/16" = 1'-0"

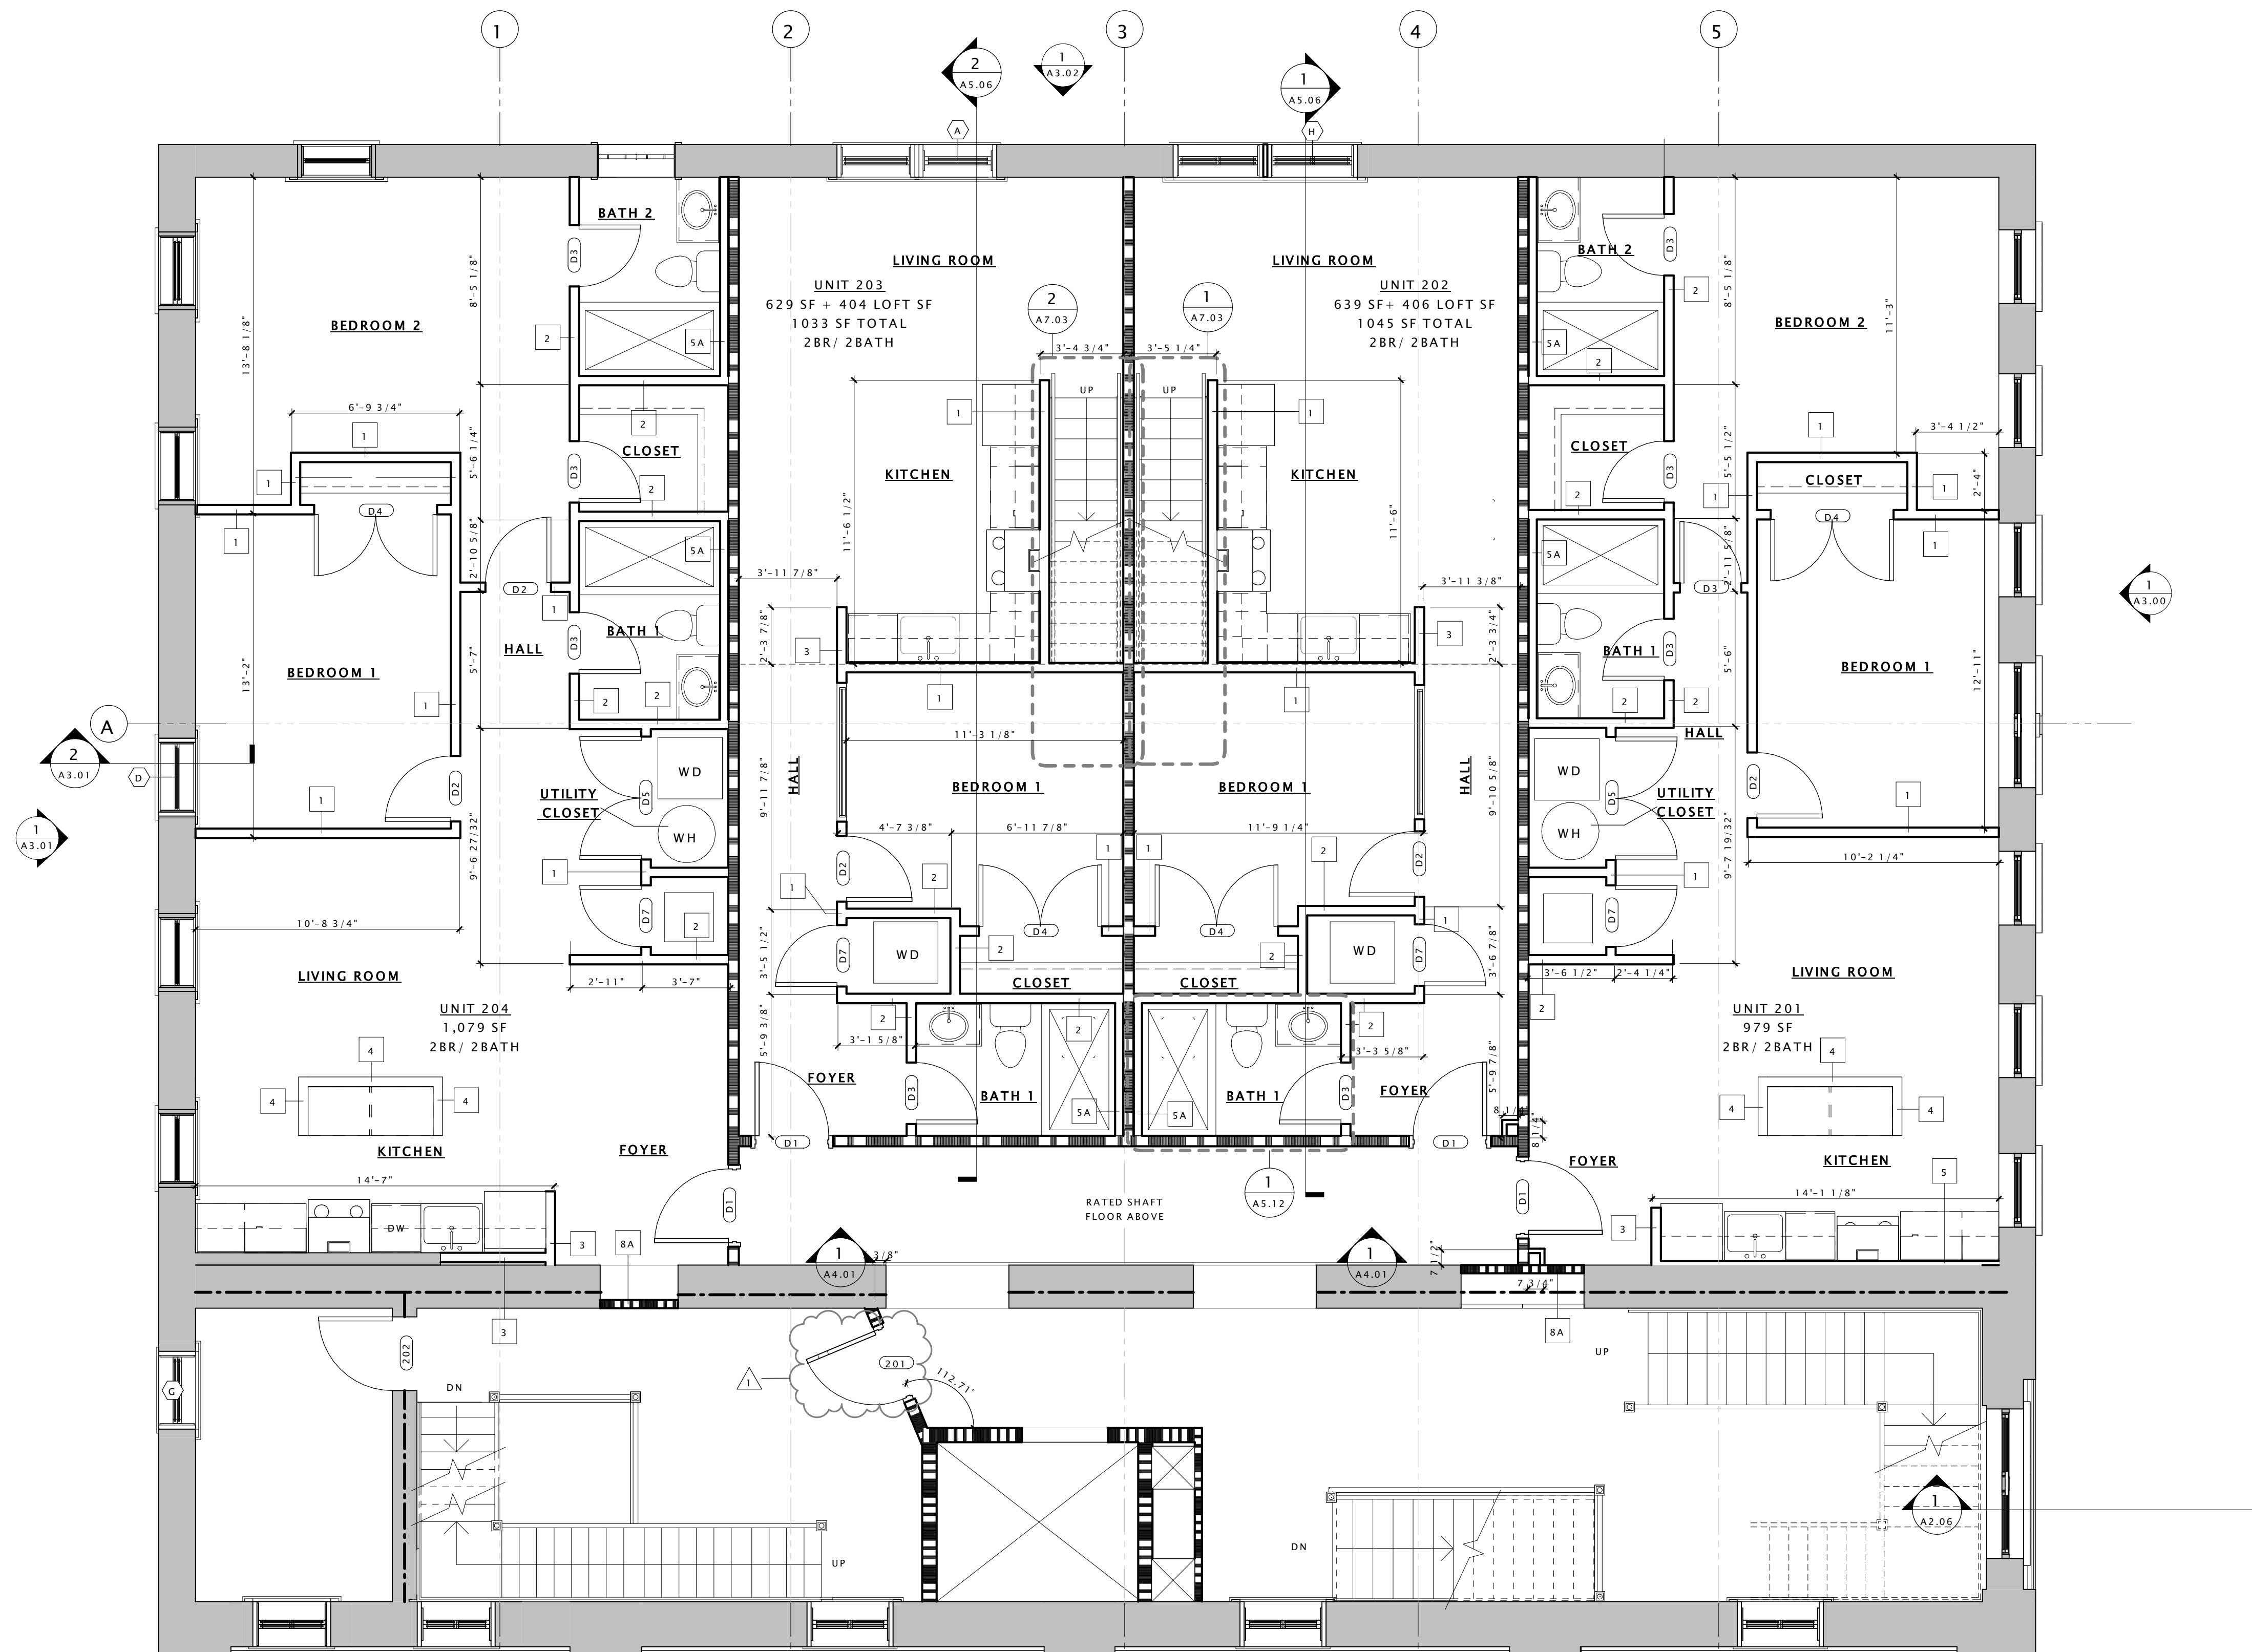
1 ENLARGED 2ND FLOOR
SCALE: 1/4" = 1'-0"

- 31 INSPECT EXISTING FLUE SHAFTS AND REPAIR BRICK AS NECESSARY TO MAINTAIN A WATER TIGHT ASSEMBLY
- 32 INSTALL NEW FLUE CAP
- 33 NEW DRYER VENT EXHAUST OPENING

- 34 REPAIR AND RESTORE EXISTING HARDWOOD FLOOR AS NECESSARY AND CREATE ONE HOUR FLOOR/CEILING ASSEMBLY - SEE SPECIFICATIONS AND SHEET A0.01 FOR MORE INFORMATION

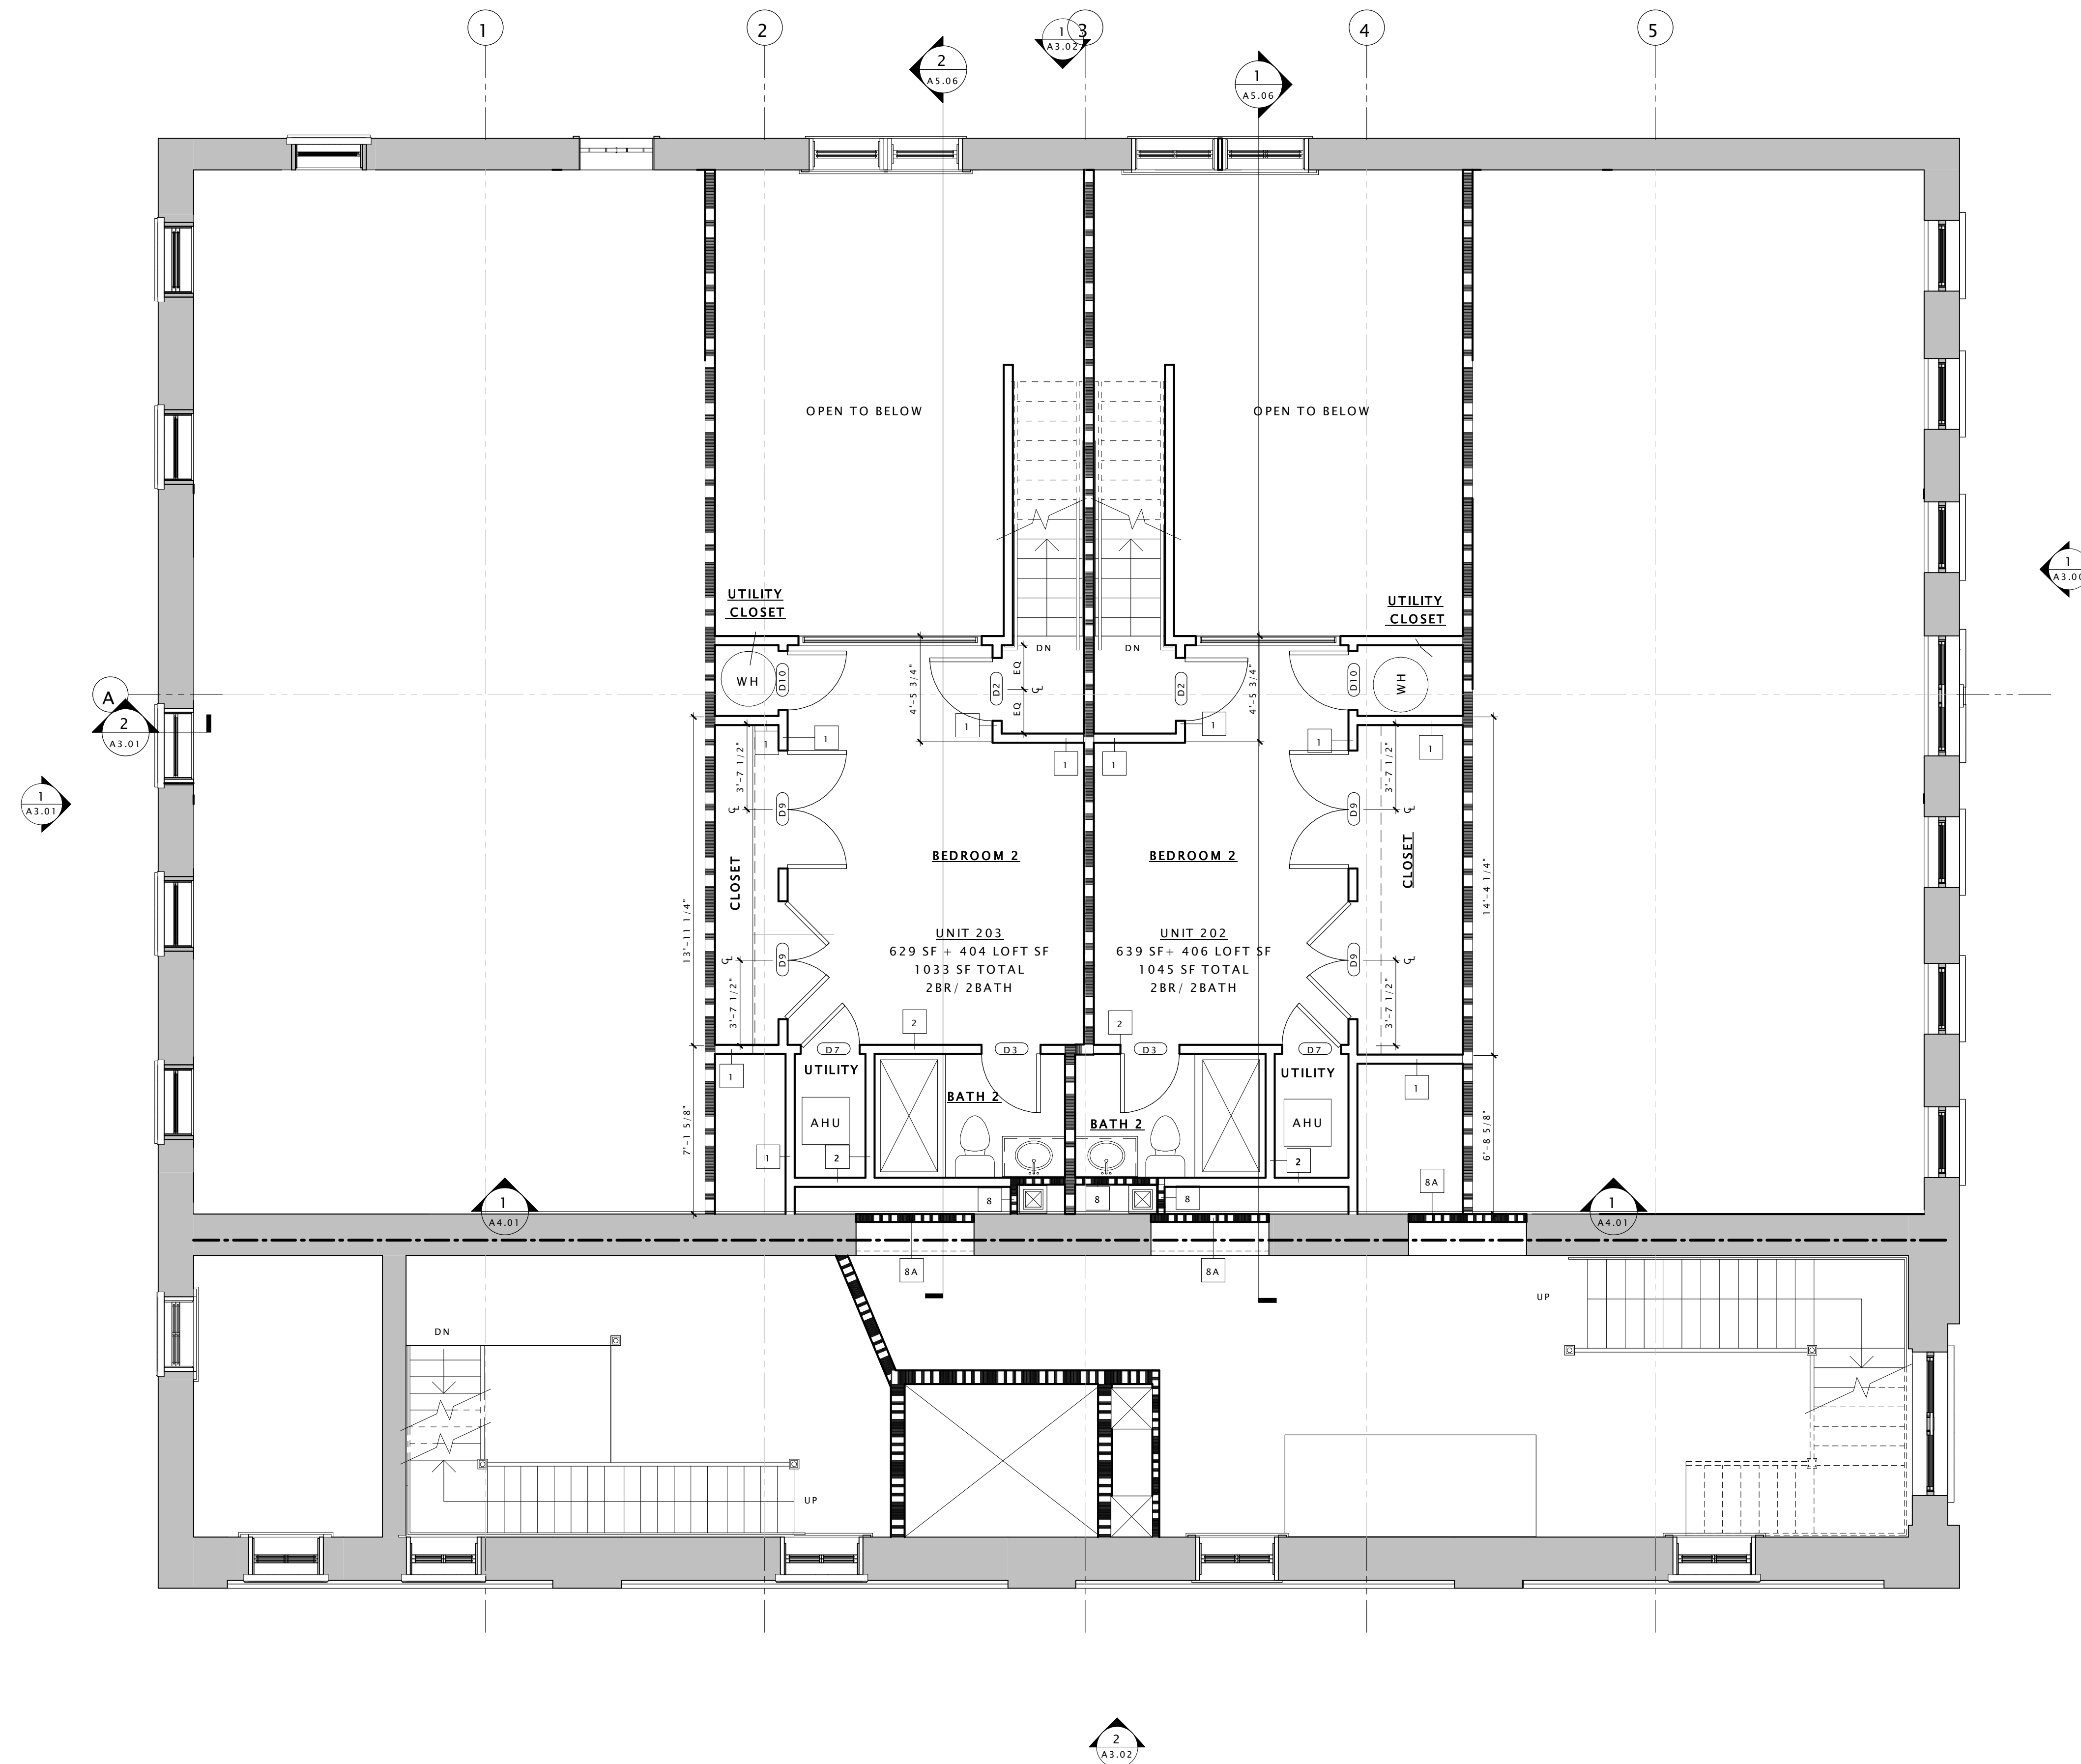
ENLARGED 2ND FLOOR LOFT
SCALE: 1/4" = 1'-0"

- CLEAN AND POLISH EXISTING HISTORIC TILE FLOORS.
- EXISTING DOOR TO REMAIN AND FIXED IN PLACE SO THAT THEY ARE NOT OPERABLE
- EXISTING WOOD DOORS TO BE REPAIRED. RECEIVE NEW HARDWARE, PAINTED, AND RESTORED TO WORKING ORDER - SEE DOOR SCHEDULE FOR MORE INFORMATION

- INSPECT EXISTING FLUE SHAFTS AND REPAIR BRICK AS NECESSARY TO MAINTAIN A WATER TIGHT ASSEMBLY
- INSTALL NEW FLUE CAP
- NEW DRYER VENT EXHAUST OPENING
- REPAIR AND RESTORE EXISTING HARDWOOD FLOOR AS NECESSARY AND CREATE ONE HOUR FLOOR/CEILING ASSEMBLY - SEE SPECIFICATIONS AND SHEET A0.01 FOR MORE INFORMATION
