6. COA-073709-2020

Commission of
Architectural Review

STAFF REPORT

Rehabilitate an existing carriage house and alter roof form.

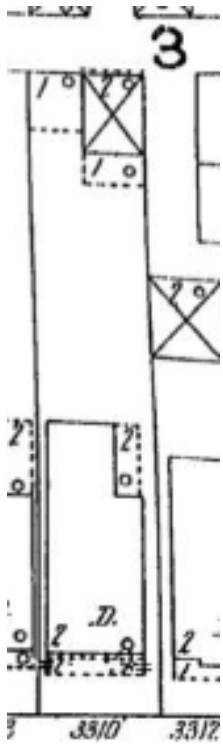
Figure 1. 1905 Sanborn map

- The applicant requests approval to renovate a 2-story brick carriage house at the rear of the property.
- The carriage house predates 1905, as it is shown on the 1905 Sanborn map. The building has undergone multiple alterations, including the demolition of two 1-story additions, alterations to the roof, and infilling of openings.
- The applicant is proposing the following work:
 - rehabilitate an existing 2-story deck
 - reopen infilled openings
 - replace all windows and doors
 - install new gutters
 - install new exterior lighting
 - add metal siding to the top of the walls
 - replace the roof
 - install 2 skylights
 - brick repointing and repair

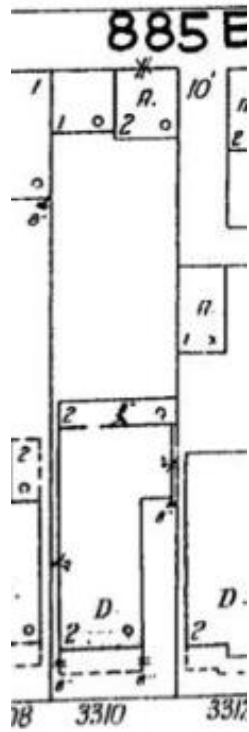
Figure 2. 1925 Sanborn map

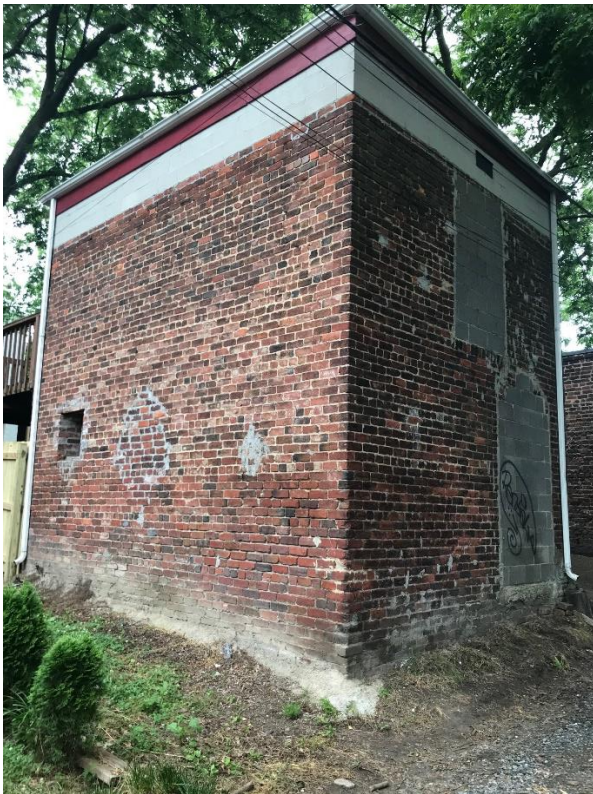
Figure 3. North and east elevations of existing carriage house

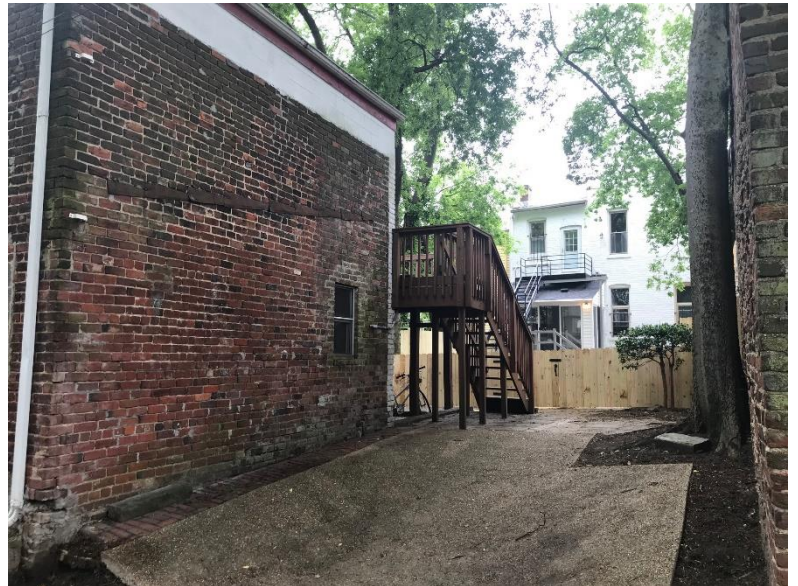
Figure 4. East elevation and deck, as viewed from alley

<p>Porches and Porch Details #1, pg. 49</p>	<p><i>Porches railings and balustrades are important character-defining features of historic buildings. The proportions of these railings are a significant contributing feature to the appearance of both the individual structure and the character of the entire neighborhood.</i></p>	<p>Staff finds that the proposed new handrail on the existing second-story deck is not consistent with the design or proportions of historic railings found throughout the district, as it extends below the decking. <u>Staff recommends the new deck railing not extend below the decking and a revised design compatible with the district be submitted for administrative approval.</u></p>
<p>Materials & Colors #2, pg. 47</p>	<p><i>Materials used in new residential construction should be visually compatible with original materials used throughout the district.</i></p>	<p>Staff finds that though metal is a common material used for outbuildings in the district, the application of metal siding on a portion of a brick wall is not consistent with historic materials.</p>
