Commission of Architectural Review

1. COA-169066-2025	Final Review	Meeting Date: 7/22/2025
Applicant/Petitioner	Will Gillette	
Project Description	Rehabilitate an existing rear porch and second-story sunroom	
Project Location		
Address: 1212 West Franklin Street		
Historic District: Monument Avenue		
<p>High-Level Details:</p> <p>The applicant proposes to rehabilitate a two-story masonry building, including rebuilding the existing rear sunroom and covered deck.</p> <p>A door on the east elevation will also be converted into a window.</p> <p>The rebuilt second story sunroom will resemble the original's fenestration but will have shorter windows on the side elevations.</p> <p>Decorative mullions that match the original and are based on photographic documentation will be applied to the new windows.</p>		
Staff Recommendation	Approval, with Conditions	
Staff Contact	Alex Dandridge, Alex.Dandridge@RVA.gov, (804)646-6569	
Previous Reviews	None.

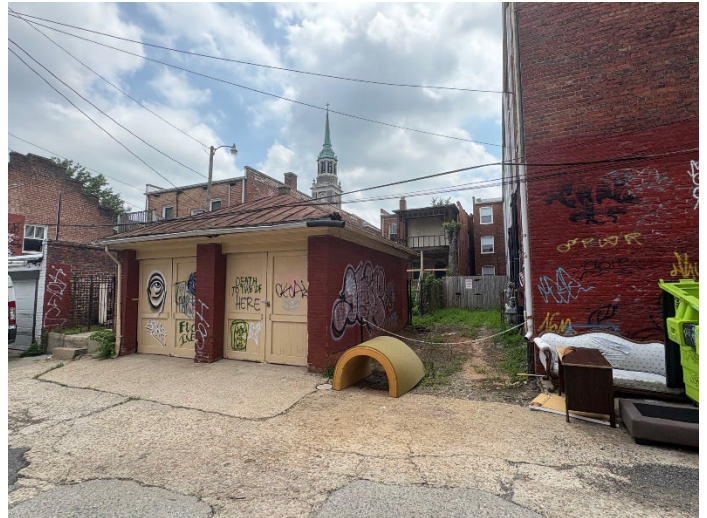
Figure 2. 1212 West Franklin Street rear. View of sunroom, porch, and garage from the alley. July 2025.

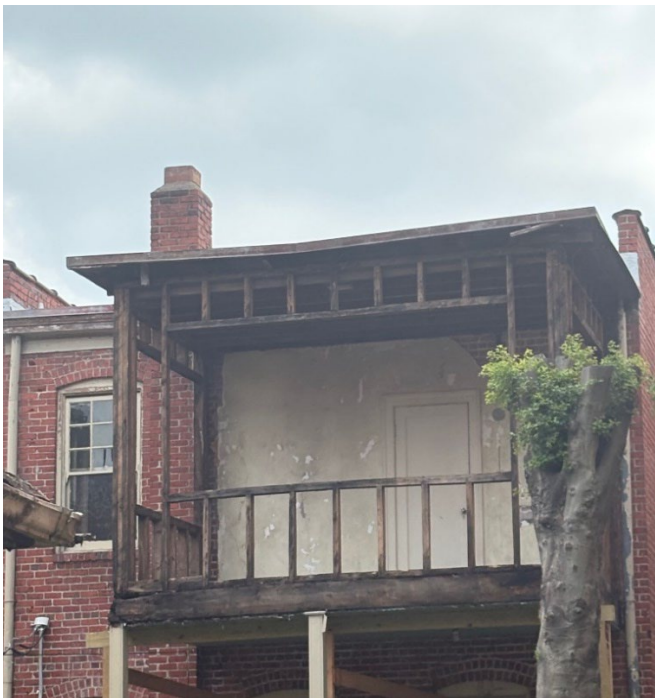
Figure 3. 1212 W. Franklin Street. Current condition of rear, second story sunroom. July 2025.
