**COMMISSION OF ARCHITECTURAL REVIEW  
STAFF REPORT  
February 27, 2018, Meeting**

5. **COA-029597-2018** (J. & S. Bliley) **2609 Monument Avenue  
Monument Avenue Old and Historic District**

**Project Description:** **Construct a second story addition.**

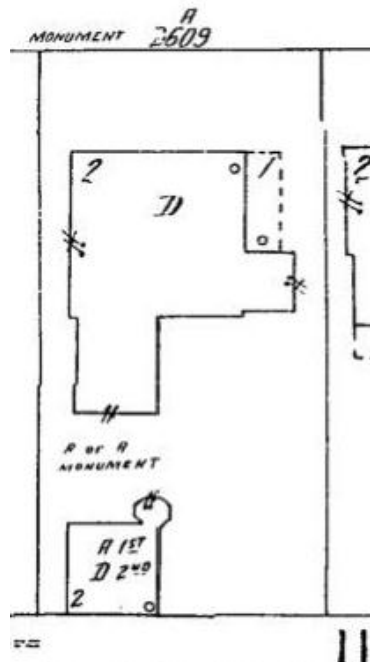
1950 Sanborn Map

Based on the 1950 Sanborn map, it appears that the structure has not been altered from its original plan. The only documented alteration staff was able to confirm was the enclosure of the side porch with glass in 1991. The application for the alteration states that "no change to the structure occurred and no alteration to the home occurred."
