7. COA-066685-2020

Commission of Architectural Review

STAFF REPORT

Alter existing fenestration, enlarge a rear deck and add partial screening.

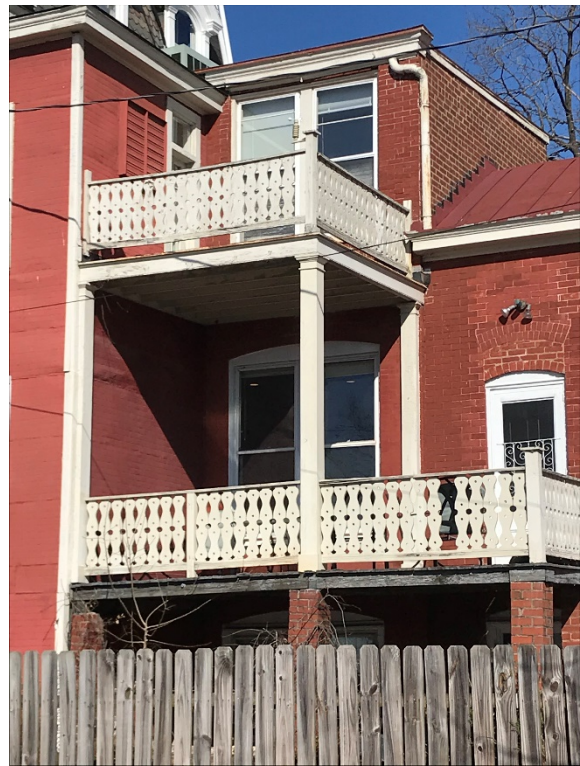
Figure 2. View of south elevation from Libby Hill Terrace.

windows is replicated on three floors. Staff recommends the new doors be aligned by converting the westernmost window to a door on the second story. In addition, staff recommends the new doors be at least half-lite doors, to maintain the open appearance of the windows.

Staff has confirmed with the architect for the project that an existing opening on the south elevation in the rear massing of the building will be enlarged to accommodate a new window. The existing sill will be lowered to create an opening that is the same size as the adjacent windows. Staff finds that the proposed alteration will be minimally visible from the public right of way and is supportive of this change. Staff recommends the existing jambs and head height be maintained, and the new window have a simplified or contemporary design rather than the 6/6 light configuration proposed.

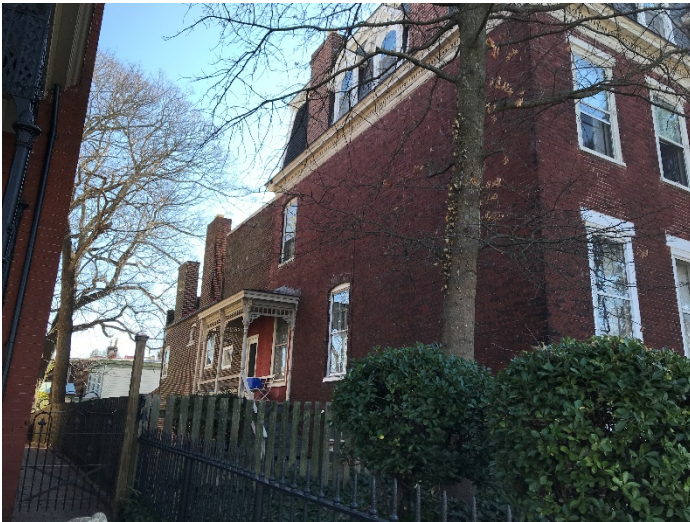
Figure 3. View of north elevation from North 29th Street.

The applicant is proposing to relocate an existing window that is currently in what has become an interior space. A new window will be created on the second story on the north elevation, in the oldest section of the building. Staff finds that this proposed new window opening is highly visible from the street, due to the large setback to the adjacent building. The addition of a new window on a visible elevation that attempts to replicate the historic windows by using salvaged materials is not consistent with the Guidelines. Staff recommends denial of the proposed second story window in the main massing on the north elevation.
