4. COA-062015-2019

3516 East Broad Street

STAFF REPORT

Remove two rear doors and install one rear double door with sidelights and transom.

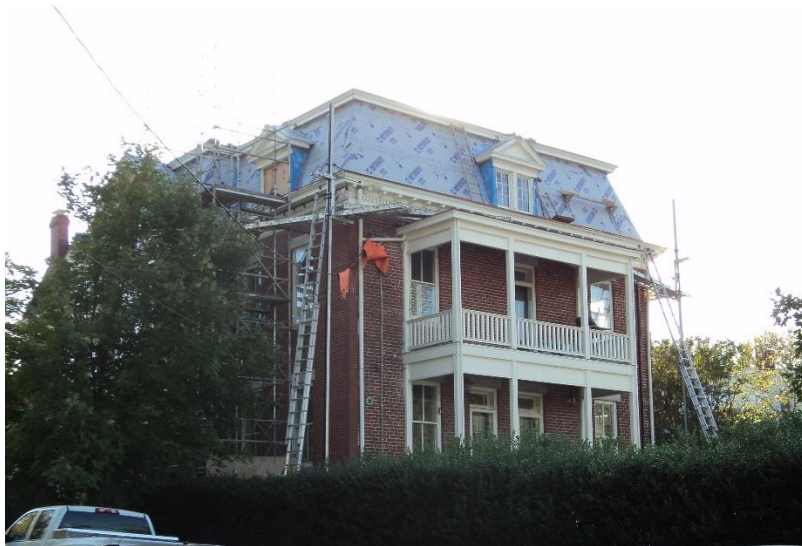
Figure 1. View of rear elevation from North 36th Street

- The Guidelines recommend against altering original masonry openings. Due to the visibility of the doors from North 36th Street, staff recommends denial of the proposed alteration to the masonry openings.

The applicant is proposing to remove the existing doors and transoms at the rear of the home. The photographs submitted with the application are not clear enough to determine whether the existing doors are original or
