**Staff Report**  
**City of Richmond, Virginia**

**Commission of Architectural Review**

4. COA-142863-2024	Final Review	Meeting Date: 2/27/2024
Applicant/Petitioner	Stephen Casey	
Project Description	Construct a new retaining wall and rebuild a portion of a foundation.	
Project Location		
Address: 504 North 26 <sup>th</sup> Street		
Historic District: Church Hill North		
<p>High-Level Details:</p> <p>The applicant proposes exterior alterations to a frame dwelling ca. 1854 otherwise known as the (Thomas S. Hundley House).</p> <p>Exterior alterations will include reconstructing the southeast wall of the foundation, constructing a sunken, basement-level side entrance with an associated retaining wall and steps, and the front porch floor and posts will be replaced.</p> <p>Concrete porch floor will be replaced with wood, and posts will be replaced with new 4x4 inch square posts.</p>		
Staff Recommendation	Approval, with Conditions	
Staff Contact	Alex Dandridge, (804) 646-6569, alex.dandridge@rva.gov

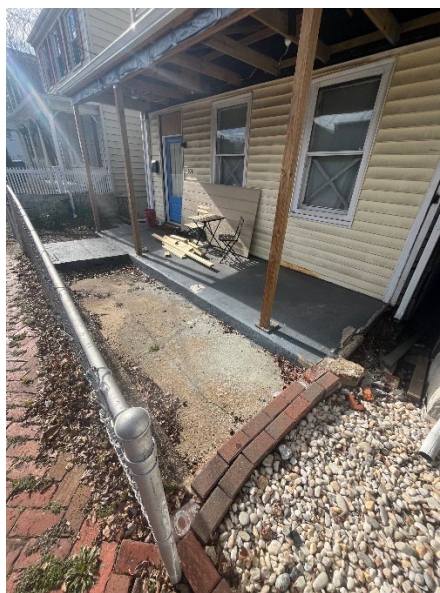
Figure 2. Front porch concrete slab and slender wooden posts.

Guideline Reference	Reference Text	Analysis
<b>Porch and Entrance Repair, pg. 71</b>	<p>4. <i>Do not remove or radically change entrances and porches important in defining the building's overall historic character. Front and side porches are architecturally more ornate than utilitarian back porches.</i></p> <p>5. <i>The entire porch should only be replaced if it is too deteriorated to repair or is completely missing; replacements should match the original as much as possible.</i></p> <p>8. <i>Do not strip entrances and porches of historic material and details that should be retained in any repair or partial replacement.</i></p>	<p>Currently the front porch floor is a concrete slab. The applicant proposes to remove the concrete slab and reconstruct the porch floor using wood decking. The concrete slab porch floor is likely not original. Staff supports its removal. <u>Staff recommends that the new decking boards be installed perpendicular to the face of the building and be tongue and groove to be compatible with decking designs and profiles found throughout the district.</u></p> <p>The existing porch has slender, square, wooden posts supporting the porch roof. The applicant proposes to replace these posts with new simple square posts. The porch roof will be replaced with black-colored EPDM roofing. Photographic documentation demonstrates that the porch originally featured simple wooden posts.</p> <p>The front porch will have a concealed gutter, a PVC soffit, and the 4"x4" wooden posts will have a PVC wrap.</p> <p>Based on photographic documentation, staff believes that the front porch roof is original to the building. <u>Staff recommends that the front porch roof not be removed or altered.</u></p> <p>Staff finds that the alterations to the front porch are in-keeping with the style of the building and with the photographic documentation.</p>

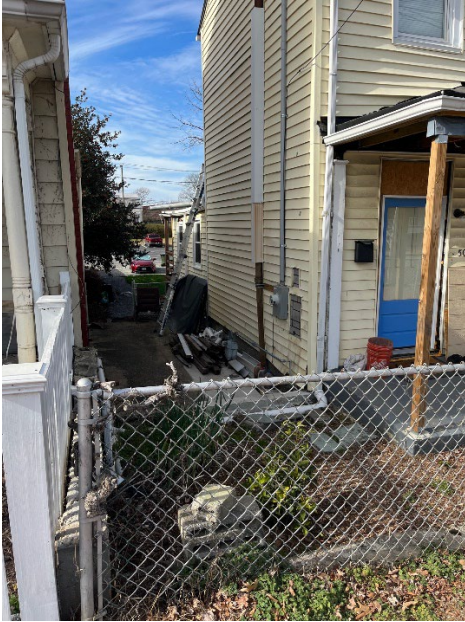
Figure 3. 504 N. 26<sup>th</sup> Street. Existing conditions of the side yards and future location of new basement level entrance.

<p>The application states that the southeast portion of the foundation is in disrepair due to water, shifting soils, and improper past repairs. The applicant proposes to reconstruct this portion of the foundation to ensure the stability and longevity of the building. Images submitted with the application appear to show evidence of water infiltration and shifting bricks. It is the staff's opinion that the foundation be repaired to ensure the longevity of the building. <u>Staff recommends that the foundation wall be reconstructed, and limited to only the sections that need repair. Staff recommends that applicants re-use historic material, if possible (possibly as a veneer), in the reconstruction. Staff recommends that any new brick be</u></p>

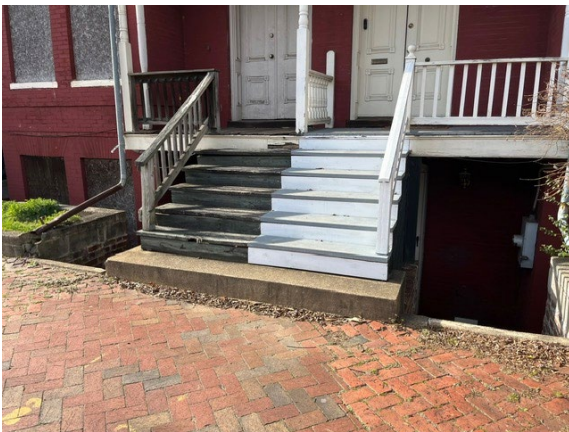
Figure 5. Existing basement level entrances on the subject block.

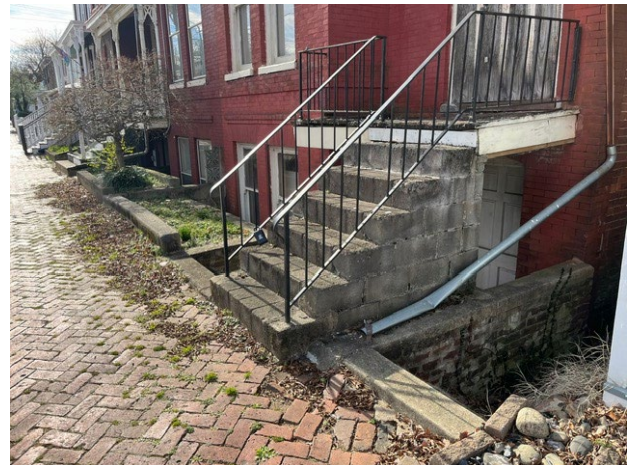
Figure 6. Existing basement level entrances on the subject block.
