#### Staff Report City of Richmond, Virginia

### **Commission of Architectural Review**

2. COA-138395-2023	Final Review Meeting Date: 11/28/2023
Applicant/Petitioner	John W. Collier III
Project Description	Rehabilitate an existing dwelling and construct a rear addition.
Project Location	818 80 80 80 80 80 80 80 80 80 80 80 80 80
Address: 514 West Marshall Street	105 105 105 105 105 105 105 105 105 105
Historic District: Jackson Ward	310
High-Level Details:	131/25    151/35    151/
<ul> <li>The project includes a complete rehabilitation of the exterior and interior.</li> <li>A new addition will be added to the northwest side of the rear/ north side. The addition will be 16 by 10 feet.</li> <li>The porch was removed due to its poor condition.</li> <li>The dwelling was divided into two apartments around 1950.</li> </ul>	732  732  732  732  733  734  735  735  735  735  735  735
Staff Recommendation	Approval
Staff Contact	Annie Delaroderie, anne.delaroderie@rva.gov, 804-646-6335
Previous Reviews	The City of Richmond property maintenance required that the front porch to be removed sometime in 2019, due to its unsafe condition; however, Staff was unable to locate any documentation of t

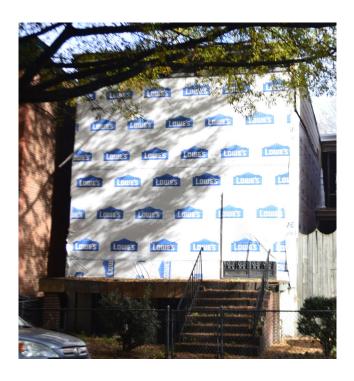
Figure 1. Current view of 514 West Marshall Street. The photograph was taken on November 17, 2023.

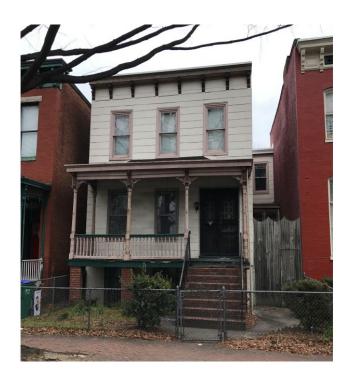
Figure 2. View of 514 West Marshall Street, from March 1, 2019.

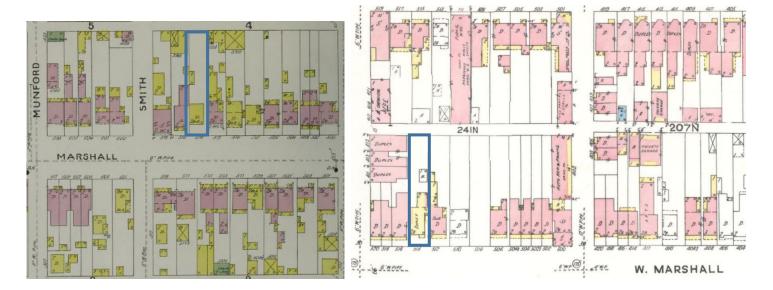
Figure 3. 1895 Sanborn map showing 514 West Marshall Street. This map conveys that the building was likely built before 1895. At this time, the house was a two-story dwelling with a detached one-story building in the rear.

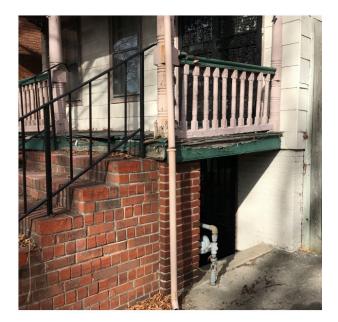
Figure 5. Detail of the front porch before it was removed. Photograph from March 1, 2019.

Residential Buildings: Typical Problems, page 87.	Inappropriate Porch Remodeling and Porch Removal: A significant character-defining architectural feature is lost when original porches on historic homes are removed.	The city asked the owner of 514 West Marshall Street to remove the porch at this residence due to its poor condition. The porch roof and all of its components are inside the house. The owner intends to repair the porch materials and put the porch back in place to match its original appearance, including roof form and material. <a href="Staff">Staff</a> recommends that paint colors for the porch be submitted to staff for Administrative Review and Approval.
Wood: Typical Problems, page 91.	Cracked or warped boards may result from long-term exposure to the extremes of weather or from pressure stresses. Removal and replacement with sound boards is often the only solution.  Cracked, peeling or blistering paint signals excessive moisture, improperly prepared paint surfaces or chemical incompatibility of paint layers. Rot is a fungus that consumes wood and thrives in dark, moist areas such as unventilated or light-deprived areas.	A front porch floor remains in place, but does have areas that are deteriorated beyond repair. The supporting corner and side porch boards are in poor condition, showing severe rot, decay, and cracked paint. Staff recommends that decking boards that are deteriorated beyond repair be replaced in-kind to match the width and profile (tongue and groove), width, and be installed perpendicular to the face of the building.

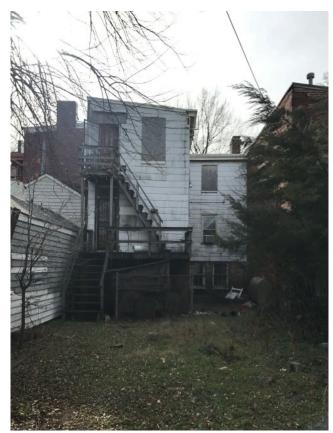
Figure 9. Rear view of 514 West Marshall Street, March 1, 2019.

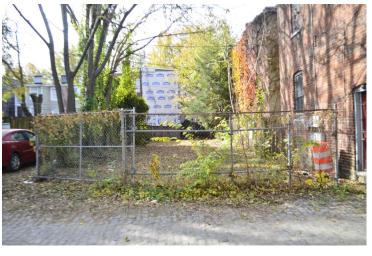
Figures 10 and 11. Current rear view of 514 West Marshall Street. Figure 11 shows the distance of the new addition from the alley.

The proposed addition will be compatible with neighboring houses' rear additions based on its form and massing.
	The new rear addition will be clad in horizontal lap siding with a 7" reveal. Staff recommends that the lap siding be either fiber cement siding or wood. Final material submitted to staff for review and approval.
All new residential and commercial construction, whether in the form of additions or entire buildings should be	The roof of the addition will be a membrane roof that will match the color of the existing.  There will be a new, two story rear deck that will be
characterize the setting and context. To protect the context of the surrounding historic district, new construction should reference the materials, features, size, scale, proportions, and massing of the existing historic buildings in its setting.	supported by 16"x16" brick piers. Staff recommends that the new deck have a finished appearance with no exposed hardware. Staff recommends that the railings not be "nailed-up" pickets, but be a finished design such as "Richmond Rail". Final railing design submitted to staff for review and approval.
