Staff Report City of Richmond, Virginia

Commission of Architectural Review

3. COA-113062-2022	Final Review	Meeting Date: 7/23/2024	
Applicant/Petitioner	Write applicant name and organization here.		
Project Description	Write ordinance headline text here.		
Project Location	319/3205	409 41	
Address: 3103 E. Broad Street	315 3300 3308	5	
Historic District: St. John's Church	309 310		
High-Level Details:	3206		
The applicant proposes to replace existing wood siding on the façade of a pre-1879 frame dwelling with smooth Hardiplank siding with a 8 1/4 inch reveal.	3201	3401 3401 3403 3403 3405 3411 307 309 307 309 307 309 307 309 307 309 307 309 307 309 307 309 307 309 307 309 307 309 307 309 309 309 309 309 309 309 309	
Staff Recommendation	Denial		
Staff Contact	Alex Dandridge, (804) 646-6569, alex.dandridge@rva.gov		
Previous Reviews	Staff administratively reviewed and approved an application in Jureplacement of deteriorated wood siding on the sides and rear of Hardiplank siding.

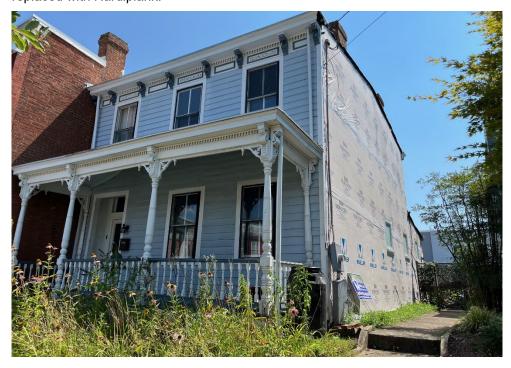
Figure 1. Existing Conditions -Façade with wood siding, sides and rear being replaced with Hardiplank.

The applicant requests to replace existing wood, lap siding on the façade with Hardiplank siding with an 8 ¼ inch reveal. It will be colored "Mist Gray", like the existing color of the building.

Staff reviewed and approved the replacement of wood siding on the sides and rear of the building with Hardiplank in June 2024. These elevations are minimally visible from the public right-of-way.

Based on a site visit, the existing wood siding on the façade appears to be in good to fair condition. Some boards need replacement. The applicant has not submitted images indicating that the façade siding is deteriorated beyond repair.
