**COMMISSION OF ARCHITECTURAL REVIEW  
STAFF REPORT  
March 28, 2017, Meeting**

14. **CAR No. 17-047** (T. Schaaf)

**1208 West Franklin Street  
Monument Avenue Old and Historic District**

**Project Description:** **Reconstruct front porch, roof balustrade and fence, replace front second story doors.**

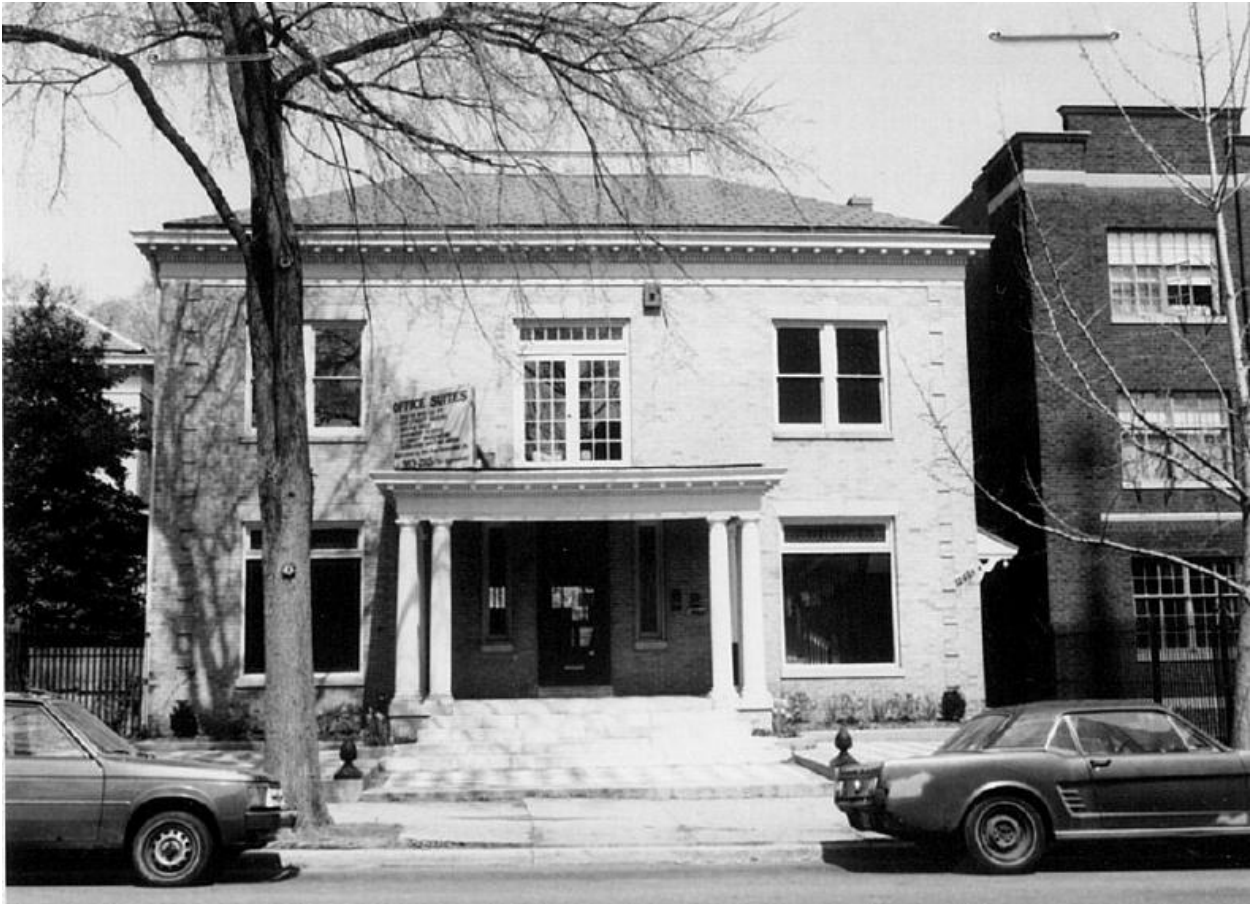
1208 W. Franklin Street, 1969 or 1970

would be more appropriate. Staff recommends that the replacement doors match the design shown in the survey documentation, the design to be submitted to staff for administrative review and approval.

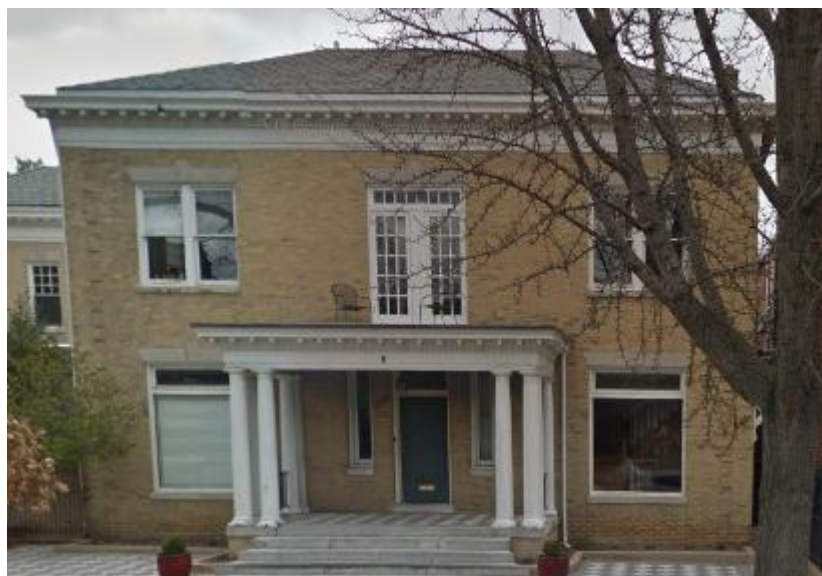
1208 W. Franklin Street, February 2016 (Source: Google street view)

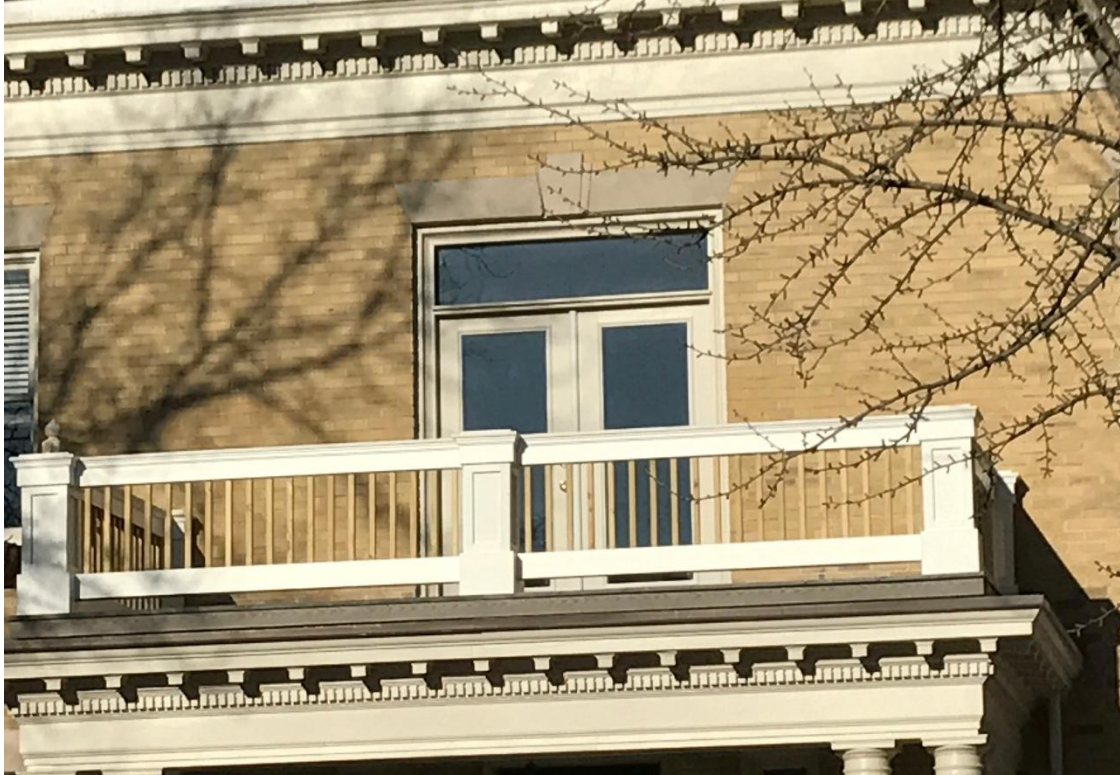
1208 W. Franklin Street, February 2017

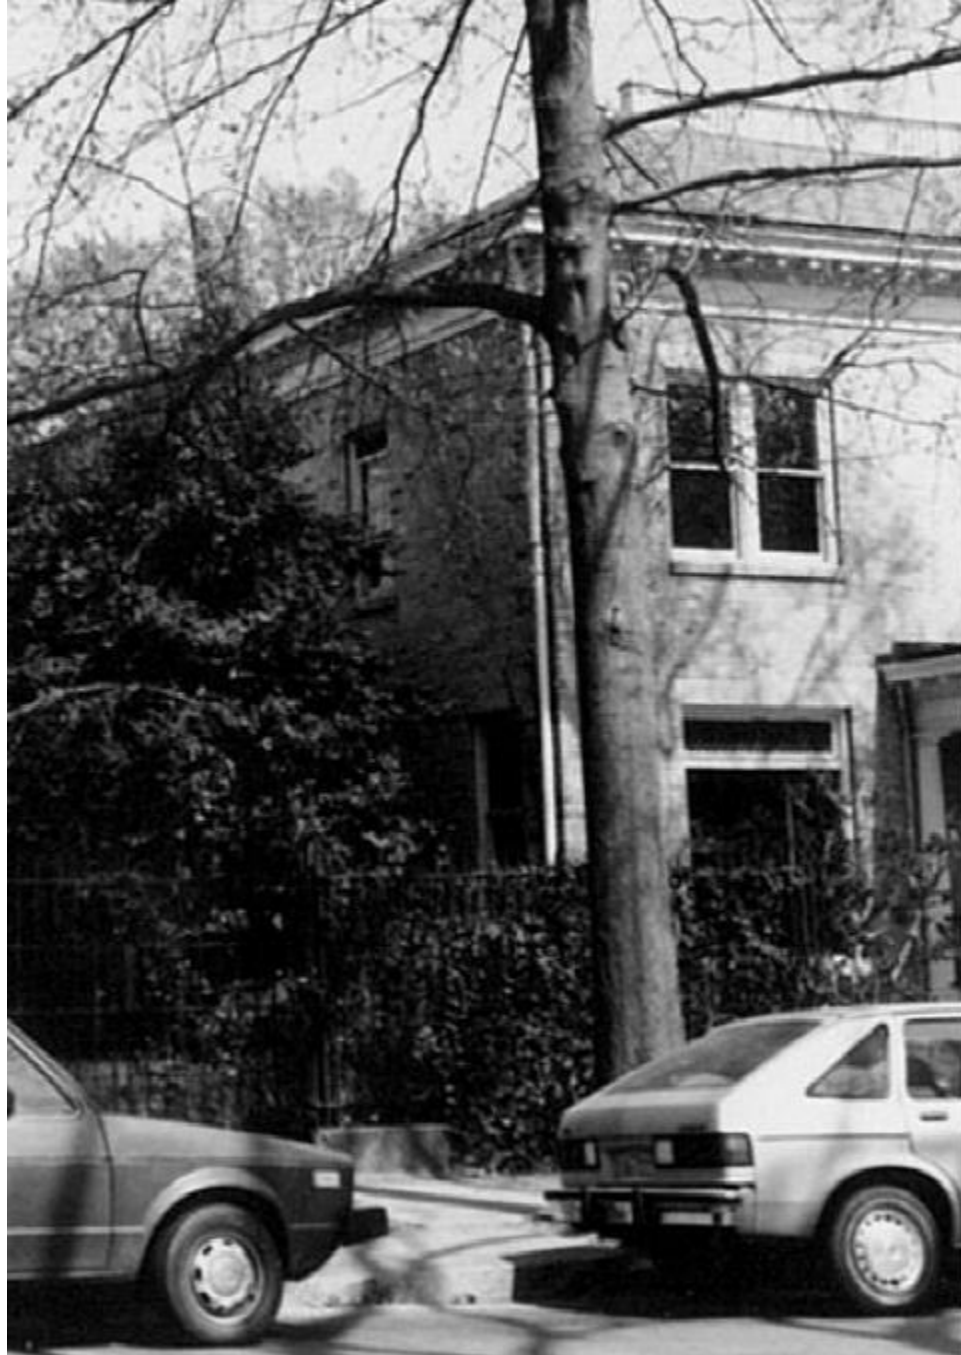
1208 W. Franklin Street, 1969 or 1970, showing the missing roof balustrade

Documentation also exists for the proposed reconstruction of the roof balustrade. The applicant has supplied the original house plans which show the balustrade design and has stated physical evidence of the balustrade can be found on the roof. The applicant proposes to install a balustrade that matches the new porch balustrade. Staff has found photographic evidence of the missing roof balustrade,

which matches the design shown in the house plans. The *Guidelines* state that documentation should be used to reconstruct missing elements (pg. 57, #7). As sufficient documentation of the missing balustrade exists, staff recommends that the roof balustrade be designed to match the photographic and historical documentation, rather than the new porch balustrade design.

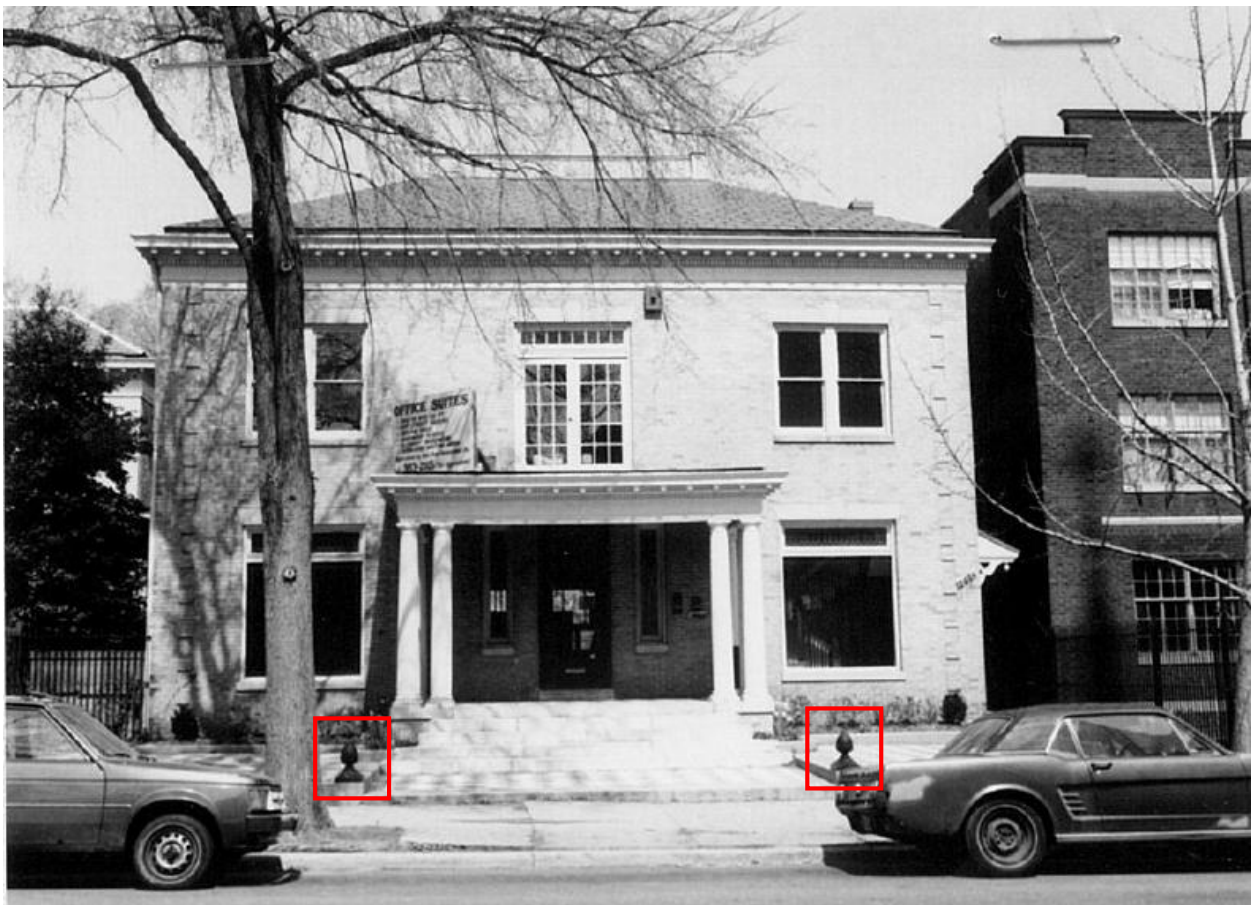
1208 W. Franklin Street, 1969 or 1970

The applicant also proposes to install a front-yard fence, to match an existing fence next door. Plans for the proposed fence were not submitted however based on the existing fence, the proposed fence may not meet zoning fence height restrictions. The *Guidelines* state that if not original to a site, new street-front fences, walls, and gates are not recommended. The applicant has submitted photographs of metal objects in the concrete which they believe is evidence of a fence. Based on the 1969-1970 photographs, these objects are most likely left from decorative finials which can be seen on both corners of the patio. There is no other evidence of a former fence around the patio. Based on this evidence and the recommendation for front yard fences in the *Guidelines*, staff cannot recommend approval of the proposed fence. If the Commission wishes to approve the fence, staff recommends plans and details of the proposed fence and gate be submitted for administrative review and approval to ensure the design is consistent with the existing fence.
