# 1. COA-041237-2018

511 North 21<sup>st</sup> Street

# Commission of Architectural Review

**Construct a two-story porch on the rear and alter the openings on the rear elevation.**

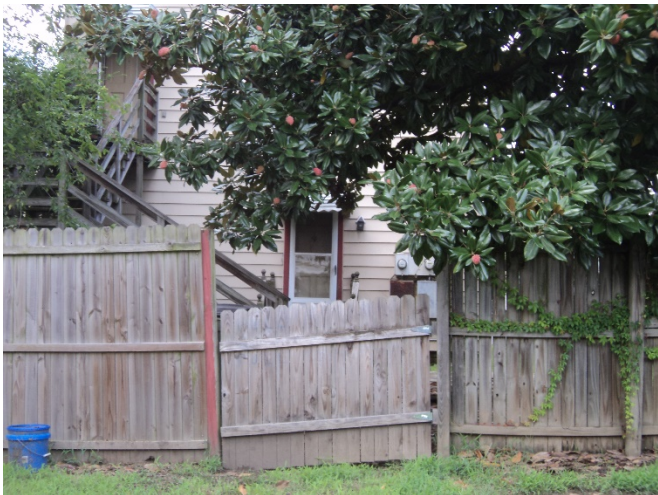
Figure 5. Existing first-story door opening.

Pg. 71, #14	<i>Do not remove original doors and door surrounds.</i>	On the first story the applicant is proposing to convert an existing single door to full light double French doors. <u>As full double doors are not a form typically found on historic buildings in the Union Hill Historic District, staff recommends the existing opening be maintained at its current size.</u>
Pg. 49, Doors and Windows #1	<i>The size, proportion and spacing patterns of door and window openings in a new addition should follow patterns established by the original building.</i>	<u>New windows and doors should be wood or aluminum clad wood with simulated divided lites to include interior and exterior muntins and a spacer bar between the glass.</u>
Pg. 49, Doors and Windows #2	<i>The architectural appearance of original windows should be used as models for new windows.</i>
