**Staff Report**  
**City of Richmond, Virginia**

**Commission of Architectural Review**

COA-098253-2021	<b>Final Review</b>	<b>Meeting Date: 9/28/2021</b>
<b>Applicant/Petitioner</b>	Martin Coenen	
<b>Project Description</b>	Alter a former storefront, removing a fixed set of doors and replacing with a window; replace existing entry doors.	
<b>Project Location</b>		
<b>Address: 513 N. 27<sup>th</sup> St.</b>		
<b>Historic District: Church Hill North</b>		
<b>High-Level Details:</b> <ul style="list-style-type: none"> <li>The applicant proposes to alter a former storefront on a ca. 1870 brick Italianate converted commercial building.</li> <li>The applicant proposes to replace the first floor windows to match the existing 2<sup>nd</sup> floor windows and install transom windows.</li> <li>The applicant proposes to replace the northern entrance doors with new, wooden doors.</li> <li>The applicant proposes to replace the inoperable southern entrance doors with windows.</li> <li>Historic Richmond Foundation has a preservation easement on this property.</li> </ul>

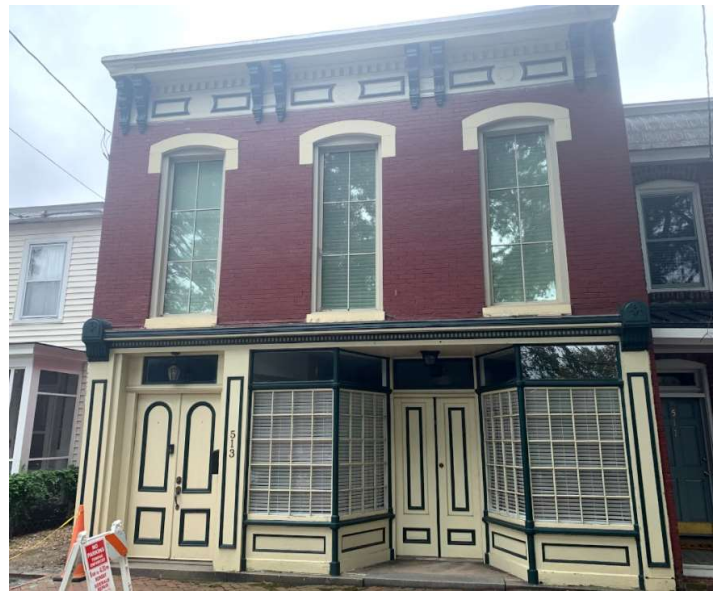
Figure 2. Façade photo

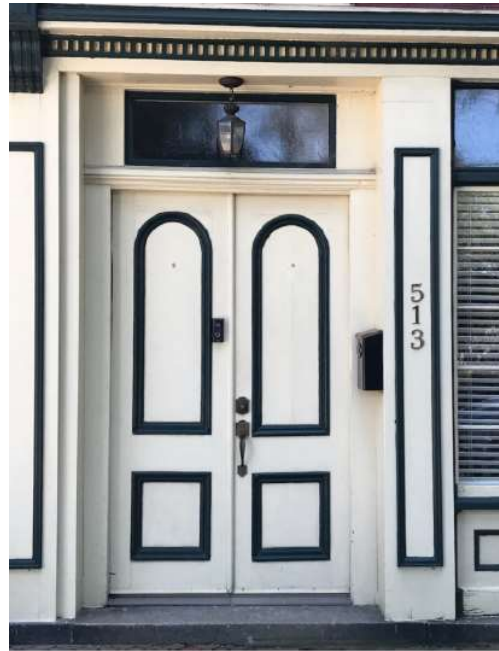
Figure 4. Existing front entry doors to be replaced.

Guideline Reference	Reference Text	Analysis
<p>Building Elements – Porches, Entrances, and Doors, pg. 71</p>	<p><i>14. Do not remove original doors and door surrounds. Replacement doors and door surrounds with stamped or molded faux paneling or leaded, beveled, or etched glass are strongly discouraged and rarely permitted. Stamped or molded faux panel doors are inappropriate substitutes for door types found in historic districts.</i></p>	<p>The applicant proposes replacing the northern entrance doors with new, wooden doors with taffeta privacy glass. The applicant has stated that the doors are deteriorated beyond repair. After a site visit, staff believes the current doors are original to the building and can be repaired. Therefore, <u>Staff recommends denial of replacing the northern entry doors with new, wooden doors and recommends that if the door cannot be repaired, that it be replaced in-kind.</u></p>

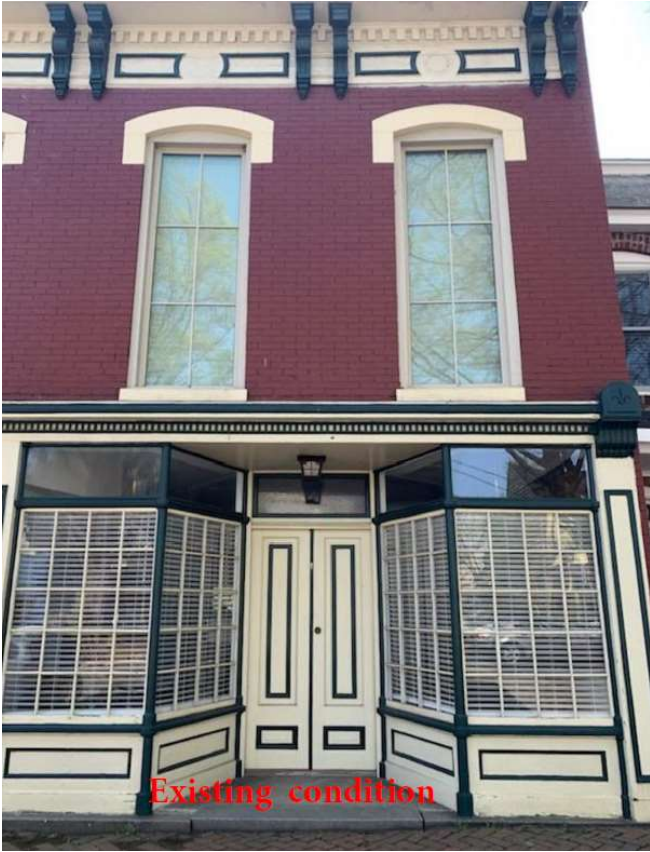
Figure 5. Existing secondary entrance with fixed doors to be replaced with a window.

<p>Standards for Rehabilitation – Residential Construction, pg. 59</p>	<p><i>5. Retain original windows including both functional and decorative elements such as frames, sash, muntins, glazing, sills, hood molds, paneled or decorated jambs and moldings, shutters and exterior blinds.</i></p> <p><i>6. Retain original entrances and porches including doors, frames, fanlights, sidelights, steps, balustrades, pilasters, entablatures, columns, and decorative features.</i></p>	<p>The applicant proposes replacing the 4 existing, 5 by 4 store front windows with windows to match the existing second story windows and to install transom windows. Staff was unable to locate documentation demonstrating that the current windows are not the original. Therefore, <u>staff recommends denial of the installation of new store front windows.</u></p> <p>The applicant proposes replacing the inoperable southern entrance doors with windows to match the existing first floor windows. Staff believes the current doors are original to the building. Although the southern door is inoperable as an entrance, staff believes it’s an important architectural feature of the front façade. Therefore, <u>Staff recommends denial of replacing the southern doors with windows.</u></p>
