# Commission for Architectural Review Application for Certificate of Appropriateness

Address: 308 W Clay Street

Historic District: JACKSON Ward

<b>PROJECT SUMMARY</b>	<b>2</b>
<b>PROPERTY DESCRIPTION</b>	<b>3</b>
<b>AREAS PROPOSED FOR DEMOLITION</b>	
Description & Photos	<b>4-7</b>
Breakdown of Current Area	<b>7</b>
Materials	<b>8</b>
Repair Estimates	<b>8</b>
Considerations for Repair vs. New	<b>8</b>
<b>PROPOSED ALTERATIONS &amp; ADDITIONS</b>	
Description	<b>9</b>
Breakdown of Proposed Area	<b>10</b>
Materials	<b>10-11</b>
<b>ATTACHMENTS</b>	
A. Plat of Survey	<b>12</b>
B. Engineer's Report	<b>13</b>
C. Site Plan – Current & Proposed	<b>14</b>
D. Floor Plans – Current & Proposed	<b>15-16</b>
E. Elevations – Current & Proposed	<b>17-19</b>

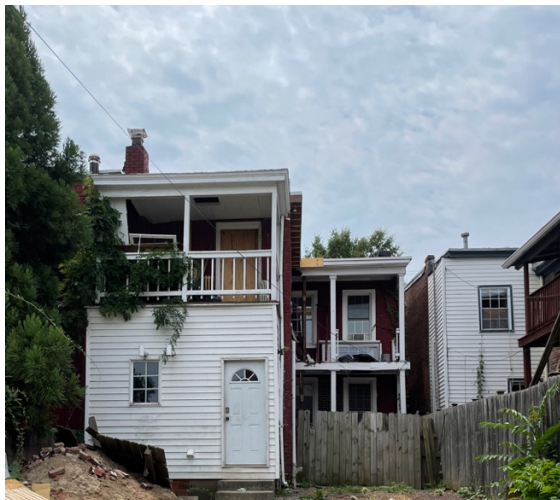
This proposal is for a remodel of the rear portion of the house with 2 components:

- 1) Removal of the remainder of the rear porches (seen on the right of this photograph), The rebuild is an addition with a slightly larger footprint than the existing rear porch area to accommodate expanded living and dining space as well as a new master bathroom on the 2<sup>nd</sup> floor.
- 2) The existing mudroom and 2<sup>nd</sup> story balcony (seen on the left of this photograph) will be removed and replaced with a more functional utility room and rear entrance on the ground floor with an open deck above to be accessed from the 2<sup>nd</sup> floor.

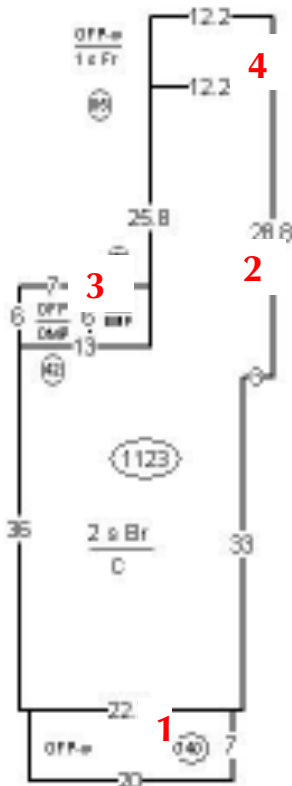
## PROPERTY DESCRIPTION

308 W Clay is an existing two-story single family attached brick home on a 2900 sf parcel.

1. In a review of Sanborn maps, we estimate the original home ("Main House") was built sometime during the late 1870's / early 1880's.
2. A rear brick building was added sometime around the turn of the century (reference as "1900 Addition"), and 1905 maps show that this building was at some point connected to the Main House. This rear portion of the house has a shared wall with the property at 306 W Clay Street.
3. The double porch on the rear of the house at one time spanned the entire width of the Main House and was partially enclosed at the time of the connection of the Main House to the 1900 Addition.
4. A mudroom and upper balcony were added sometime later.

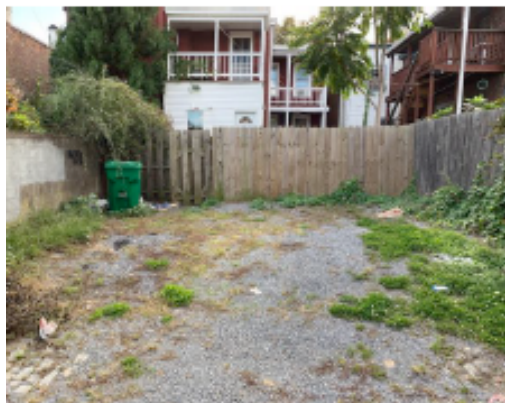
From the alley connected to Brook Road, behind our block of W Clay:  
306 is to the left, with a 6' concrete wall adjacent to our property.  
310 W Clay has a 6' wooden fence at the right edge of our property.

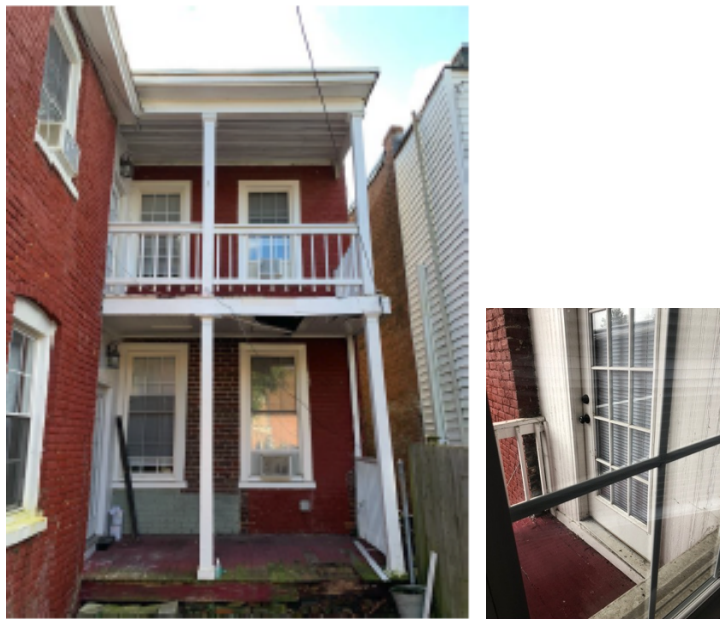
## #1 – DOUBLE PORCH

The Main House originally had a covered porch that ran across the length of the rear of the house. It is unclear whether this was always a double porch, as the slope of the “floor” of the 2<sup>nd</sup> story porch has a distinct pitch that resembles more of a roof than a floor.

At some point around the turn of the 20<sup>th</sup> century, about half of the porch was enclosed to establish interior access between the original (Main House) portion of the home to the rear brick building (1900 Addition) that had been added sometime after the original build.

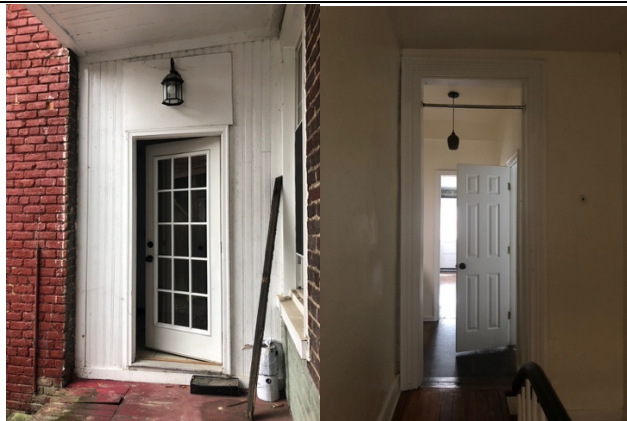
There are exterior access doors for each of these porches. We are unable to determine when these were added, but they do not appear to have architectural significance to the house, as the original exterior access is now part of the interior.

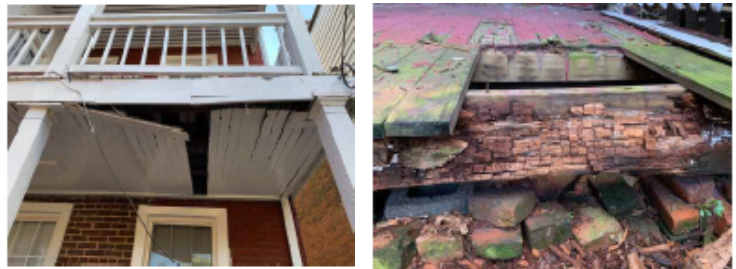
The porches themselves are not safe or functional for use. They are in a significant state of disrepair, with a crumbling foundation and wood elements that are missing or coming apart.

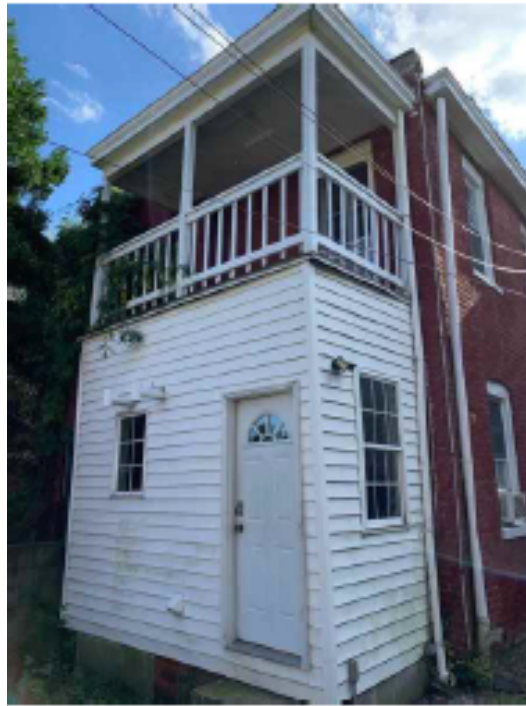
## #2 – MUDROOM & UPPER BALCONY

At yet another later date (sometime well into the 20<sup>th</sup> century), a mudroom, enclosed with aluminum siding and a 2<sup>nd</sup> floor balcony were added to the rear of the 1900 Addition. The mudroom serves as the rear entryway into the house and connects to the kitchen inside.

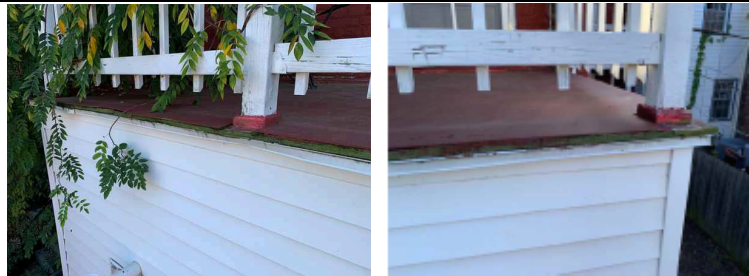
The rear balcony floor has been covered with 1/4" plywood and what can be seen underneath is green with mildew, indicating moisture is being trapped. At a minimum, this floor and potentially the ceiling of the existing mudroom would need to be replaced.

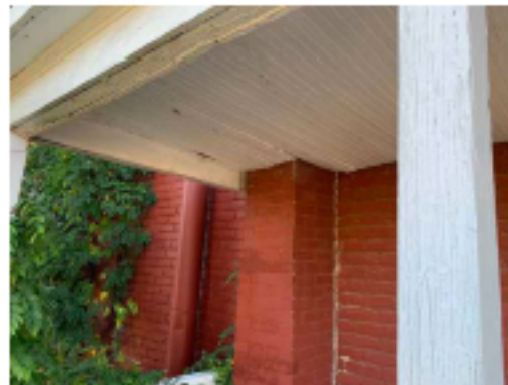
There is also a small inoperable chimney that runs from the ground to the roof at what was once the exterior corner of the 1900 Addition.

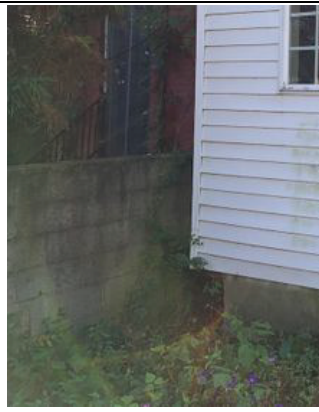
The mudroom and balcony were built “around” the chimney. The entire structure abuts directly to a 6’ concrete wall extending from the house at the edge of the property at 306 W Clay.

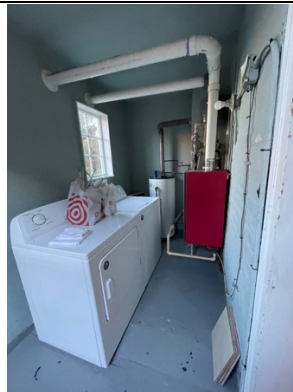
The current area of the mudroom interior is approximately 11’ x 5.5’, including the chimney (behind the boiler in the top right of the photo).

This room houses the boiler for heating, a hot water heater and laundry facilities. The space is crowded and does not allow for any additional storage.

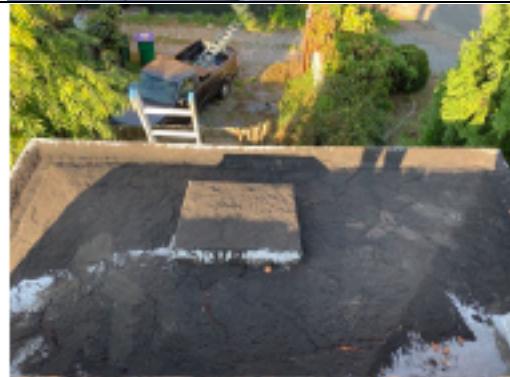
There is evidence of water intrusion in the metal roof structure. The roof has been coated with roofing tar in multiple layers which has dried and cracked and is not offering protection to the roof.

Recoating is not a viable option; the coating was likely done to repair a leak and that coating has failed.

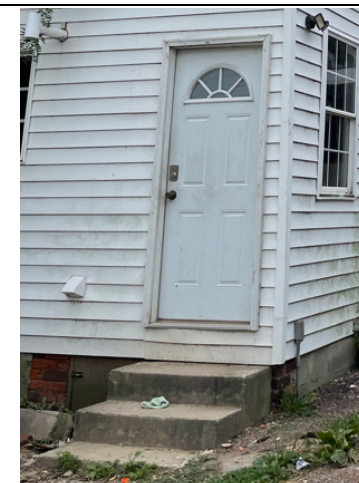
Exterior stairs to the mudroom and house are concrete, with no landing at the door, and no handrail.

The door jamb is rotted and needs repair / replacement.

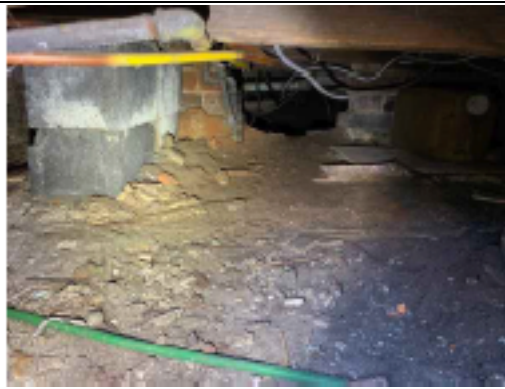
There is limited access under the house, with only a small opening (not large enough for an adult to enter), and even with a flashlight, it is clear there is no further human access beyond the mudroom to access the crawlspace under the kitchen (lower floor of the 1900 Addition).

This is dirt only, with no vapor barrier under the mudroom.

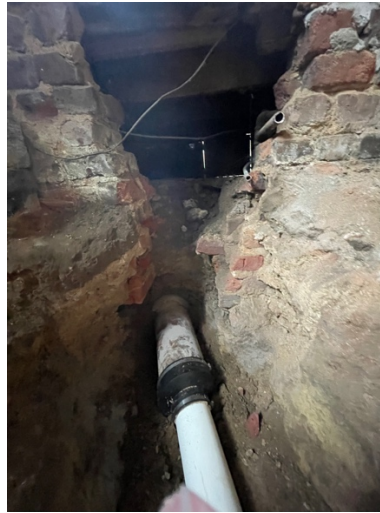
Wastewater pipes have been replaced under the kitchen with an interior remodel but were not accessible through the mudroom. These pipes run to the edge of the property in the alley.

The pipes replaced thus far were terra cotta, and we believe these pipes may be the originals that were laid at the time plumbing was added to the house (est. early 20<sup>th</sup> century)

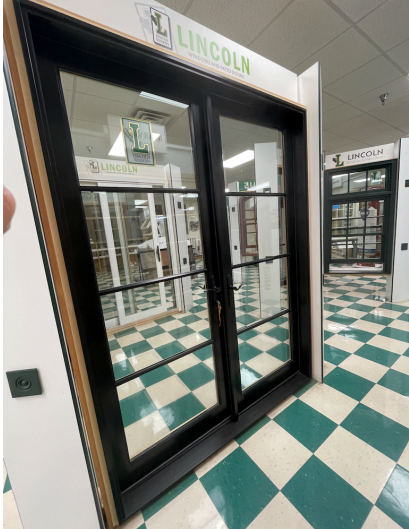
Deck: Lincoln Outswing double patio doors - Metal (aluminum) clad exterior; wood interior; Full lite / 4 panes each; 36” wide

with thin rails and styles

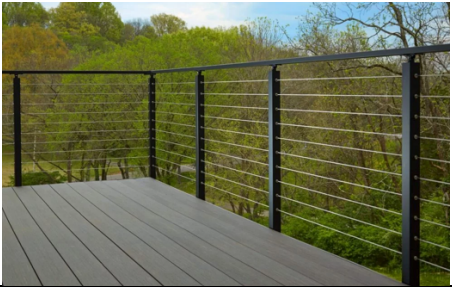
Decking & Stairs	N/A	Treated Wood – Cedar or similar with Black clad metal railing

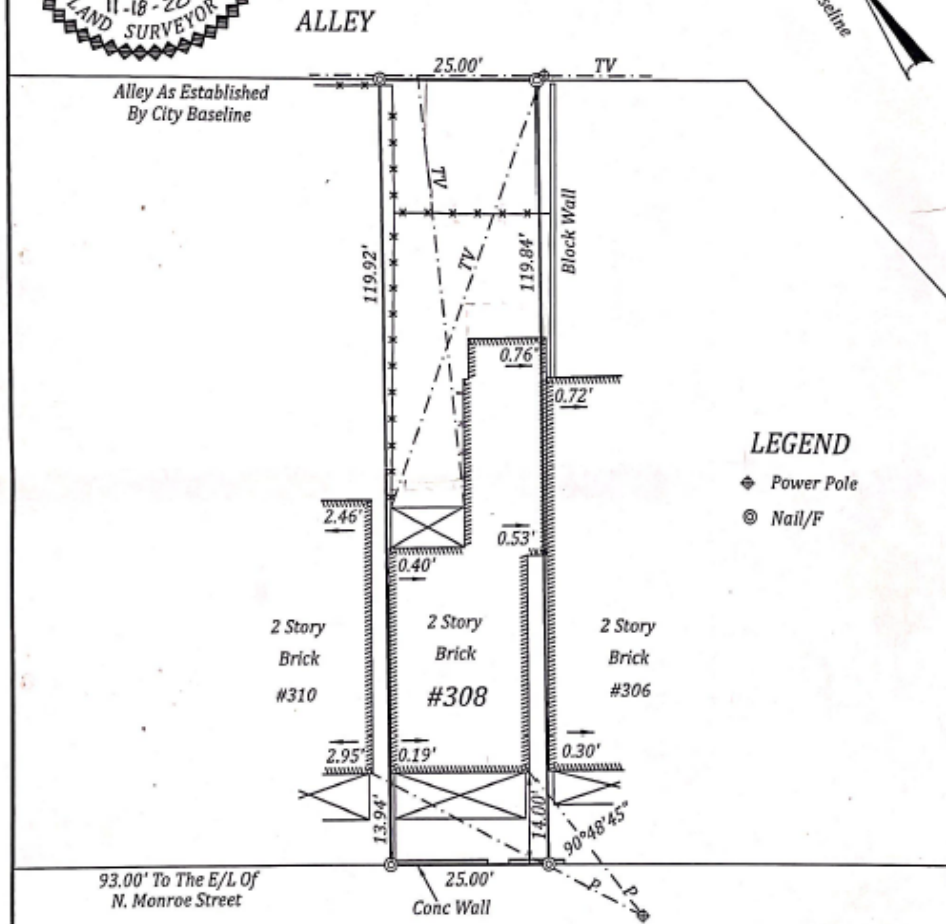
# ATTACHMENT A: PLAT OF SURVEY

SURVEY OF  
 LOT AND IMPROVEMENTS THEREON LOCATED AT  
**#308 W. CLAY STREET**  
 RICHMOND, VIRGINIA

See Attachment A - Plat of Survey
