Property Address: 3104 E Broad St , Richmond, VA, 23223 (BLDR-147901-2024) Current **Zoning:** R-6
Historic District: St John's Church

Changes to the front: Paint similar to property next door (3106 E Broad St). Change windows like-to-like.
Handcrafted repair of the moldings where necessary. Side: Partial demo of existing masonry wall to extend area.

SCOPE OF WORK:
DESCRIPTION: EXTERIOR FACADE PROVIDING RESTORATION, AND IN-KIND PLACE REPLACEMENTS BASED ON THE DISTRICT'S HISTORIC STANDARDS AND GUIDELINES

COVER
SHEET

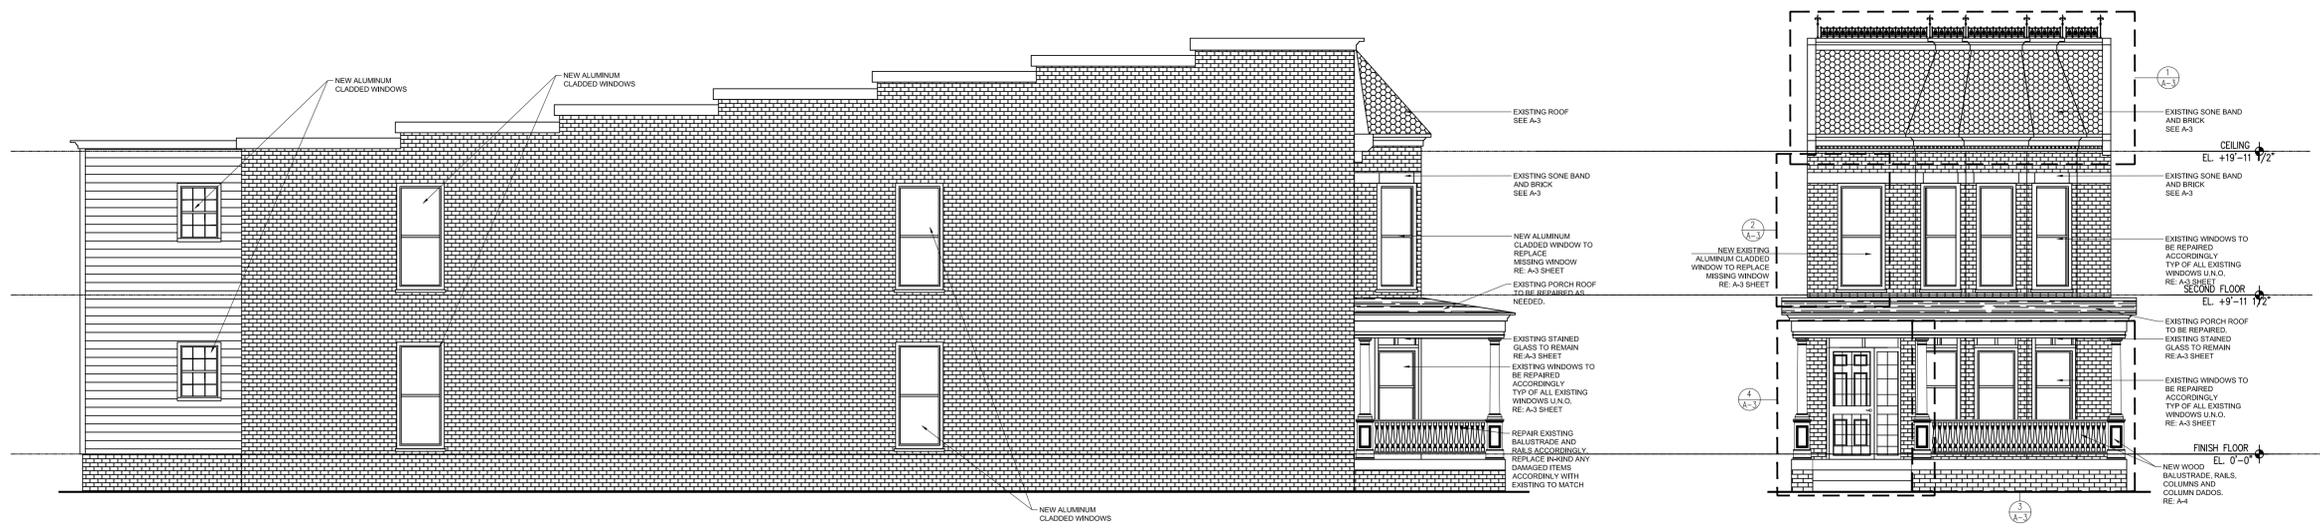
1
A-2 **RIGHT ELEVATION**
SCALE: 3/16=1'-0"

2
A-2 **FRONT ELEVATION**
SCALE: 3/16=1'-0"

SEE SHEET A-3 FOR FRONT ELEVATION ENLARGEMENTS AND NOTES

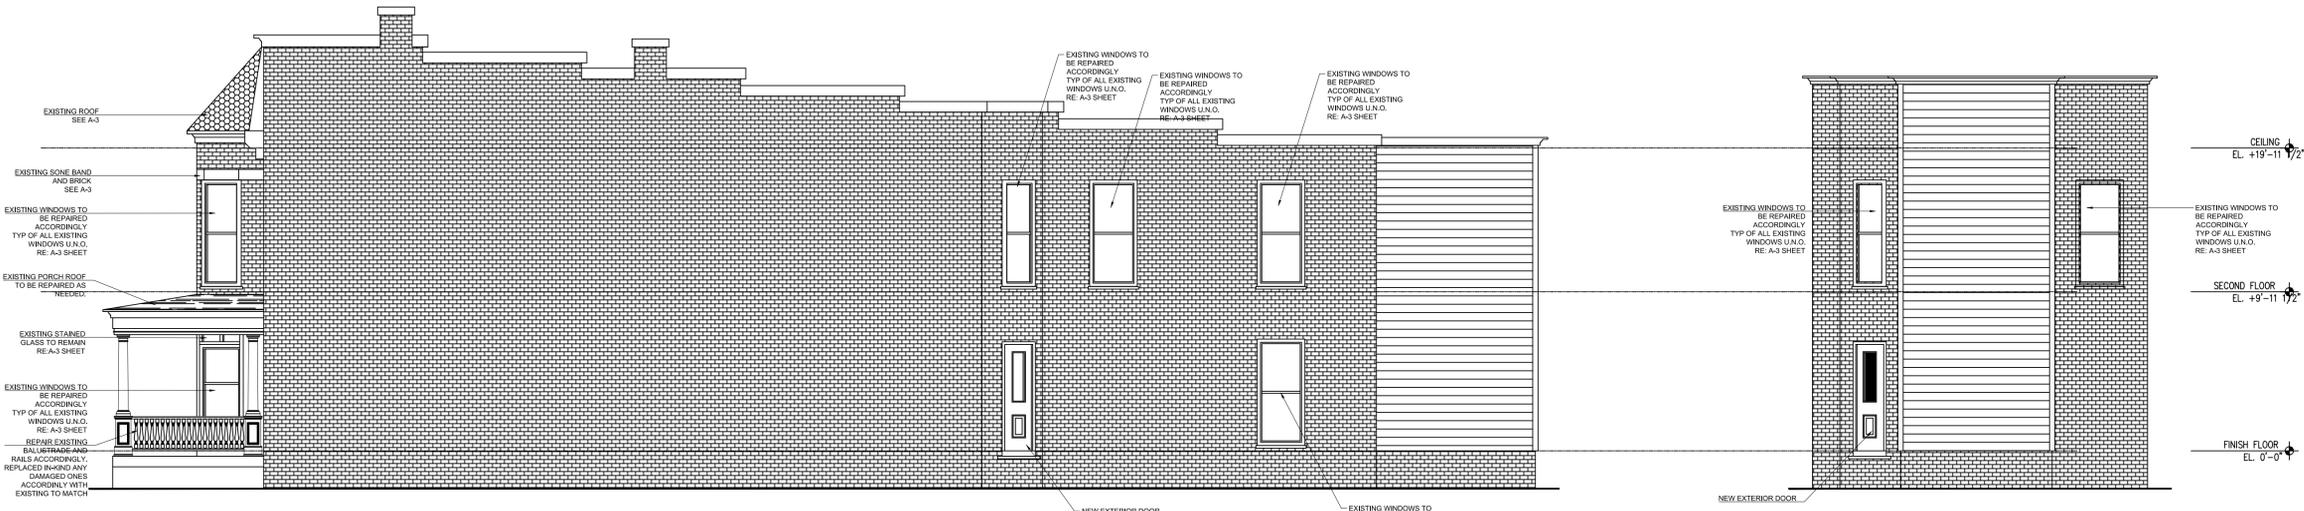
3
A-2 **LEFT ELEVATION**
SCALE: 3/16=1'-0"

2
A-2 **REAR ELEVATION**
SCALE: 3/16=1'-0"

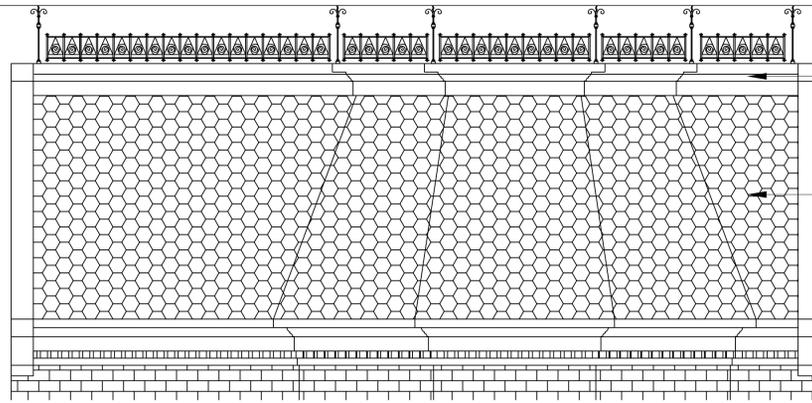
1
A-3

REPAINT EXISTING CORNICES

EXISTING SLATE ROOF. REPAIR AND REPLACE TILES AS NEEDED. INSPECT SUPPORTING STRUCTURAL MEMBERS TO ENSURE STRUCTURAL INTEGRITY. SEE RECOMMENDED ROOF REPAIR NOTES ON THIS SHEET AND SHEET A-6

ROOF REPAIRS RECOMMENDATION NOTES:
REPAIR EXISTING ROOFS WITH LIMITED REPLACEMENT IN-KIND WITH EQUAL OR COMPATIBLE MATERIAL OF THOSE EXTENSIVELY DETERIORATED OR MISSING SHINGLES.

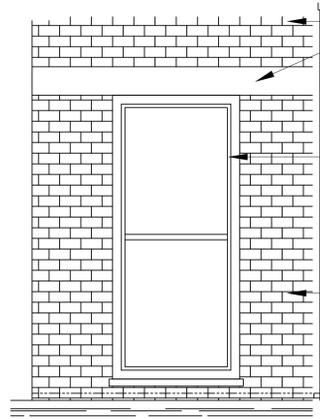
2
A-3

EXISTING STONE BAND AND BRICK MASONRY TO BE CLEANED AND REPAIRED. SEE RECOMMENDATIONS TO WASHING/CLEANING AND RESTORING MASONRY NOTES ON SHEET A-5

NEW ALUMINUM CLADDED DOUBLE HUNG REPLACEMENT WINDOW SEE NEW WINDOW NOTES ON THIS SHEET.

EXISTING STONE BAND AND BRICK MASONRY MORTAR RE-POINTED (IF NEEDED) AND REPAIRED AND NEEDED. SEE RECOMMENDATIONS TO MORTAR AND REPOINTING MASONRY NOTES ON THIS SHEET AND SHEET A-5

BRICK AND STONE WASHING RECOMMENDATIONS NOTES:
CLEANING OF MASONRY SHOULD BE CARRIED OUT BY A KNOWLEDGEABLE CONTRACTOR WHO SPECIALIZES IN NON-INVASIVE CLEANING TECHNIQUES. THE GENTLEST MEANS POSSIBLE INVOLVING LOW PRESSURE WATER WITH A MILD DETERGENT IS BEST.

MORTAR RE-POINTING RECOMMENDATION NOTES:
REPLACEMENT MORTAR SHOULD DUPLICATE ORIGINAL IN STRENGTH, COMPOSITION, COLOR TEXTURE AND PROFILE. THE RE-POINTING SHOULD BE CARRIED OUT BY A KNOWLEDGEABLE CONTRACTOR IN HISTORIC PRESERVATION REMOVE MORTAR BY HAND-RAKING THE JOINTS ONLY. NEVER USE ELECTRICAL SAWS OR HAMMERS.

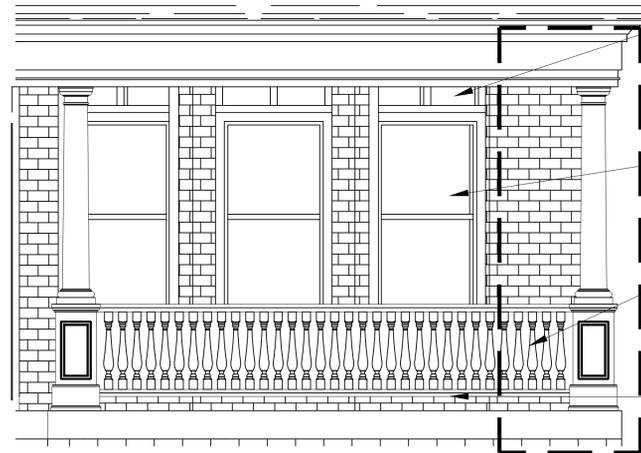
3
A-3

EXISTING GLASS STAINED GLASS TRANSOMS TO BE CLEANED AND REPAIRED ACCORDINGLY. SEE GLASS RECOMMENDATIONS ON THIS SHEET AND SHEET A-6

NEW ALUMINUM CLADDED DOUBLE HUNG REPLACEMENT WINDOWS, PAINTED.

EXISTING WINDOW RECOMMENDATION NOTES:
REPAIR EXISTING WOOD FRAMES AND USE IN KIND-REPLACEMENT IF PARTS ARE MISSING. TREATMENTS INCLUDE SURFACE CLEANING, RE-PAINTING, RE-COATING IF NECESSARY AND APPLYING APPROPRIATE SEALANTS FOR AIR TIGHTNESS. ORIGINAL WINDOWS SHOULD BE REPAIRED BY PATCHING, SPLICING, CONSOLIDATING OR OTHERWISE REINFORCING THEM. WINDOWS SHOULD BE WEATHER STRIPPED TO ENSURE ALL JOINTS ARE TIGHT AND SEALED TO PREVENT AIR AND WATER INFILTRATION.

NEW WINDOWS RECOMMENDATION NOTES
THE ARCHITECTURAL APPEARANCE OF WINDOWS SHOULD BE USED AS MODEL FOR NEWWINDOWS. THEY PARTICULARLY SHOULD MATCH IN HEIGHT, TYPE, SASHES, AND MUNTINS.

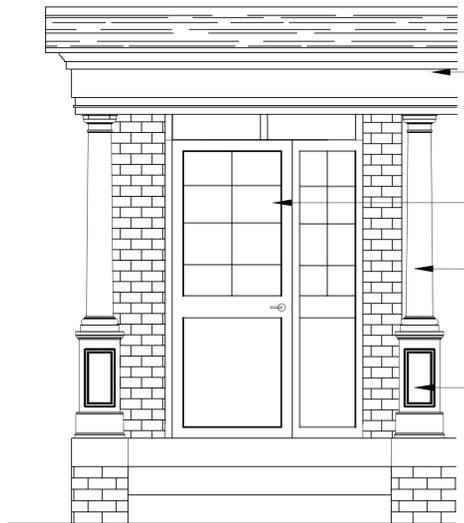
4
A-3

EXISTING PORCH WOOD ENTABLATURE TO BE REPAIRED. SEE WOOD RECOMMENDATIONS ON WOOD REPAIR OR REPLACEMENT ON THIS SHEET AND SHEET A-6

EXISTING WOOD COLUMNS TO BE REPAIRED AS NEEDED. SEE RECOMMENDATIONS FOR WOOD REPAIR ON THIS SHEET AND SHEET A-6

EXISTING WOOD COLUMNS DADOS TO BE REPAIRED AS NEEDED. SEE RECOMMENDATIONS FOR WOOD REPAIR ON ON THIS SHEET AND SHEET A-6

WOOD RECOMMENDATION NOTES:
REPAIR WOOD MEMBERS BY PATCHING, PIERCING-IN CONSOLIDATING AND USING IN-KIND REPLACEMENT OF DAMAGE PIECES AS NEEDED.

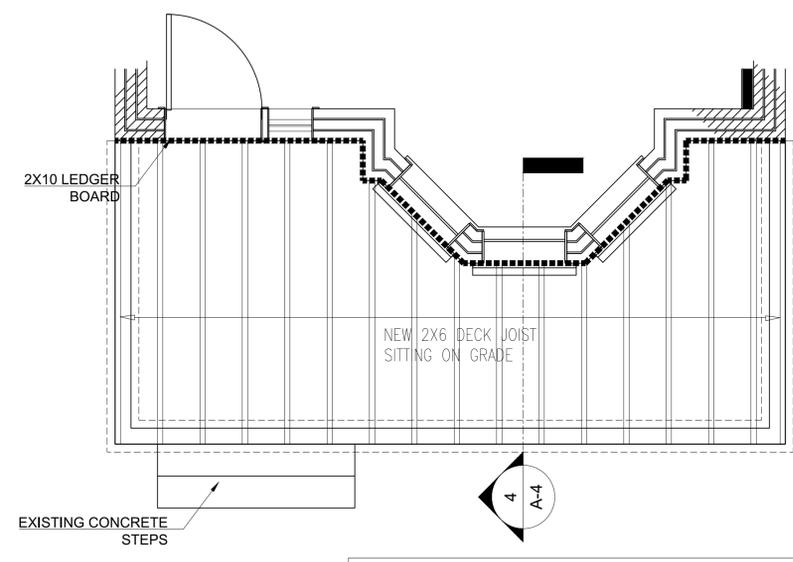
NOTE: ALL DECK LUMBER IS TO BE PRESSURED TREATED
2 PORCH FRAMING PLAN
SCALE: 3/8"=1'-0"

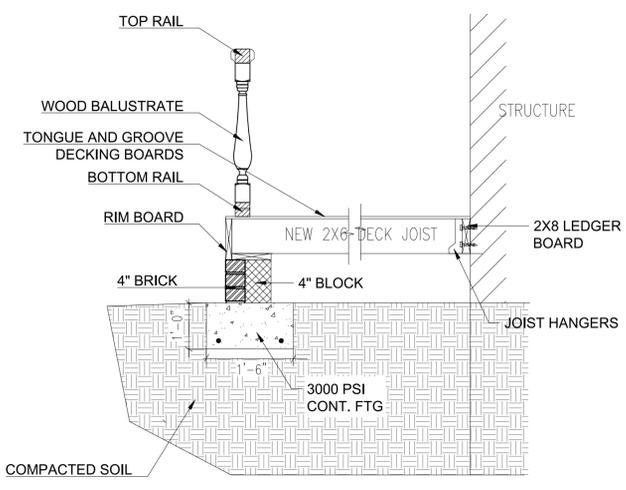
NOTE: ALL DECK LUMBER IS TO BE PRESSURED TREATED
4 FOOTING/FRAMING SECTION
SCALE: 3/8"=1'-0"

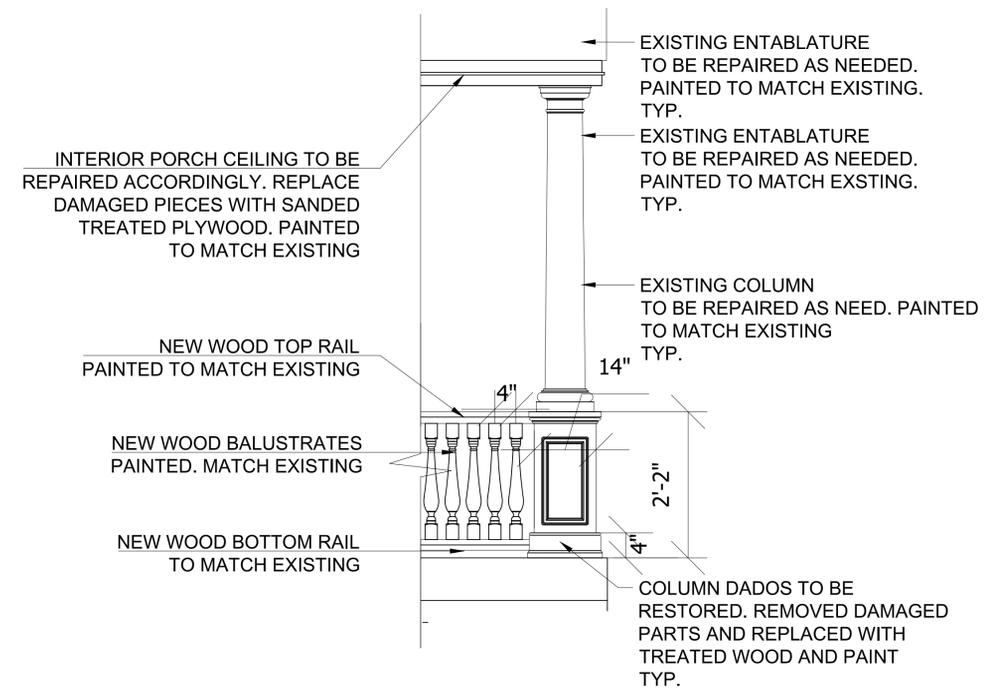
5 FRONT FACING PORCH BALUSTRATES AND COLUMN DETAILS
SCALE: 3/8"=1'-0"

INTERIOR PORCH CEILING TO BE REPAIRED ACCORDINGLY. REPLACE DAMAGED PIECES WITH SANDED TREATED PLYWOOD. PAINTED TO MATCH EXISTING

EXISTING ENTABLATURE TO BE REPAIRED AS NEEDED. PAINTED TO MATCH EXISTING TYP.

EXISTING COLUMN TO BE REPAIRED AS NEED. PAINTED TO MATCH EXISTING TYP.

COLUMN DADOS TO BE RESTORED. REMOVED DAMAGED PARTS AND REPLACED WITH TREATED WOOD AND PAINT TYP.

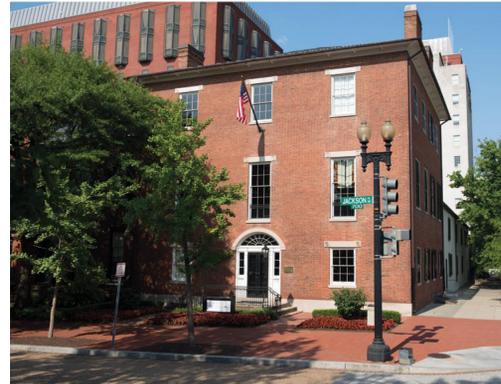
(2) (a) Decatur House in Washington, DC, was designed by William Henry Latrobe and constructed in 1816. (b) In the late-19th century, the facade was "modernized" by removing the limestone lintels on the first floor and replacing them with decorative sandstone lintels in the style of the period. (c) In the mid-20th century, the house was brought back to its original appearance based on historic documentation. Photos: The White House Historical Association and Decatur House, a National Trust Site.

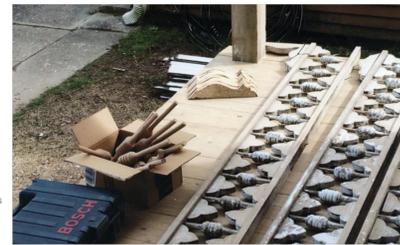
(5) New wood trim pieces were milled to match the few remaining historic features to replace those that were missing.
