2. COA-063226-2019

Commission of Architectural Review

STAFF REPORT

Reconstruct a front porch and reinstall cast iron posts and railing.

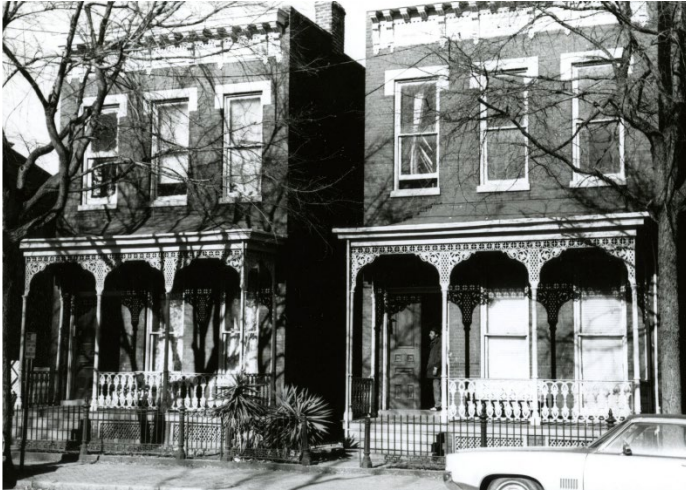
Figure 1. 416-414 West Clay Street, 1978

The front porch has been missing since at least 2007. The Jackson Ward Historic District book, published by the Department of Planning and Community Development in 1978, notes that 414 and 416 West Clay Street are identical Italianate houses with cast iron porches. A photograph of the building confirms that the front porch designs were identical.

The plans do not include any details on proposed gutters. The 1978 photograph indicates that the front porch originally had a built-in box gutter. Staff recommends the new porch include a box gutter and the applicant submit additional information for administrative approval.

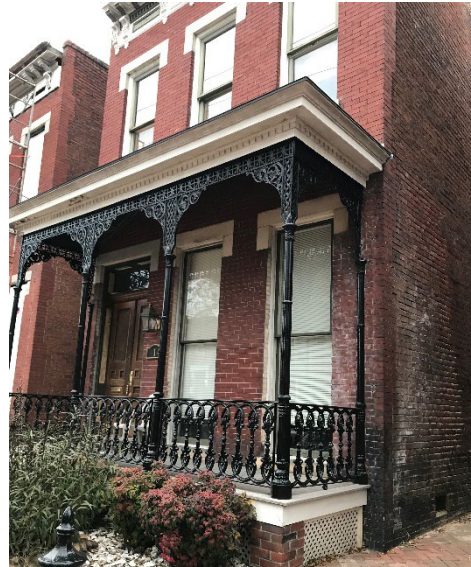
Figure 2. Front porch at 414 West Clay Street.

The applicant is proposing to reconstruct the front porch at 416 West Clay Street to replicate the existing porch at 414. The applicant has informed staff that the cast iron elements are extant and will be reinstalled. Staff recommends approval of the proposed porch reconstruction.

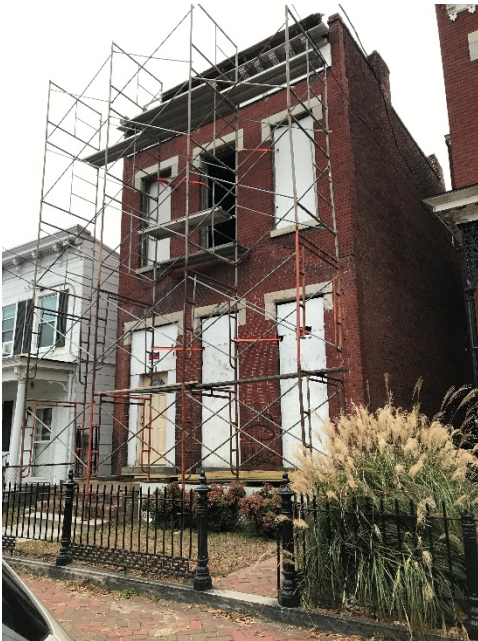
Figure 3. 416 West Clay Street, existing conditions.

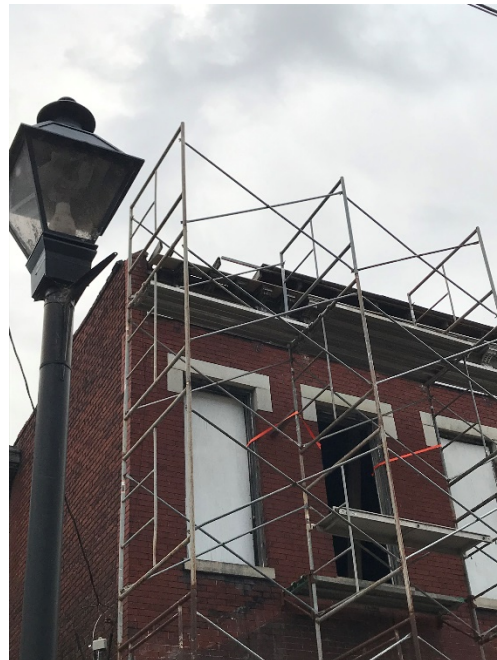
Figure 4. Section of missing cornice.

Staff notes that there may be additional repair work needed on the building, such as repair and reconstruction of the cornice, and window repair. Staff recommends that if any additional exterior work is required, the applicant work
