13. COA-071870-2020

2400 Venable Street

Commission of Architectural Review

STAFF REPORT

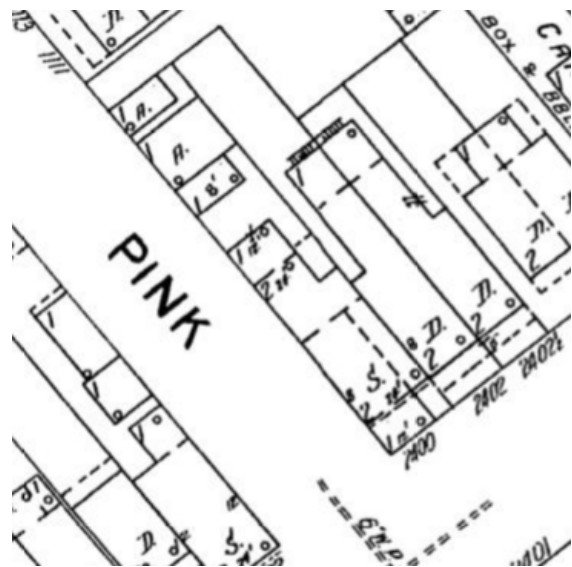
Figure 2. 1925 Sanborn map

- The applicant proposes to rehabilitate a two-story brick mixed-use building on the corner of Venable and Pink Streets.
- The John P. Harwood house was built as a single-family home ca. 1856. The building was converted to a store in the 1920s. According to Sanborn maps of the property it has existed in its current footprint since at least 1925.

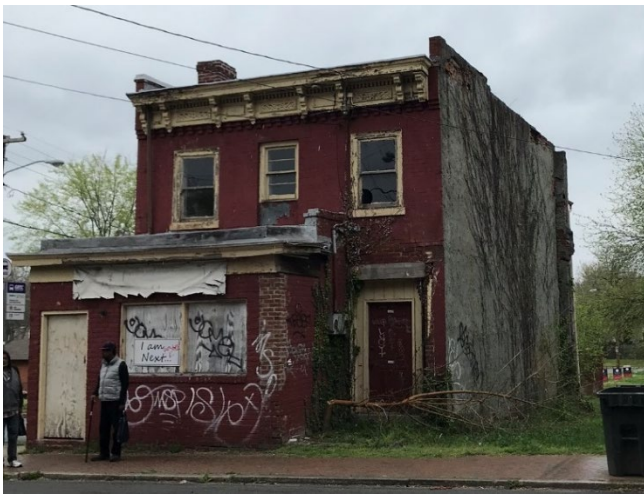
Figure 3. 2400 Venable Street façade, existing conditions

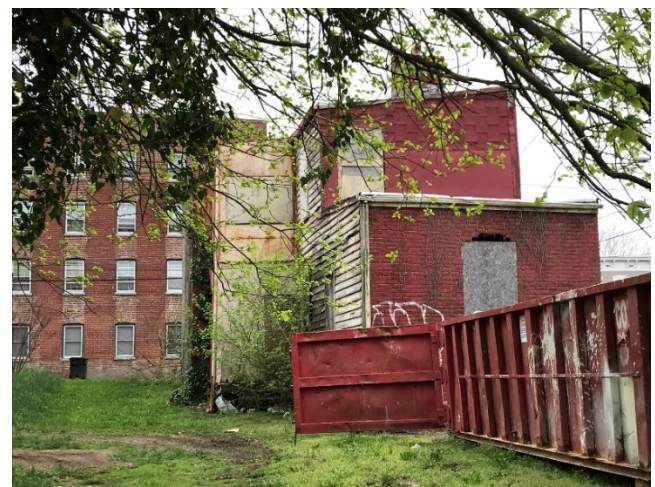
Figure 4. Rear elevations, existing conditions

The applicant is proposing to remove a substantial portion of the existing building, the rear portions of which predate 1905, and the front of which dates to the 1920s. There is existing historic fabric in these sections of the building including historic brick, wood siding, and wood windows and doors. Staff recommends retention of all historic material that has not deteriorated past the point of feasible repair. Further, staff recommends the existing wood siding be repaired and retained, and any deteriorated siding be replaced in-kind with new wood.

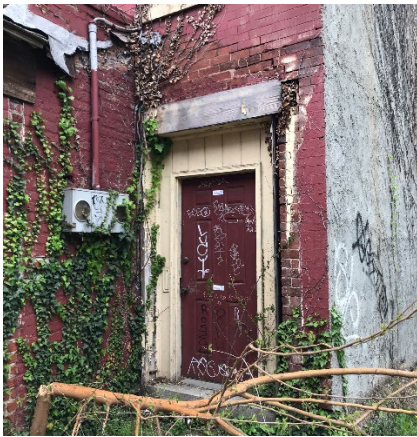
Figure 5. Existing front entrance

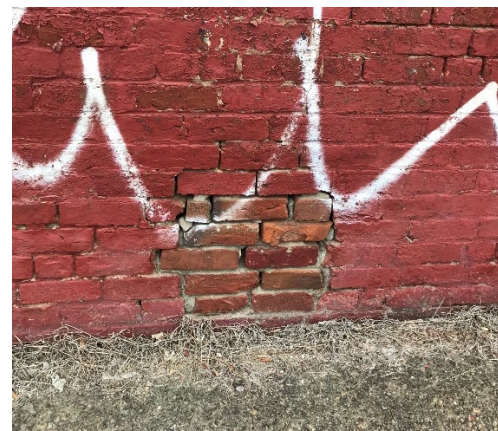
Figure 6. Detail of damaged brick

Staff has requested information from the applicant regarding the current conditions of the front and rear sections. However, the applicant has not included documentation that indicates that the existing front and rear sections are deteriorated beyond the point of feasible rehabilitation. Photographs of the interior indicate that portions of the roof of the 1-story portion are missing but they do not indicate that the existing walls are not sound.
