## Commission of Architectural Review

5. COA- 142784-2024	<b>Final Review</b>	Meeting Date: 2/27/2024
Applicant/Petitioner	Rodney Young	
Project Description	Replace a steel fire escape with wood.	
Project Location

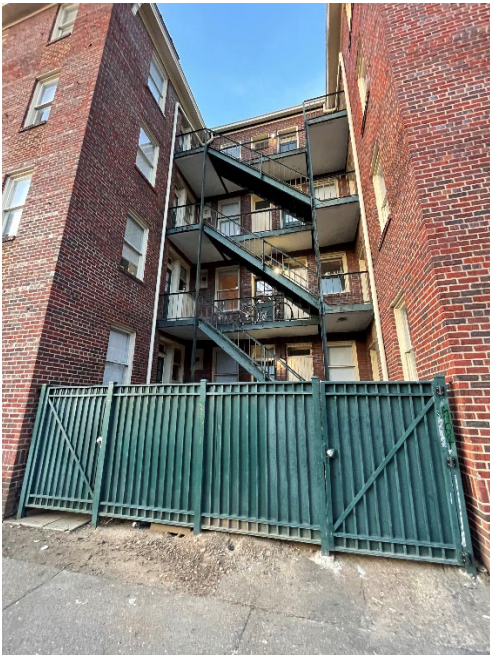
Figure 3. View of the fire escape on the south side of 22 South Arthur Ashe Boulevard.

Address: 22 South Arthur Ashe Boulevard		
Historic District: Boulevard		
High-Level Details: <ul style="list-style-type: none"> <li>The applicant proposes to fully remove and replace the south fire escape and the exterior stairs located on the north side of the building.</li> <li>The fire escape on the south side of this building is highly visible, along the north side of West Cary Street.</li> <li>The central stairs, along the north side of the building are not visible from public right of ways.</li> <li>This building is a 4-story multi-family apartment building, built in 1921.</li> </ul>		
Staff Recommendation	Partial Approval	
Staff Contact	Annie Delaroderie, <a href="mailto:anne.delaroderie@rva.gov">anne.delaroderie@rva.gov</a> , 804-646-6335.

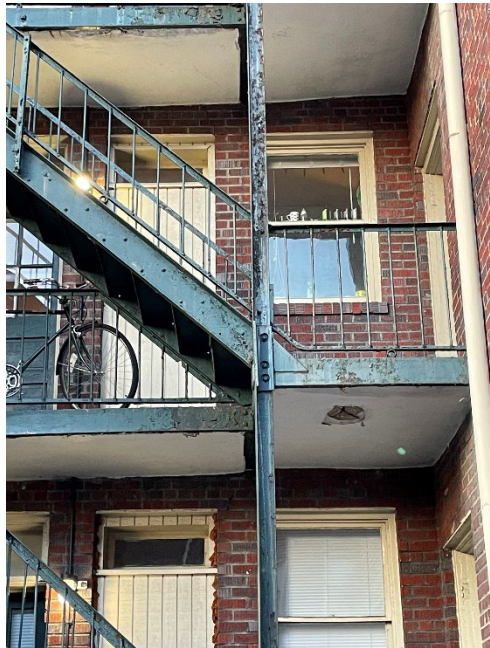
Figure 4. Zoomed-in image of deterioration of the steel and concrete floors along the second floor of the fire escape.

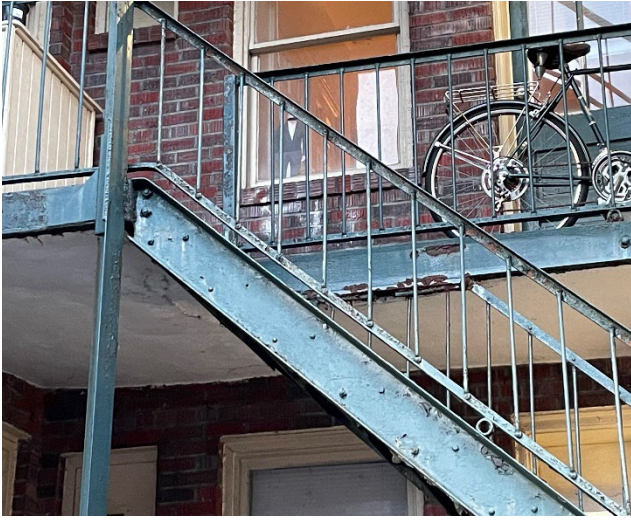
Figure 5. Zoomed-in image of deterioration of the steel and concrete floors along the second floor of the fire escape.
