Staff Report
City of Richmond, Virginia

Commission of Architectural Review

7. COA- 142785-2024	Final Review	Meeting Date: 2/27/2024
Applicant/Petitioner	Rodney Young	
Project Description	Replace a steel fire escape with wood.	
Project Location		
Address: 23 South Arthur Ashe Boulevard		
Historic District: Boulevard		
High-Level Details: <ul style="list-style-type: none"> The applicant proposes to fully remove and replace the south fire escape and the exterior stairs located on the north side of the building. The fire escape on the south side of this building is highly visible, along the north side of West Cary Street. The central stairs, along the north side of the building are only minimally visible from the rear, public alley. This building is a 3-story multi-family apartment building, built in 1922. During a Site Visit on February 8, 2024, staff noticed the concrete floors have been replaced with wooden boards. 		
Staff Recommendation	Partial Approval	
Staff Contact	Annie Delaroderie, anne.delaroderie@rva.gov , 804-646-6335.

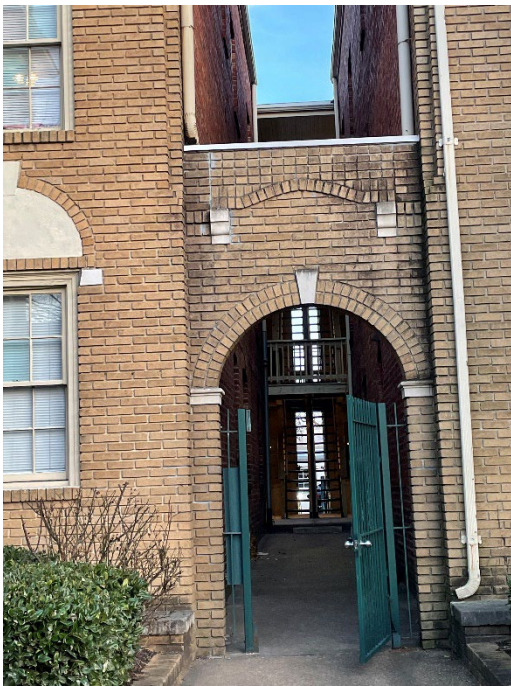
Figure 2. View of the center stairs from Arthur Ashe Boulevard.

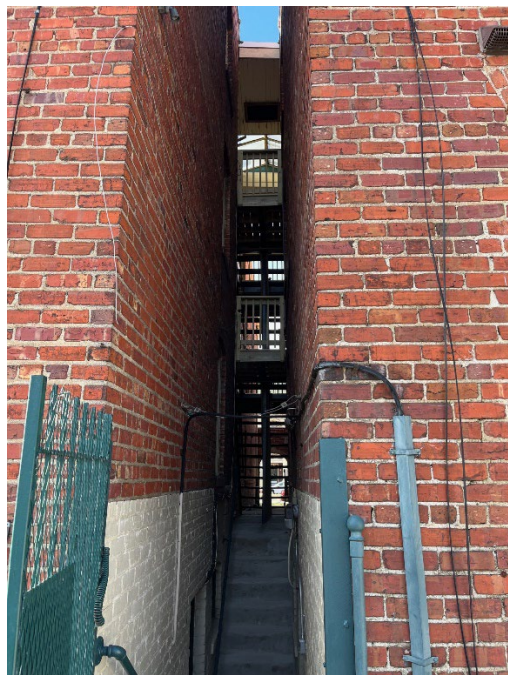
Figure 3. View of the center stairs, from the rear, public alley.

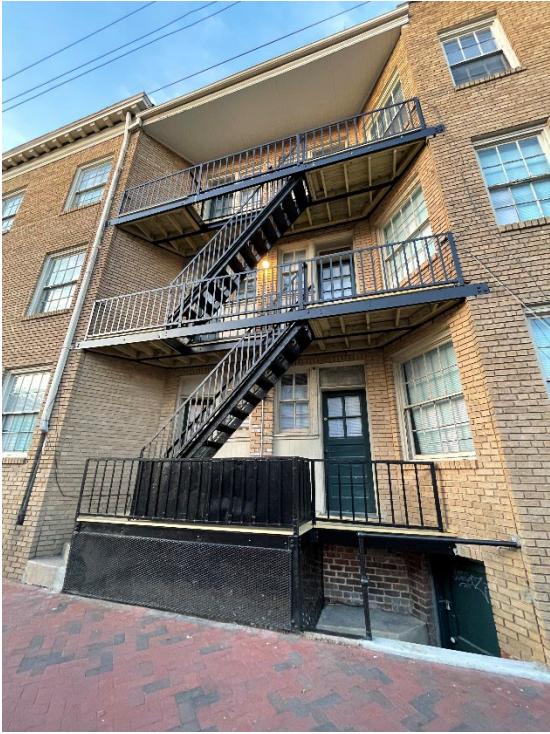
Figure 4. View of the fire escape on the south side of 23 South Arthur Ashe Boulevard. The new floor boards and their exposed decking can be seen on the second and third floors.

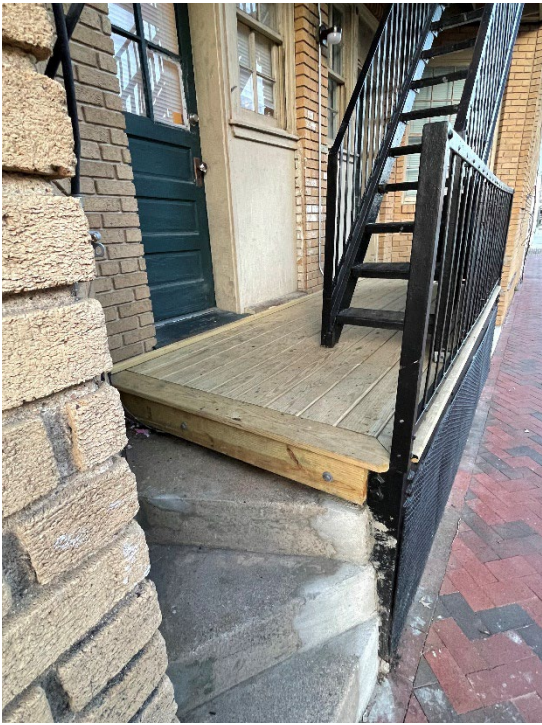
Figure 5. View of the replaced floorboards on the first floor of the fire escape on the south side of 23 South Arthur Ashe Boulevard.

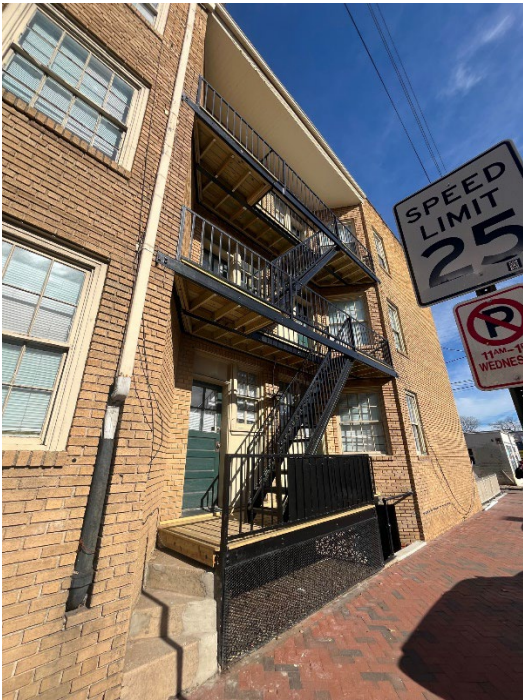
Figure 6. View of the exposed decking on the fire escape on the south side of 23 South Arthur Ashe Boulevard.

Standards For Rehabilitation: Residential Construction, page 59.	<i>7. Repair damaged elements instead of replacing them. Use materials that match the original in type, or use physically and chemically compatible substitute materials that convey the same appearance as the surviving elements or sections.</i>	If the steel is in poor condition and cannot be repaired <u>staff recommends replacing the fire escape with steel or a similar material.</u> The fire escape is a significant historic feature on this building, and steel or a similar material would be more compatible. On a site visit, staff noticed that the concrete floor of the fire escape had been replaced with wood. <u>Staff recommends approval of the installation of wooden decking boards, as this element is minimally visible behind a steel fire escape framing.</u> <u>Staff recommends that a smooth material/underside that covers the decking's wooden joists be installed for a more finished appearance.</u>
