## 8. COA-057293-2019

# Commission of Architectural Review

STAFF REPORT

**Rehabilitate an existing two-story single-family detached residence.**

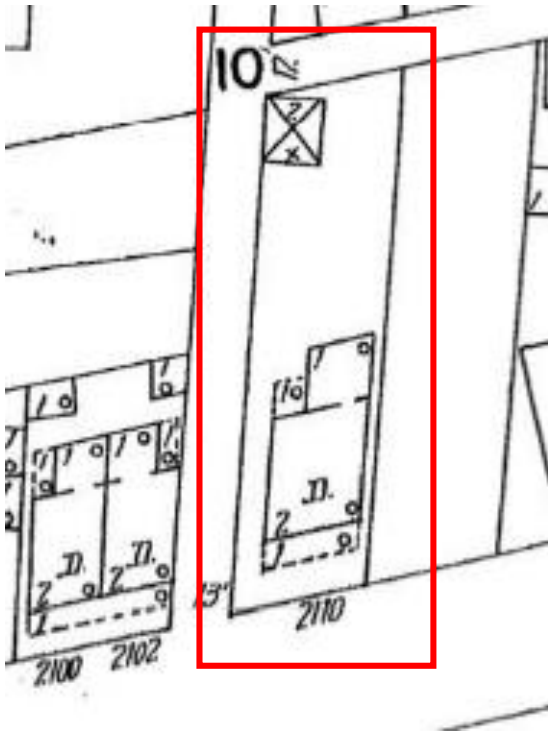
Figure 1. Sanborn map, 1905

Standards for Rehabilitation, pg. 59 #10	<i>...it is acceptable to use salvaged materials as in-kind replacement...</i>	As the windows in the rear are going to be removed to alter the openings and to accommodate the addition, <u>staff recommends that the historic windows removed be used for any window replacement or repair needed on the more visible elevations and an unused windows be maintained on the property.</u>
Standards for New Construction, Siting, pg. 46 #1	<i>Additions should be subordinate in size to their main buildings and as inconspicuous as possible. Locating additions at the rear or on the least visible side of a building is preferred.</i>	The proposed addition is located at the rear of the building, is subordinate in size, and is differentiated from the historic building by a 6" inset.
Standards for	<i>...adding features or salvaged architectural</i>	Sanborn maps indicate that a one-story porch

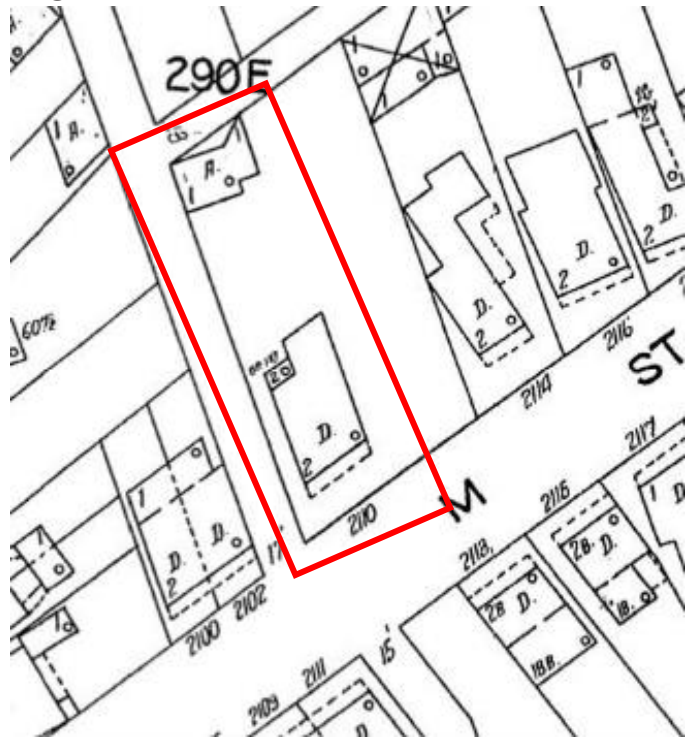
Figure 2. Sanborn map, 1925

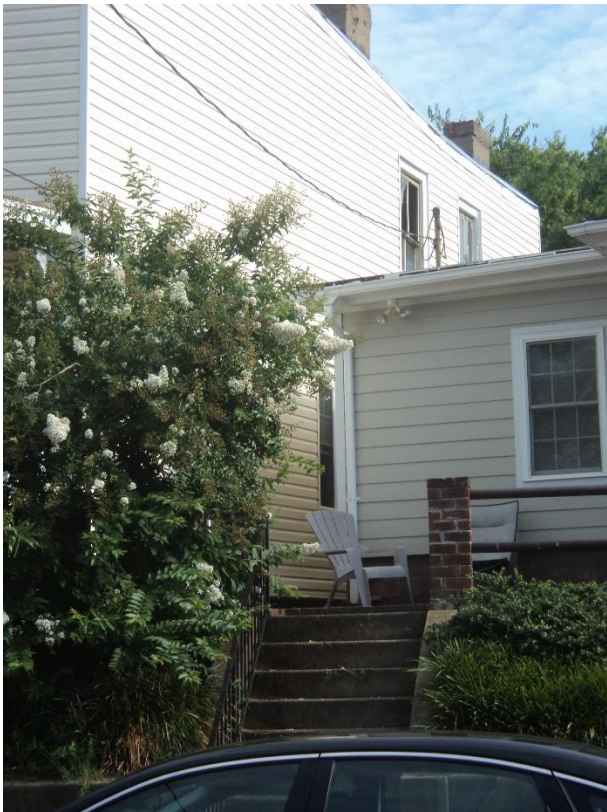
Figure 3. Window detail, east elevation

Standards for Rehabilitation, pg. 59 #5	<i>Retain original windows including both functional and decorative elements such as frames, sash, muntins, glazing, sills, hood</i>	The application indicates that the windows on the façade will be retained and restored, which is consistent with the Guidelines which

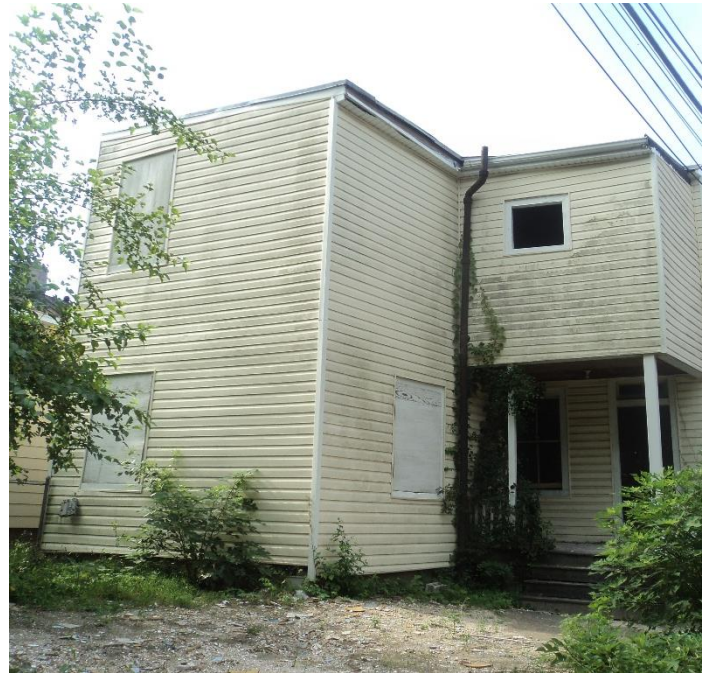
Figure 4. Rear elevation
