Staff Report
City of Richmond, Virginia

Commission of Architectural Review

6. COA-119139-2022	Final Review	Meeting Date: 10/25/2022
Applicant/Petitioner	Sydney Jordan-Cooley	
Project Description	Various exterior alterations to an existing single-family, detached dwelling.	
Project Location		
Address: 9 N. 30th St.		
Historic District: St. John's Church		
High-Level Details: <ul style="list-style-type: none"> • Install a helical pile to support the cantilevered bay • Remove brick and stucco cladding to perform repairs to the wood frame underneath • Install Hardiplank siding • Repair soffit, cornice, and fascia with Boral • Replace trim around window; replace with Boral. 		
Staff Recommendation		
Staff Contact	Samantha Lewis, 804-646-5207, Samantha.lewis@rva.gov	
Previous Reviews	None.	
Conditions for Approval	<ul style="list-style-type: none"> • A rendering or drawing of final helical pile and support rod design be submitted for administrative approval. • Final exterior colors submitted for administrative approval.

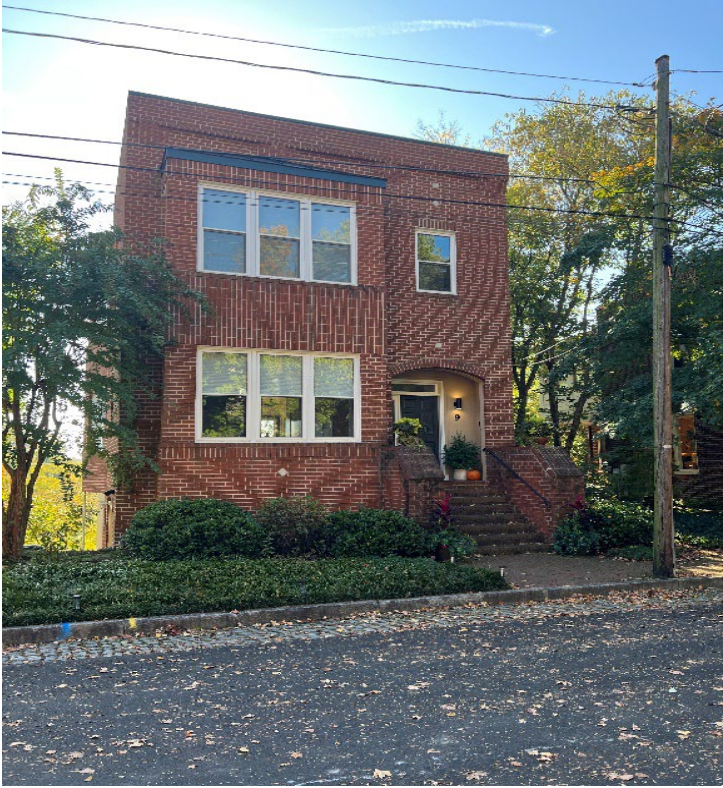
Figure 1. Façade photo

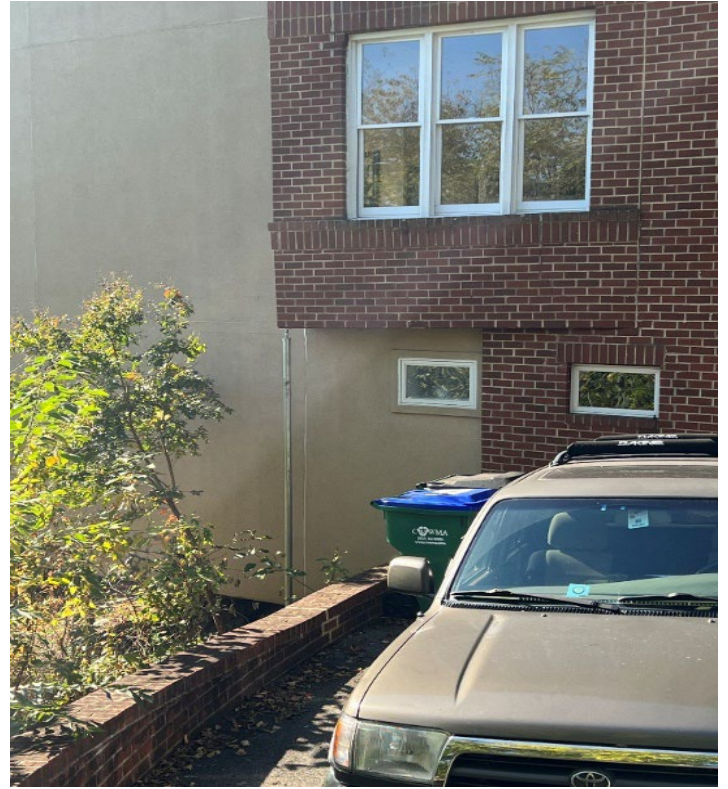
Figure 2. areas in need of repair

Building Elements, p. 67, #7 and 8	<p><i>Cornice repair should be accomplished using materials that match or are compatible with the existing cornice materials.</i></p> <p><i>Decorative details and profiles of original cornice design should dictate repair details.</i></p>	<p>Applicant has specified that the main cornice, soffit, and fascia will be repaired using Boral and match the style, shape, and color of the existing elements.</p> <p>A helical piling and support rod will be placed underneath of the bay window, as the original design of the frame and brick veneer cantilevered bay is sagging and requiring additional support. <u>Staff recommends that a rendering or drawing of final helical pile and support rod design be submitted for administrative approval.</u></p>
