10. COA-055493-2019

2011 Venable Street

Commission of Architectural Review

Construct a new, covered front porch and a rear deck and stairs.

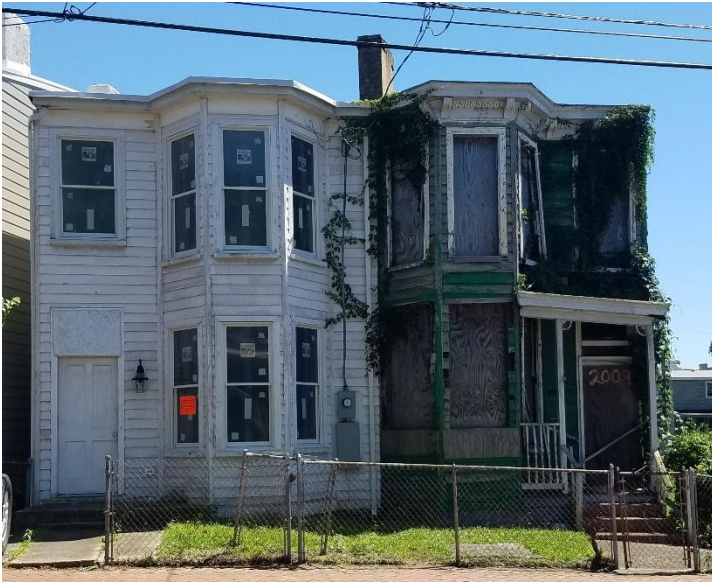
Figure 1. 2009-2011 Venable Street

The applicant has designed a replacement porch that uses elements of the historic porch. The proposed porch matches the original in size and decorative detailing. Based on the historic photographs, and comparison to other porches on the adjacent matching homes, staff finds the design generally is an accurate replication of the historic porch. Staff recommends the center column be removed from the design, as photographs indicate there was not a column in this location.

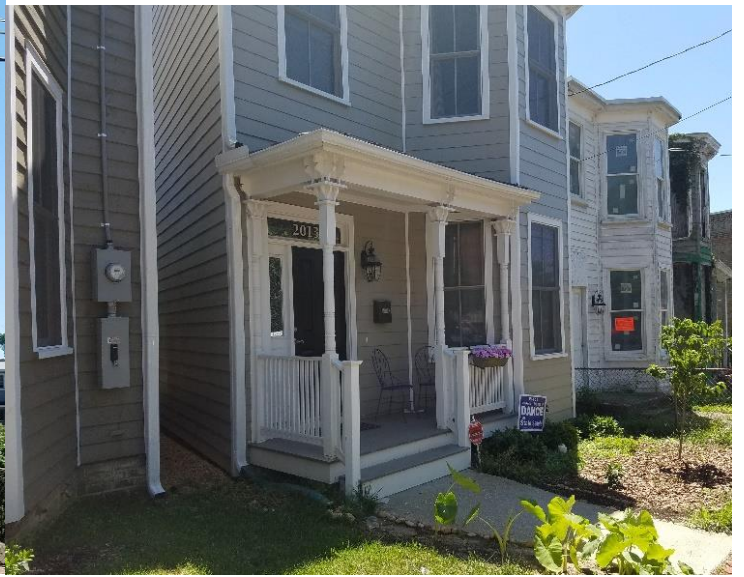
Figure 2. Restored front porch, 2013 Venable Street

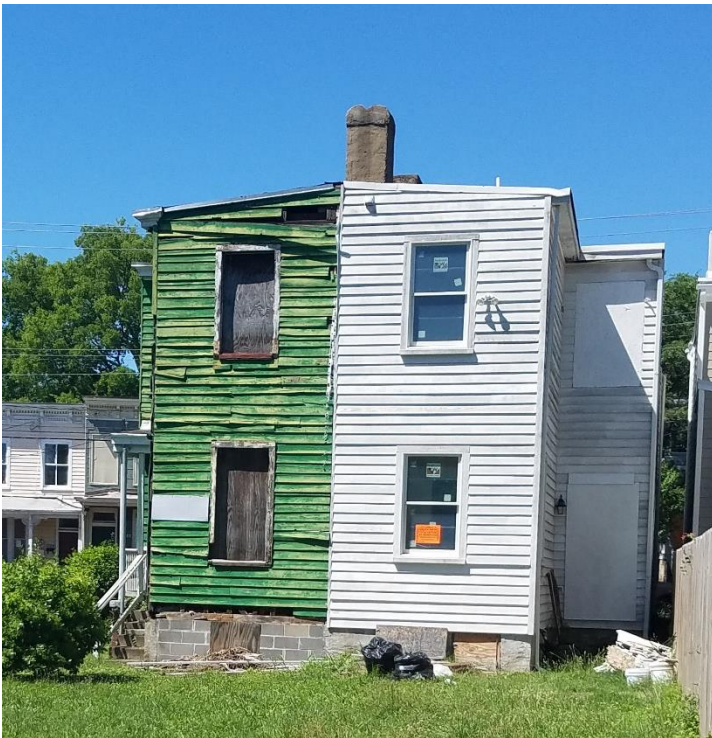
Figure 3. Rear elevation

The proposed two-story deck will not alter or damage significant elements of the home and will not create a false historical appearance. Sanborn maps indicate that there was a small square open landing at the rear of the property in this location. The proposed deck is of a contemporary design placed in a traditional location. Stairs to the upper level are not common on historic rear porches, however Sanborn maps indicate that several homes in the surrounding area did have exterior stairways.

The applicant proposes to convert an existing window on the rear wall of the home into a door. The window is visible from the rear alley as it is on the second story. Changes to openings in frame construction are reversible and do not significantly damage historic material.
