Staff Report City of Richmond, Virginia

Commission of Architectural Review

2. COA-142639-2024	Final Review Meeting Date: 2/27/2024	
Applicant/Petitioner	Stanislav Lobkov	
Project Description	Construct two single family attached dwellings.	
Project Location	916 917 15 2209 964 965 961 961 961 961	
Address: 2316-2318 Burton Street	2200 230 230 230 2318 2402 2408 2408 2408 2408 2408 2408 240	
Historic District: Union Hill		
High-Level Details: The applicant proposes to construct two attached dwellings on two vacant lots. The dwellings will be attached to the west elevation of an existing two-story frame Italianate dwelling. Historically, 2316-2318 Burton Street were the two end units of 2320-2326 Burton Street. These units were demolished sometime in the late 1970s or early 1980s. The proposed new construction will be identical in design to the existing 2320-2326 Burton Street.	2223 2225 2227 2224 2241 2324 2241 2325 2225 2227 2227 2224 2324 2325 2325 2325 2325 2325 2325

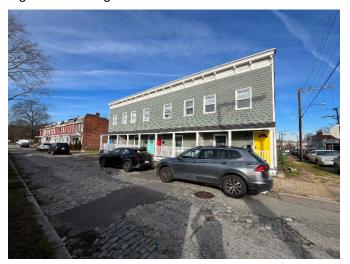
Figure 4. Subject lot at 2316-2318 Burton Street.

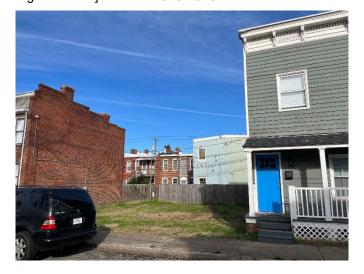
Figure 5. Block context. Looking west down Burton Street. Existing buildings have a shallow setback and do not have front yards.
