**COMMISSION OF ARCHITECTURAL REVIEW
STAFF REPORT
April 25, 2017, Meeting**

4. **COA-015011-2017** (T. Sullivan)

**815 North 22nd Street
Union Hill Old and Historic District**

**Rehabilitate the existing structure
and construct a 2 story rear addition.**

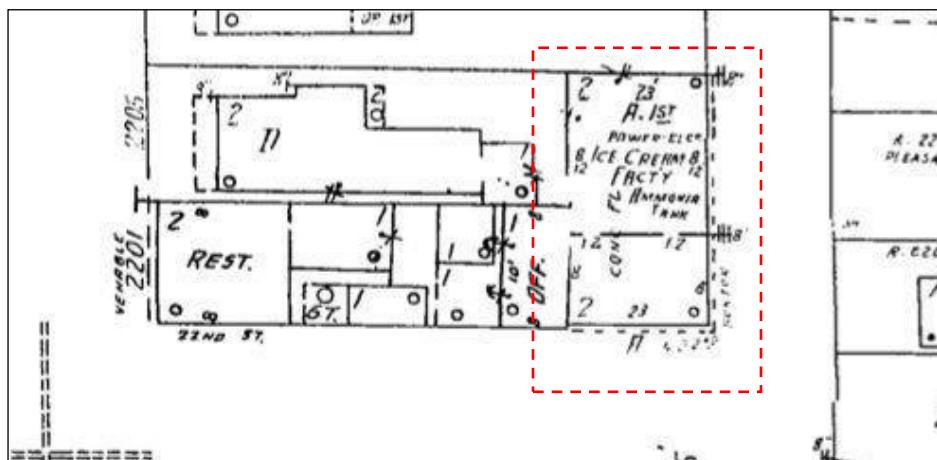
1950 Sanborn Map

The applicant requests approval to rehabilitate a structure at the corner of North 22nd Street and Burton Street in the Union Hill Old and Historic District. The existing structure is composed of a 1932 masonry building with a stucco finish and a modern frame addition at the rear which was constructed prior to the establishment of the City Old and Historic District. The historic structure was built as an ice cream factory which was part of a complex of buildings that included office space and a retail establishment that addressed Venable Street. In addition to the existing portion of the structure, the ice cream factory included another two story element which completely covered the lot as seen in the Sanborn maps and also as evident in the remnants of the concrete foundation on the site.

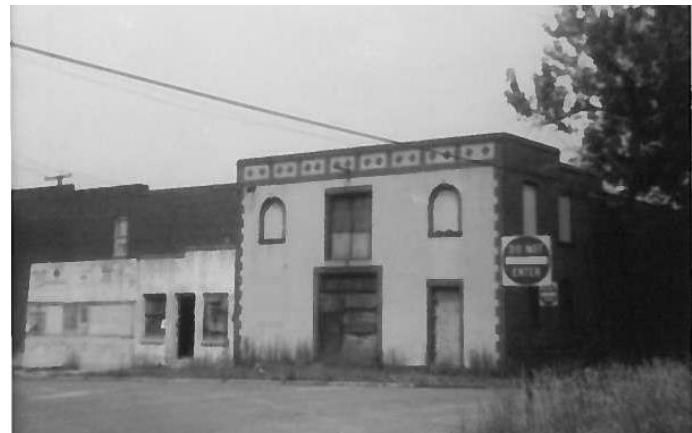
1977 Historic Richmond Foundation Survey

In addition to the rear modern rear addition, the historic structure has been altered over time to include the stucco cladding which has obscured many original details. The applicant has stated that all window openings in the original section have been rebuilt and there is no evidence on the interior of the historic masonry openings. The historic asymmetrical three bay façade included brick quoins, arched window heads and double doors on the second story, brick window and door surrounds, and a decorative frieze.

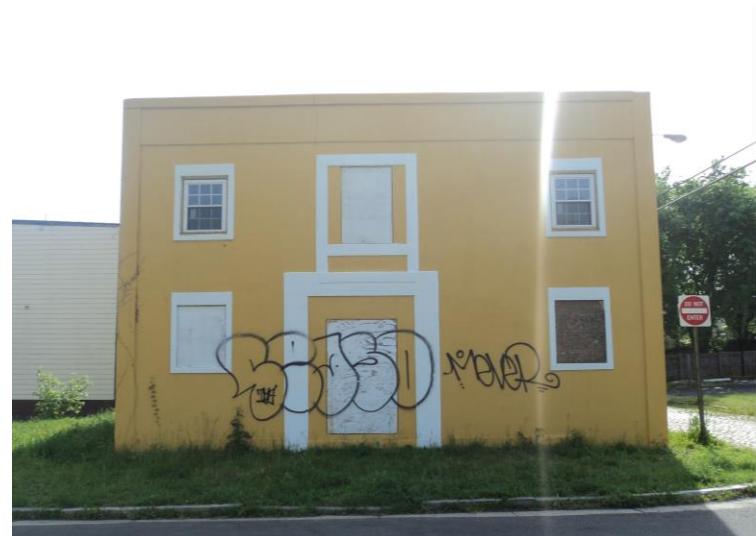
Existing Condition of the Façade of 815 North 22nd Street

The applicant is proposing to rehabilitate the existing historic structure by installing 2/2 aluminum clad wood windows with simulated divided lites in the existing openings. The applicant is proposing to include segmental arches in the window openings. On the façade, the applicant is proposing to install double doors in both the existing first and second story openings.
