Staff Report City of Richmond, Virginia

| 7. COA-112855-2022 | Final Review Meeting Date: 6/28/2022 |
| Project Description | Construct a rear addition onto 3 attached dwellings. |
| Address: 2511-2515 E. Franklin St. | 2504 2506 2508 2510 2512 2514 |

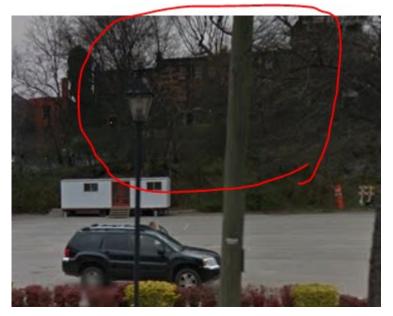
Figure 4. Original rear porch design at attached 2509 E. Franklin Street. Simple design with slim square posts and Richmond Rail.
