Staff Report
City of Richmond, Virginia

Commission of Architectural Review

6. COA-115904-2022	Final Review Meeting Date: 10/25/2022
Applicant/Petitioner	Katie Harrigan, 3North
Project Description	Rehabilitate an existing one-story commercial building, and construct a new four story, mixed-use building.
Project Location

Address: 912 Tulip Street	
Historic District: Union Hill	
<p>High-Level Details:</p> <p>The applicant requests conceptual review of a proposal to construct a new, 3-story, multi-family building and to rehabilitate a one-story masonry commercial building circa 1940's.</p> <p>The new multi-family building will be "L" shaped, and will wrap the north side and rear of the commercial building.</p> <p>The primary façade of the multifamily building will be clad in brick and feature front balconies.</p> <p>The existing commercial buildings will be rehabilitated including the repair of the existing slate mansard roof, parapet walls, and windows. The non-original, frame gable roof will be removed. A set-back rooftop patio and pergola will be added to the top of the existing buildings.</p>

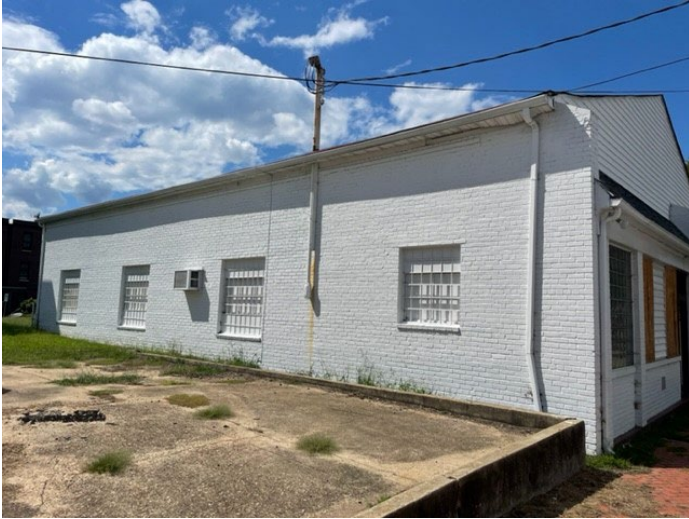
Figure 1. Existing Steel windows on commercial building

pergola and the use of vertical cladding on the upper floors of the building.
Staff Recommendations	<p>Multi-Family Building:</p> <ul style="list-style-type: none"> • Final materials including railings and screening be submitted for administrative approval. • The location of all exterior mechanical equipment be submitted for administrative approval. • Staff recommends that new sidewalks on the site be a material that is compatible with the district. <p>Commercial Building:</p> <ul style="list-style-type: none"> • The new store front windows on the existing commercial buildings match the configuration seen in the historic photograph as closely as possible. • The gable roof be removed in a way that doesn't cause any damage to any existing historic material, the new storefront windows and brick pilasters diving them match the historic photo provided by staff as closely as possible, and that the four southern facade steel windows be restored and retained.

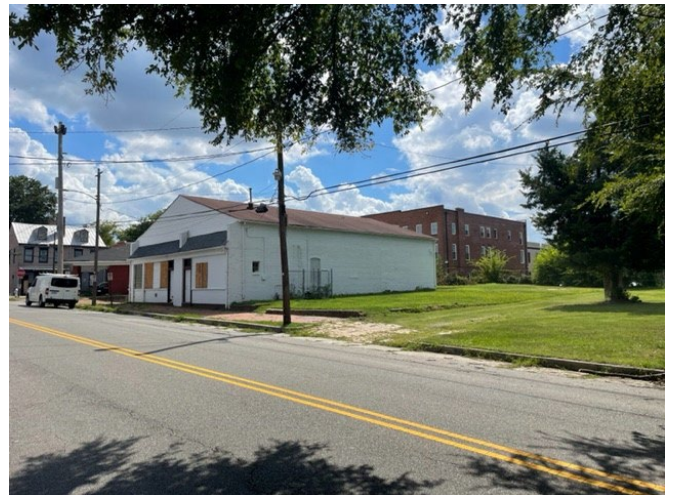
Figure 4. Existing commercial building looking southwest from Tulip Street.

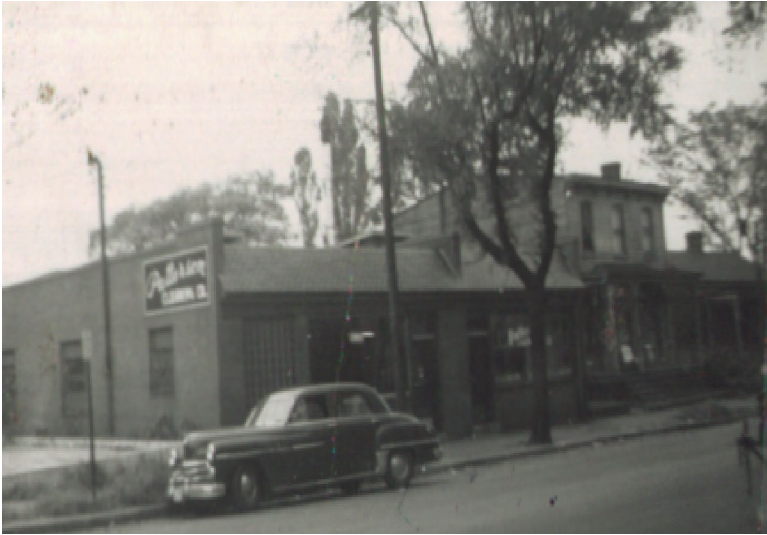
Figure 5. Historic Image, approx. 1956

<p>Form, pg. 46, #1-3</p>	<ol style="list-style-type: none"> <i>1. New construction should use a building form compatible with that found elsewhere in the historic district.</i> <i>2. New residential construction should maintain the existing human scale of nearby historic residential construction in the district</i> <i>3. New residential construction and additions should incorporate human-scale elements such as cornices, porches and front steps into their design.</i> 	<p>In the immediate area, there are 2 larger historic buildings, a 3-story masonry colonial revival building built in 1923 located at 2230 Venable street, and a 4-5 story masonry, industrial building built between 1890-1915 located at 2401-2413 Venable Street.</p> <p>More recently, new 3&4 story multi-family housing was reviewed and approved by the CAR in 2017 along Jessamine Street, which is located at the rear of the subject property.</p> <p>The proposed new construction will be a maximum of 3 stories, which is taller than most residential and commercial buildings in the district.</p> <p>During the conceptual review, it was asked that the front porch include a sidewalk level stair and entrance. The applicant has revised the plans to include this request.</p> <p>The applicant proposes to rehabilitate the existing commercial building.</p> <p>Currently, the commercial building features windows that are smaller than the original storefront windows. Photographic documentation demonstrates that the building historically featured large store front windows. Staff notes that the configuration did include the glass block window located on the south bay of the front façade. The applicant proposes to remove this window.</p> <p>Staff does not find the glass block window to be a character defining feature and feels that increasing the amount of transparency between the store and street creates a more successful pedestrian realm. <u>Staff recommends that the new store front windows on the existing commercial buildings match the configuration seen in the historic photograph as closely as possible.</u></p>

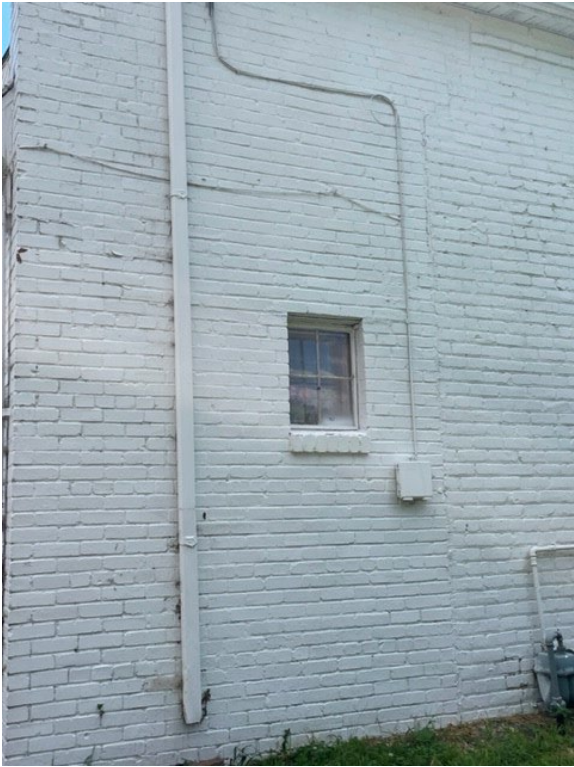
Figure 7. 4-pane window on north elevation of commercial building.

Site Improvements, Parking Lots, #1, pg. 77	<i>Parking lots should be broken up as much as possible with interior landscaped islands and should be well screened from the public right-of-way and adjacent properties.</i>	<p>A rear parking lot will be provided underneath the second story. The parking lot will be screened from view, and will be minimally visible from Tulip Street due to the absence of a rear alley.</p>
Standards for Rehabilitation, #9, pg. 5	<p><i>New additions, exterior alterations or related new construction shall not destroy historic materials that characterize the property. The new work shall be differentiated from the old and shall be compatible with the massing, size, scale and architectural features to protect the historic integrity of the property and its environment.</i></p>	<p>The applicant proposes to rehabilitate an existing commercial building located on the subject property which was built in two sections, the first being in 1941, and the second being in 1946.</p> <p>The commercial building currently features a non-original frame gable roof which may have been added sometime in the 1980's. The building is painted white and features non-original windows on the front facade, and original steel windows on the southern façade.</p> <p>The applicant proposes to remove the non-original gable roof form, to repaint the building white, remove the non-original front façade windows and install storefront windows to match the historic configuration, and to repot and repair brick as needed. No information was given on the four southern façade original windows.</p> <p><u>Staff recommends that the gable roof be removed in a way that doesn't cause any damage to any existing historic material, that the new storefront windows and brick pilasters diving them match the historic photo provided by staff as closely as possible, and that the four southern facade steel windows be restored and retained.</u></p> <p>The plans have been revised to include the small four-pane window on the north façade of the commercial building.</p>
