Commission of Architectural Review Submission Application

HISTORIC PRESERVATION CERTIFICATION APPLICATION PART 2 – DESCRIPTION OF REHABILITATION

5 & 7 EAST BROAD STREET
RICHMOND, VA 23219
REVISED 12-6-2013 JANUARY 9, 2009

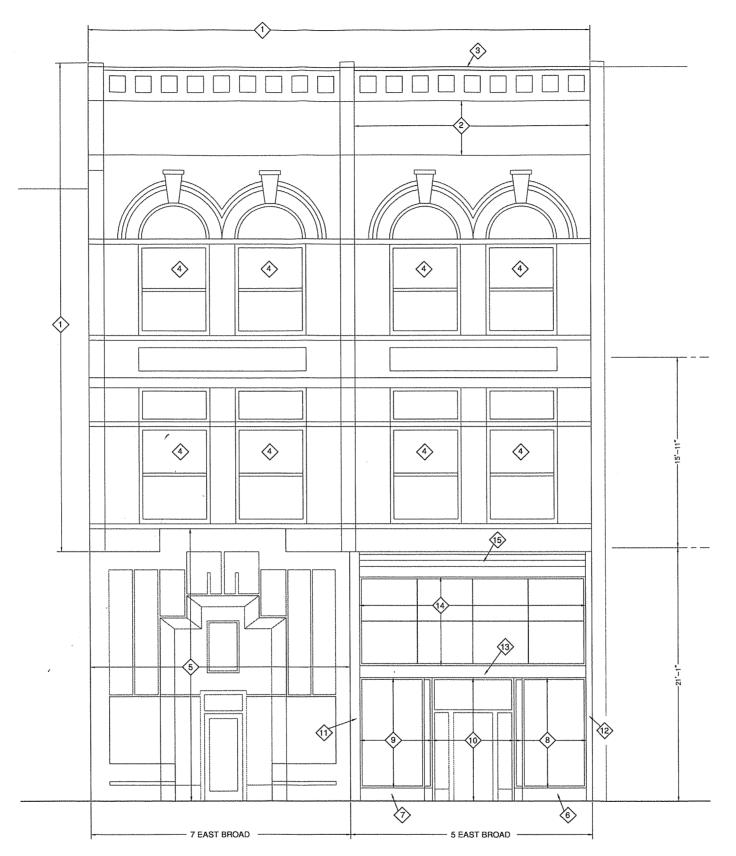
BROAD STREET NORTH ELEVATION

SCALE: 1/4" = 1'-0"

1. POINT UP DETERIORATED MASONRY JOINTS TO MATCH EXISTING. CLEAN MASONRY SURFACES.

2. REMOVE FAILED PARGING OVER MASONRY AND INSTALL NEW

4. PATCH, REPAIR AND PAINT EXISTING WOOD WINDOWS TO MATCH EXISTING, REPLACE MISSING, BROKEN AND DAMAGED WOOD PARTS TO MATCH EXISTING, REGLAZE WINDOWS AND REPLACE BROKEN, CRACKED AND MISSING GLASS.

5. REPLACE MISSING, BROKEN, DAMAGED PIGMENTED STRUCTURAL GLASS, METAL EDGING/TRIM AND JOINT CEMENT TO MATCH EXISTING. CLEAN ALL SURFACES, PB 12. REPLACE BROKEN, CRACKED GLASS IN DISPLAY WINDOWS, CLEAN TERRAZZO AT ENTRY, ABOVE THE DISPLAY WINDOWS IN THE ENTRY, PATCH AND REPAIR PLASTER TO MATCH THE EXISTING PLASTER AND PAINT. AT THE EXISTING WOOD FRAMED ENTRY, CLEAN, SCRAPE AND PAINT THE WOOD FRAME AND TRIM. PROVIDE NEW GLASS AT THE SIDELITES AND TRANSOM. REMOVE THE FLUSH METAL DOOR AND PROVIDE A NEW WOOD DOOR, FULL GLASS TO IT! THE OPENING. AT THE WOOD WINDOW ABOVE THE ENTRY DOOR, REMOVE THE WINDOW AC AND INSTALL NEW FIXED GLASS. CLEAN, SCRAPE AND PAINT THE WINDOW FRAME AND TRIM.

8. REMOVE ALUMINUM STOREFRONT FRAMING AND GLASS. PATCH AND REPAIR WOOD TRIM AT STOREFRONT PERIMETER. PROVIDE NEW WOOD MULLION AT THE OUTSIDE CORNER AND NEW GLASS. CLEAN, SCRAPE AND PAINT THE WOOD.

9. REMOVE ALUMINUM STOREFRONT FRAMING PLYWOOD AND GLASS. PATCH AND REPAIR WOOD TRIM AT STOREFRONT PERIMETER. PROVIDE NEW WOOD MULLION AT THE OUTSIDE CORNER AND NEW GLASS. PROVIDE NEW WOOD TRIM (WHERE IT IS MISSING) AT THE STOREFRONT PERIMETER TO MATCH EXISTING WOOD TRIM. CLEAN, SCRAPE AND PAINT THE WOOD.

10. PATCH, REPAIR AND CLEAN CERAMIC TILE AT ENTRY, AT THE SOFFIT/CEILING OF THE ENTRY, PATCH, REPAIR, CLEAN, SCRAPE AND PAINT THE WOOD PANELING. AT THE EXISTING WOOD FRAMED ENTRY, CLEAN, SCRAPE AND PAINT THE WOOD FRAME AND TRIM. PROVIDE NEW GLASS AT THE SIDELITES AND TRANSOM. REMOVE THE ALUMINUM DOOR AND PROVIDE A NEW WOOD DOOR, FULL GLASS TO FIT THE OPENING.

13. PATCH, REPAIR, CLEAN, SCRAPE AND PAINT WOOD TRIM ALONG THE BOTTOM EDGE OF THE STOREFRONT TRANSOM.

15. PATCH, REPAIR, CLEAN, SCRAPE AND PAINT THE WOOD CORNICE AND METAL FLASHING ABOVE THE TOP EDGE OF THE STOREFRONT TRANSOM.

Replacement brick must be used on an as-needed basis only and match the color, size, texture, and general physical characteristics of the historic brick. Good quality overall and close-up color photographs of the brick before and after replacement must be submitted with the Certification of Completed Work (Part 3).

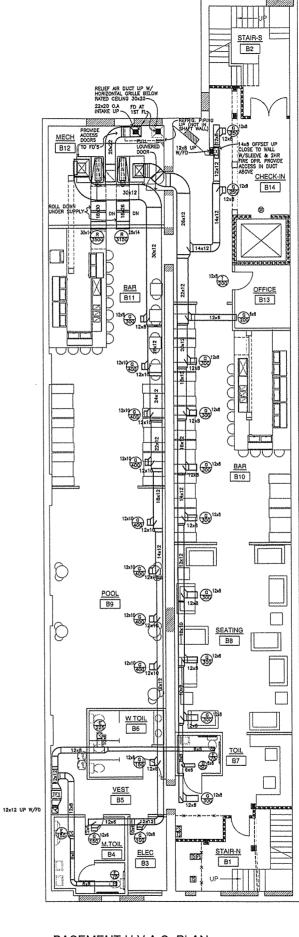
BASEMENT H.V.A.C. PLAN

Compilance Statement: The proposed mechanical design represented in this document is consistent with the building plans, specifications and other calculations submitted with this permit application. The proposed mechanical systems have been designed to meet the 90.1 (2007) Standard requirements in COMicheck Version 3.9.2 and to comply with the mandatory requirements in the Requirements Checklist.
