### COMMISSION OF ARCHITECTURAL REVIEW STAFF REPORT December 15, 2015 Meeting

4. CAR No. 15-144 (W. Hinden)

3305 – 3307 East Marshall Street Chimborazo Park Old and Historic District

# Replace existing front porch, construct new rear 2 story porches, and install new windows and doors.

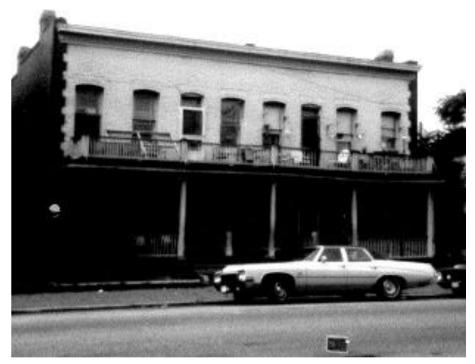
3305-3307 East Marshall Street Historic Richmond Foundation Church Hill Survey (1977)

The above photograph is pictorial documentation of the front porch prior to the 1990s alterations. The first floor porch appears to match the first floor porch of the identical, adjacent house at 3309-3311 East Marshall. As documented in this photograph, the historic porch spanned the entire façade and had five round columns rather than the proposed square posts which were located every two bays. Additionally, the second floor balcony appeared to have substantial square piers vertically aligned with the porch columns. <u>Staff recommends that the applicant should base the reconstruction of the front porch on this photographic evidence rather than modifying the existing altered porch.</u>

The Guidelines further state that the replacement of missing features shall be substantiated by documentary, physical, or pictorial evidence. Below is a photograph of the property from the 1977 Historic Richmond Foundation Church Hill Survey.
