# Commission of Architectural Review SUBMISSION APPLICATION

DESCRIPTION OF PROPOSED WORK for the Commission of Architectural Review

Strei Residence 2515 East Clay Street Richmond, Virginia 23223

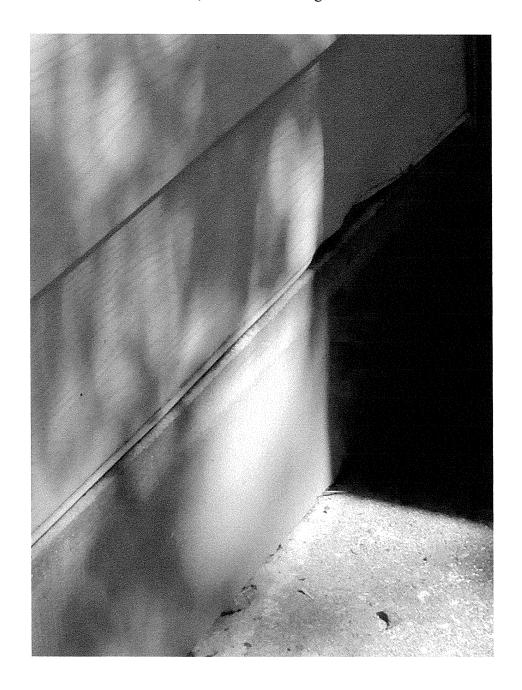
From the exterior, the foundation wall of the existing addition/enclosure has been covered in Cementitious Backer Board, so the exact condition of the foundation is not visible. The photograph shows that the edge of the board is in *front* of the edge of the siding, a condition which would allow rain into the wall, further weakening its current state.

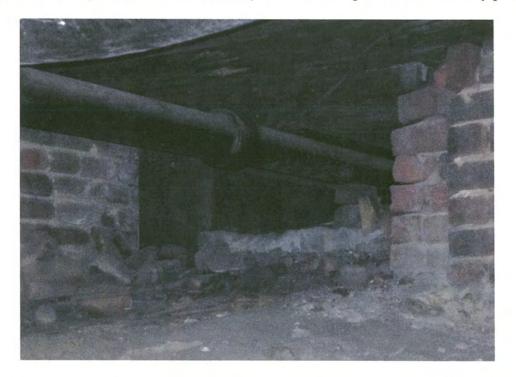
From the Basement/Crawl Space, crumbled bricks are visible on the ground in the area near the existing addition/enclosure. Also evident on the right side of the sewer line are bricks that have little to no mortar remaining between them. This may be contributing to the floor stability problem.

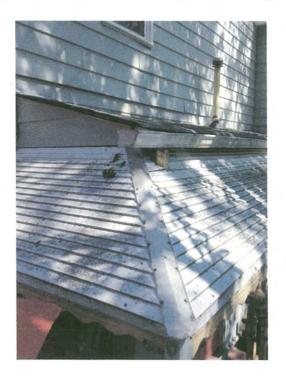
The Roof of the existing addition/enclosure is Asphalt Shingles at a slope of less that 2:12. This slope is less than the minimum slope required for this type of roof to properly shed water.

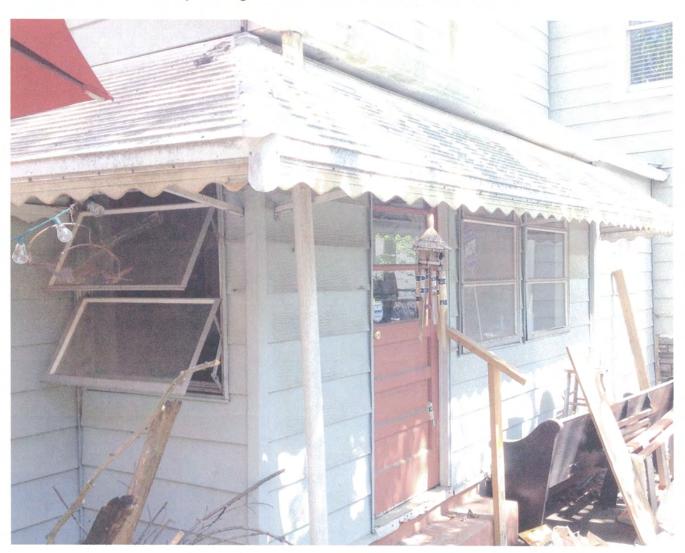
The majority of the windows on the existing construction at this area are a jalousy-type window which sometimes have issues keeping out water. The addition of the metal awning at this area may have been to try to mitigate the intrusion of water at these windows.
