Adaptive Reuse City of Richmond, VA

511 West Marshall Street

SCOPE OF PROJECT: HISTORICALLY PRESERVE EXISTING 3 STORY DWELLING.

CONVERT TO 3 APARTMENTS. ADD NEW THREE STORY ADDITION IN REAR.

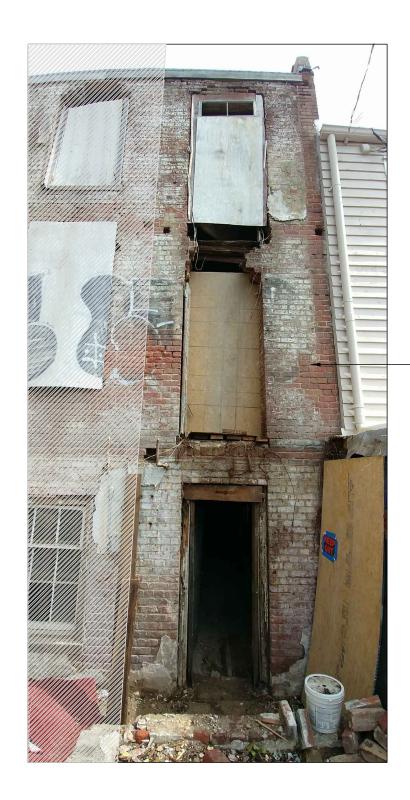
EXISTING BRICK TO BE RE-POINTED.
 EXISTING BRICK LOOSE FROM FIRE

DAMAGE TO BE USED TO INFILL

AREAS WHERE BRICK IS MISSING.

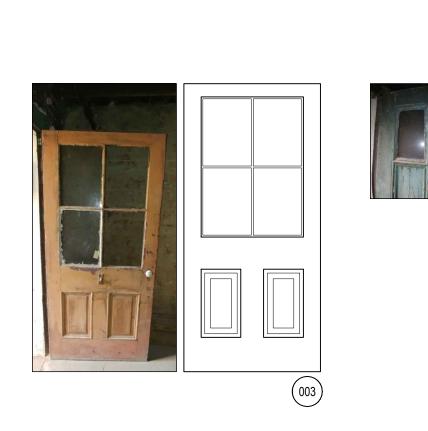
EXISTING DOOR DIAGRAMS 1/4" = 1'-0"

--- ORIGINAL DOOR MODIFIED
