## 12. COA-055419-2019

# Commission of Architectural Review

## STAFF REPORT

**Widen an existing window opening and change the window configuration from one to two double-hung wooden windows.**

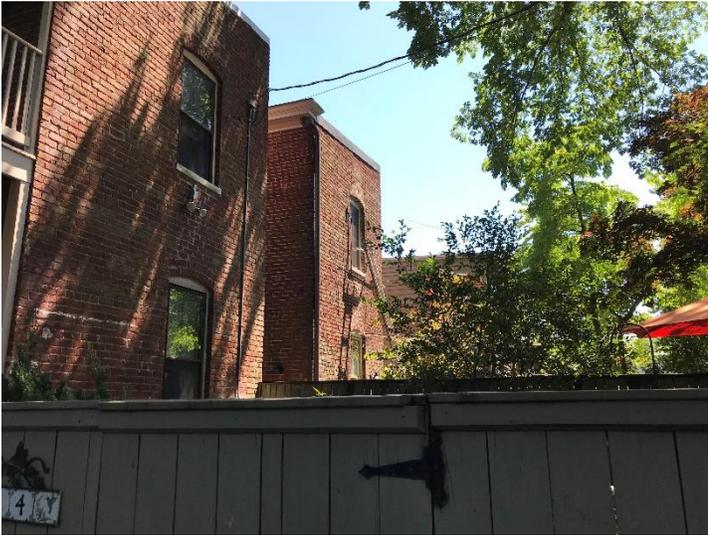
*Figure 1. Rear elevation, view from alley.*

- The existing home is a two-story brick Queen Anne double house built ca. 1905.
- The applicant proposes to enlarge a single window opening on the first story at the rear of the home. The existing window will be removed and replaced with two, two-over-two, double-hung wood windows with simulated divided lites. The new window openings will be 6'4" by 7' 4 3/4". The existing window is 6'3" by 3'2".
