6. COA-072960-2020

2520 E. Broad Street

Replace eight combination fixed and awning metal windows with eight double-hung composite windows.

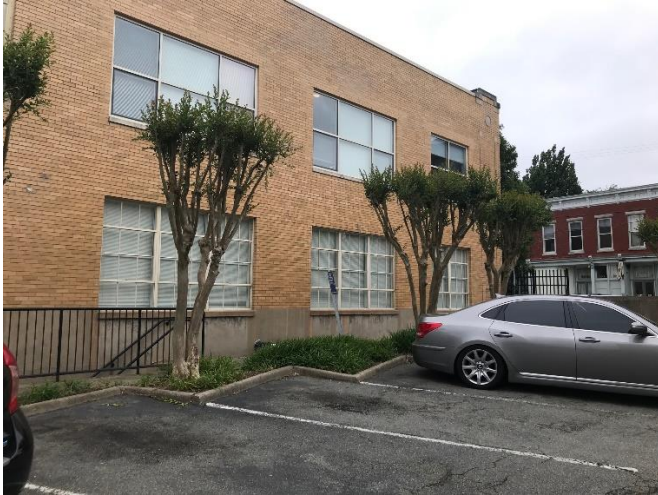
Figure 1. North 25th Street elevation.

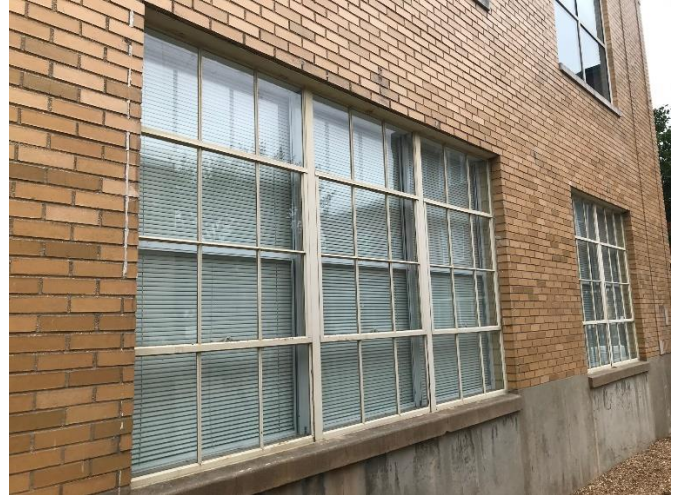
Figure 2. North 25th Street windows, detail.

The applicant has provided photographs to indicate that the current windows start at approximately 51" from the floor inside the unit and the operable portion of the window, which swings out, is approximately 70" from the floor to the bottom of the panes. The applicant has expressed concerns about being able to exit through these windows due to this configuration. To address concerns about egress the applicant proposes to change the existing sash and muntin configuration from a combination fixed and awning window to a double-hung window. Staff finds this is not in keeping with the Guidelines which recommend against changing the number, sash, depth of reveal, size, and glazing patterns of historic windows.
