# Commission of Architectural Review

STAFF REPORT

2006-2008 Venable Street

Rehabilitate two, two-story attached residences, and construct a rear deck.

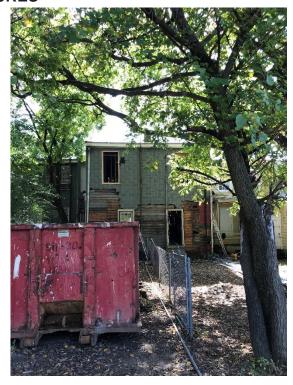
Figure 2. Rear elevation, view from alley

- The windows replacing the door openings on the rear elevation be of a contemporary design, rather than the 4/4 proposed.
- The new kitchen windows on the rear elevation fit between the existing door jambs.
