City of Richmond Interim After-Action Assessment Report

March 3, 2025

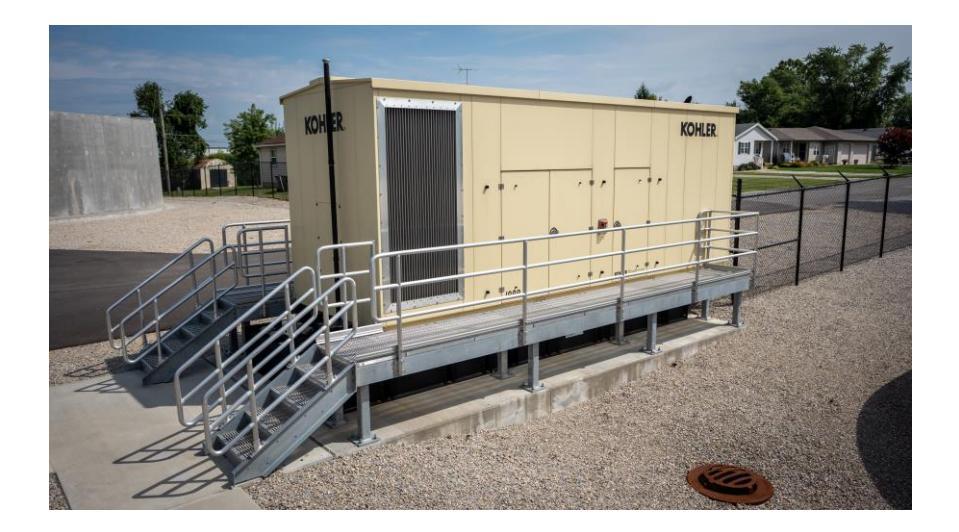
- Virginia Electrical Code requires WTP facilities have two (2) power sources, a primary and a backup.
- Richmond WTP has two (2) feeds from Dominion Energy that serve as primary and backup.
- Backup generators are a tertiary power supply source.
