**COMMISSION OF ARCHITECTURAL REVIEW
STAFF REPORT
March 24, 2015 Meeting**

10. **CAR No. 15-029** (A. Fountain)

**635 N. 27th Street
Church Hill North Old & Historic District**

Project Description: **Replace historic posts; paint**

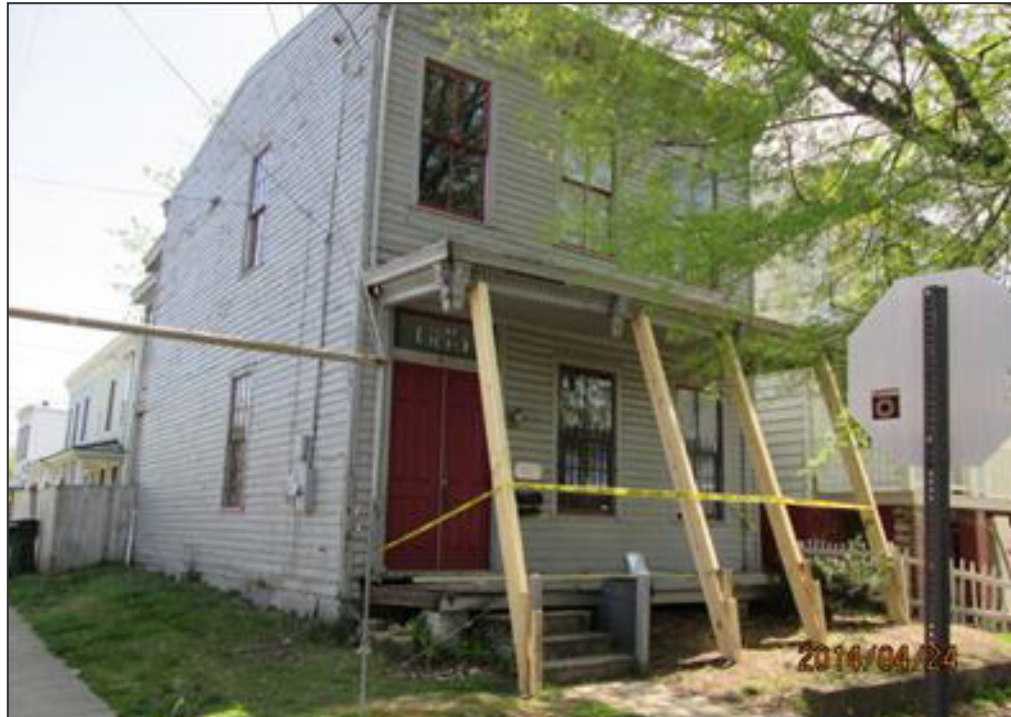
April 24, 2014

In early 2014, the property owner received a notice from the Code Enforcement & Property Maintenance division of the Department of Planning and Development Review informing them that their property was under violation due to their deteriorating front porch. According to the division, the front porch posts and railings were significantly rotted, and some columns had fallen off the porch. The property owner installed new columns and railings on the front porch. The Code Enforcement & Property Maintenance division confirmed that the work had successfully abated the violation. However, the property owner failed to apply for a building permit, and as a result the project was not reviewed by the Permits & Inspections or Planning & Preservation divisions. A Notice of Violation of the Old & Historic District requirements was issued to the property owner on January 16, 2015.

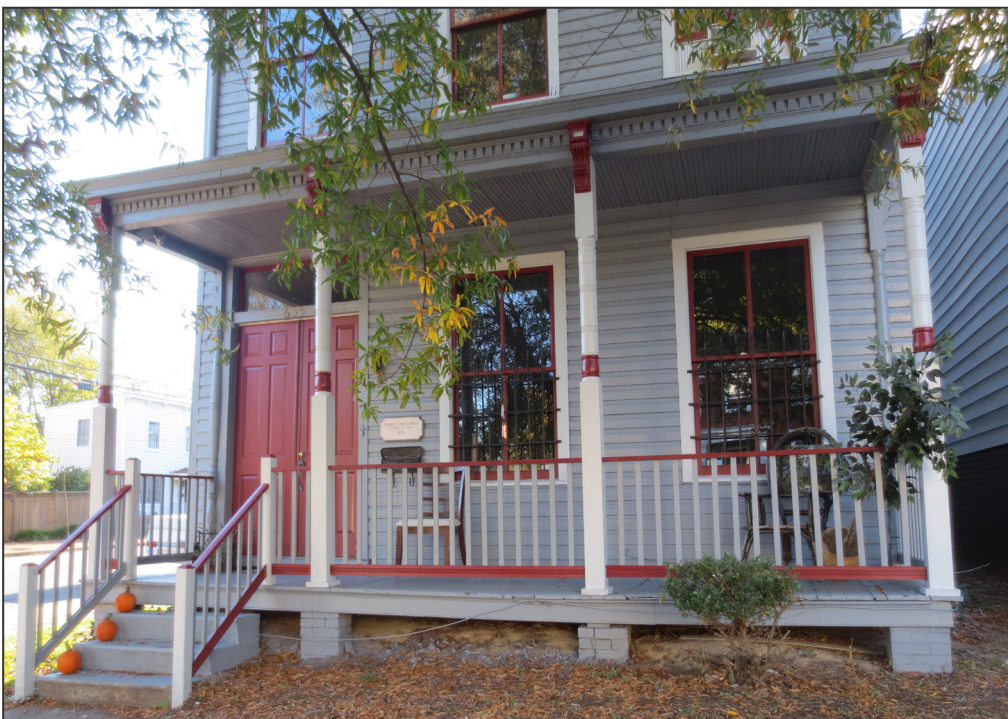
October 30, 2014

The work completed consists of the removal of the historic porch columns, and the installation of stock, turned columns. The historic capitals were preserved and reused. The historic half columns still exist against the body of the house. New posts for the handrails were also installed. The porch railings were replaced with Richmond rail that is very similar to what existed previously on the porch. The porch decking was replaced in-kind with tongue and groove wood.

Painting was also performed to the structure. This included painting the window trim white, painting the new porch columns white and red, painting the capitals red and gray, painting the bottom and lower handrails red, and painting the pickets of the handrails gray.

In regards to the painting work, elements of a column would not have historically been painted different, contrasting colors. The *Guidelines* state that, “Individual details in cornices and columns should not be emphasized with additional color” (p. 59 #5).

Staff recommends that the applicant submit a new application which proposes to replace the new, stock columns with turned columns whose design is replicated from the surviving half columns against the main structure. Staff also recommends that the applicant submit a painting plan where the columns are painted a uniform color as would have typically been found on an historic structure.
