**COMMISSION OF ARCHITECTURAL REVIEW
STAFF REPORT
July 22, 2014 Meeting**

3. **CAR No. 14-70** (A. Nasser)

**2434-2438 Venable Street
Union Hill Old & Historic District**

**Demolish retaining wall, grade lot,
construct block wall, and paint mural**

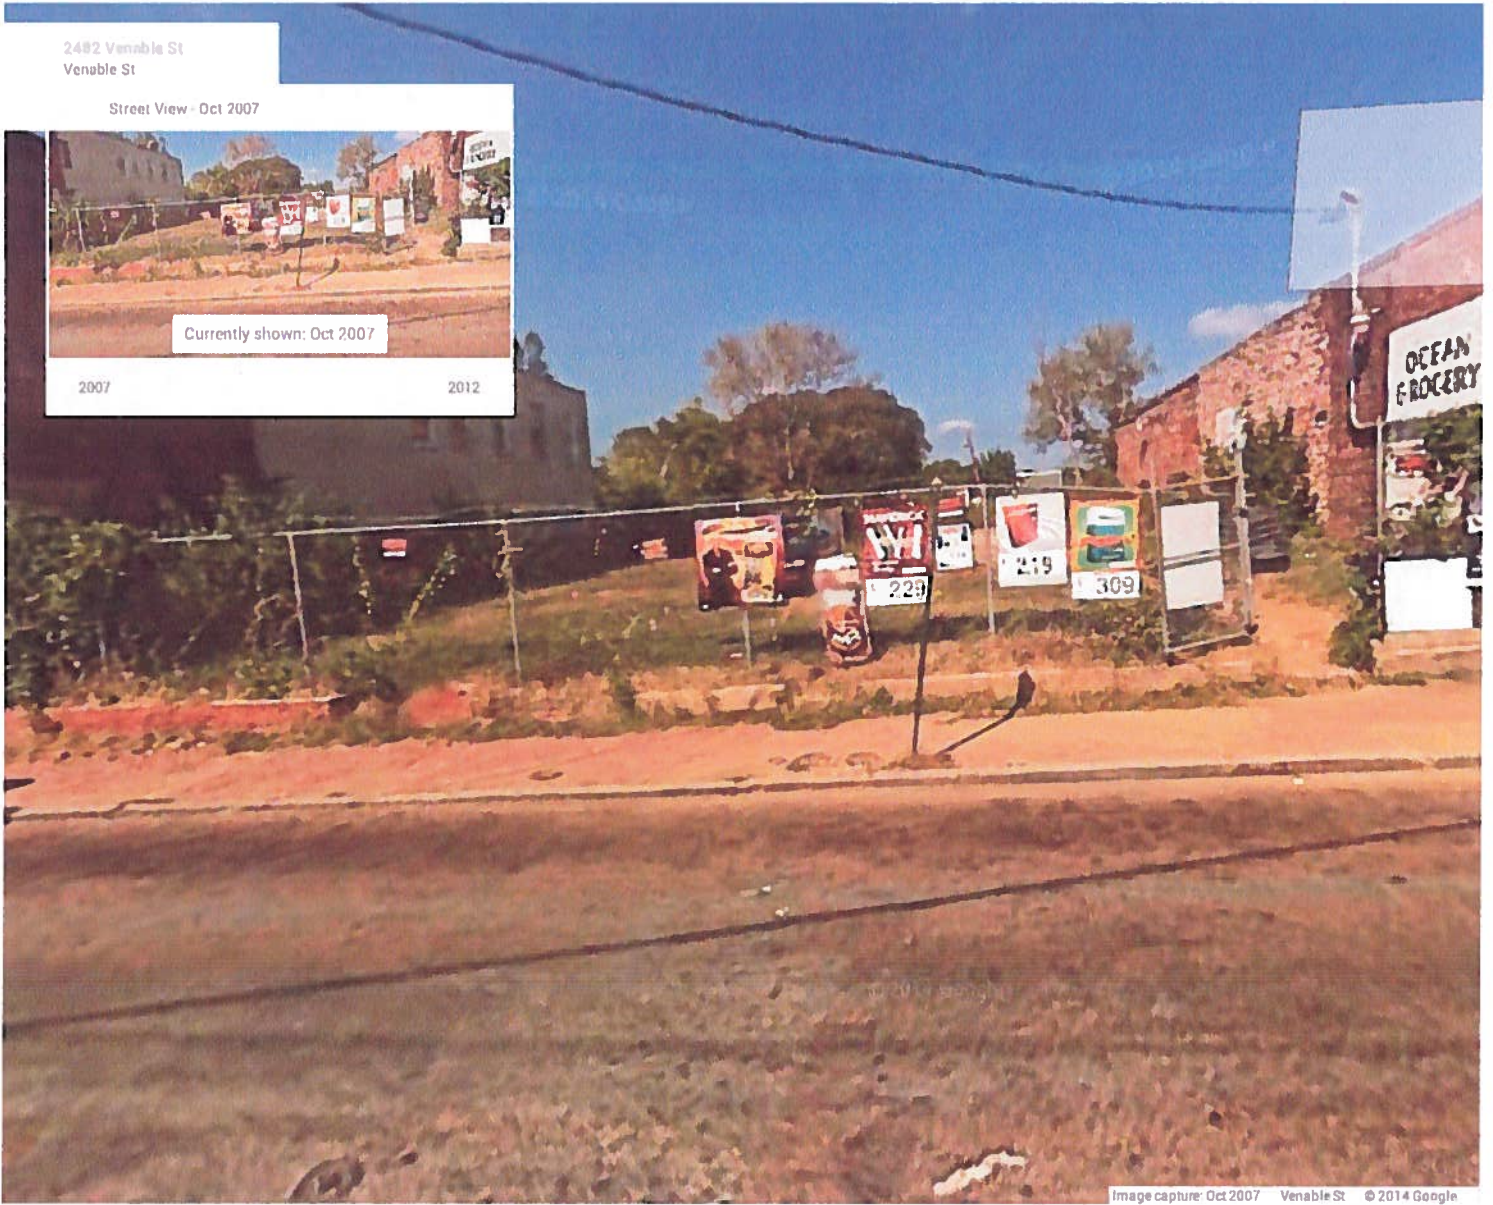
Pre-District
2007

The images attached to the staff report depict the previous conditions at the site. The applicant has expressed an interest in improving the two vacant lots for surface parking. The lots are currently covered by gravel. Commission staff advised the applicant that he would need to submit plans for improving the vacant lots to the Commission for review and approval.

Staff is more concerned with the elimination of the small retaining wall by the sidewalk and the construction of the new block wall near Ocean Grocery. Staff fully supports the removal of the non-historic chain-link fence, but the grading of the lot and the removal of the retaining wall (deteriorated as it was) encourages automobile drivers to access the gravel lot by driving over the low curb and sidewalk. There is no curb cut at this location. Since the applicant has expressed an interest in improving the gravel lots for parking, staff recommends that the applicant reconstruct the low wall as a part of a comprehensive landscaping plan

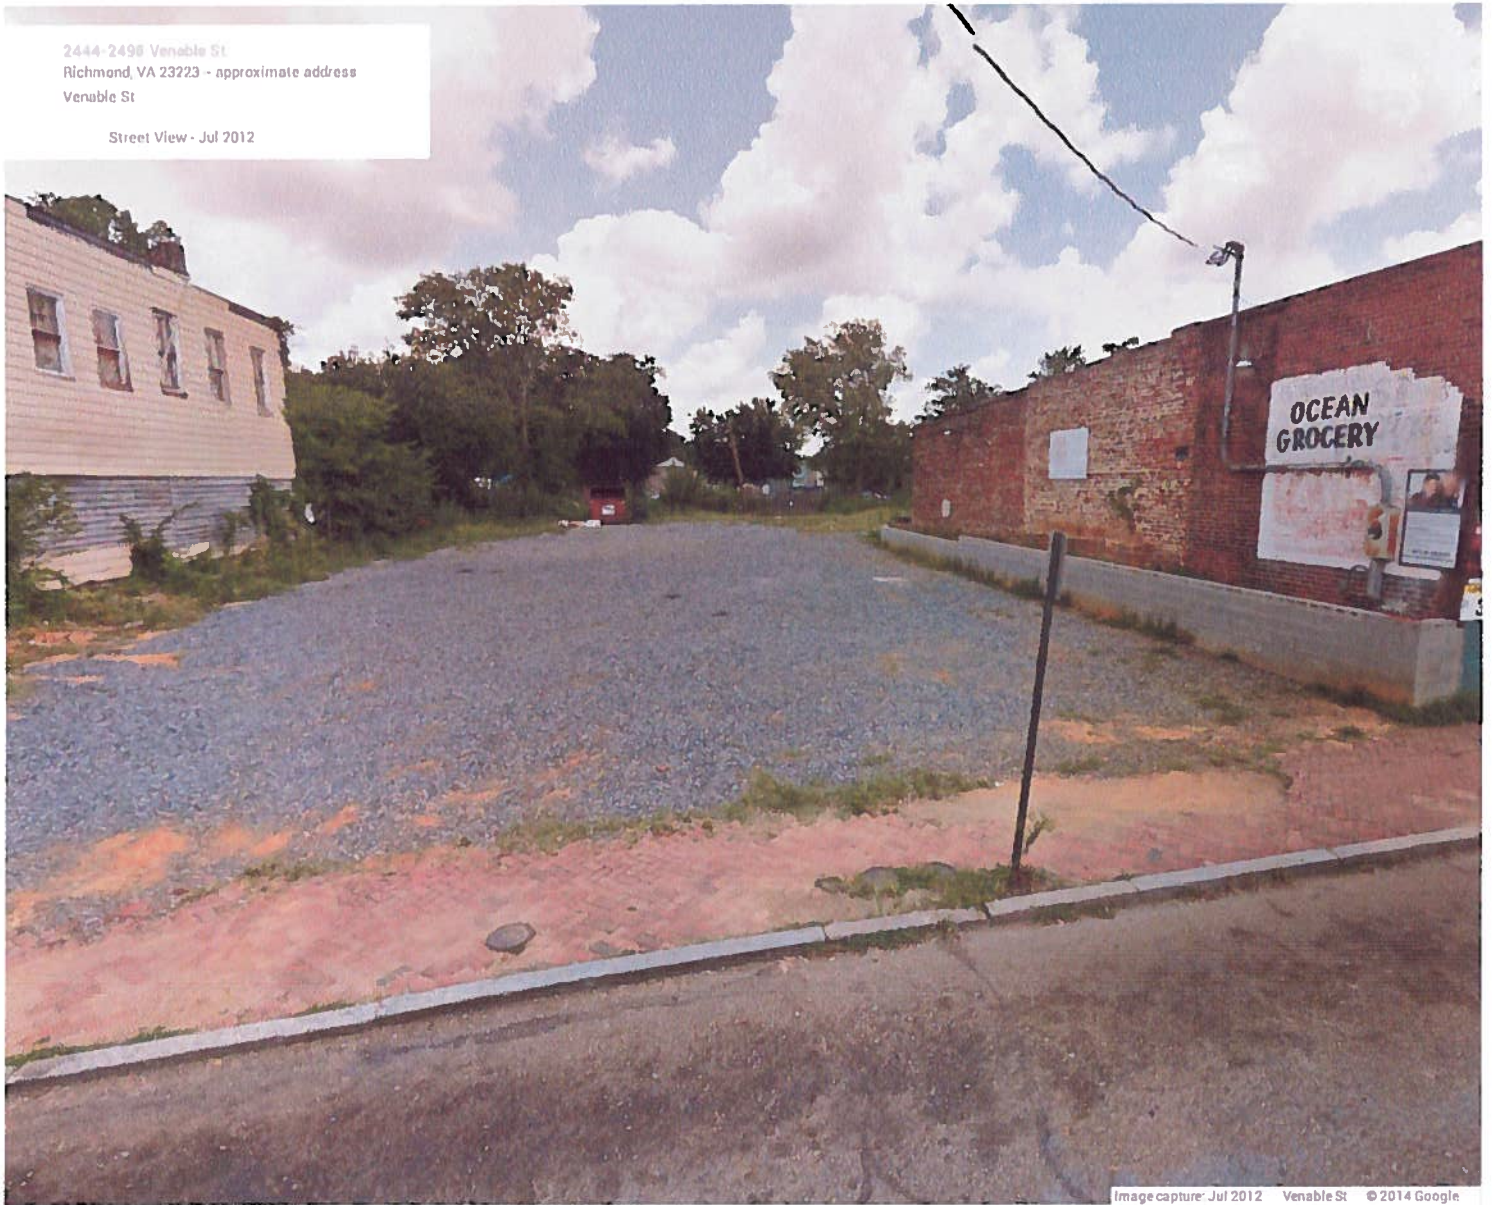
Street View - Jul 2012
