**COMMISSION OF ARCHITECTURAL REVIEW
STAFF REPORT
July 22, 2014 Meeting**

4. **CAR No. 14-72** (S. Hodges)

**2241 W. Grace Street
West Grace Street Old & Historic District**

Replace windows

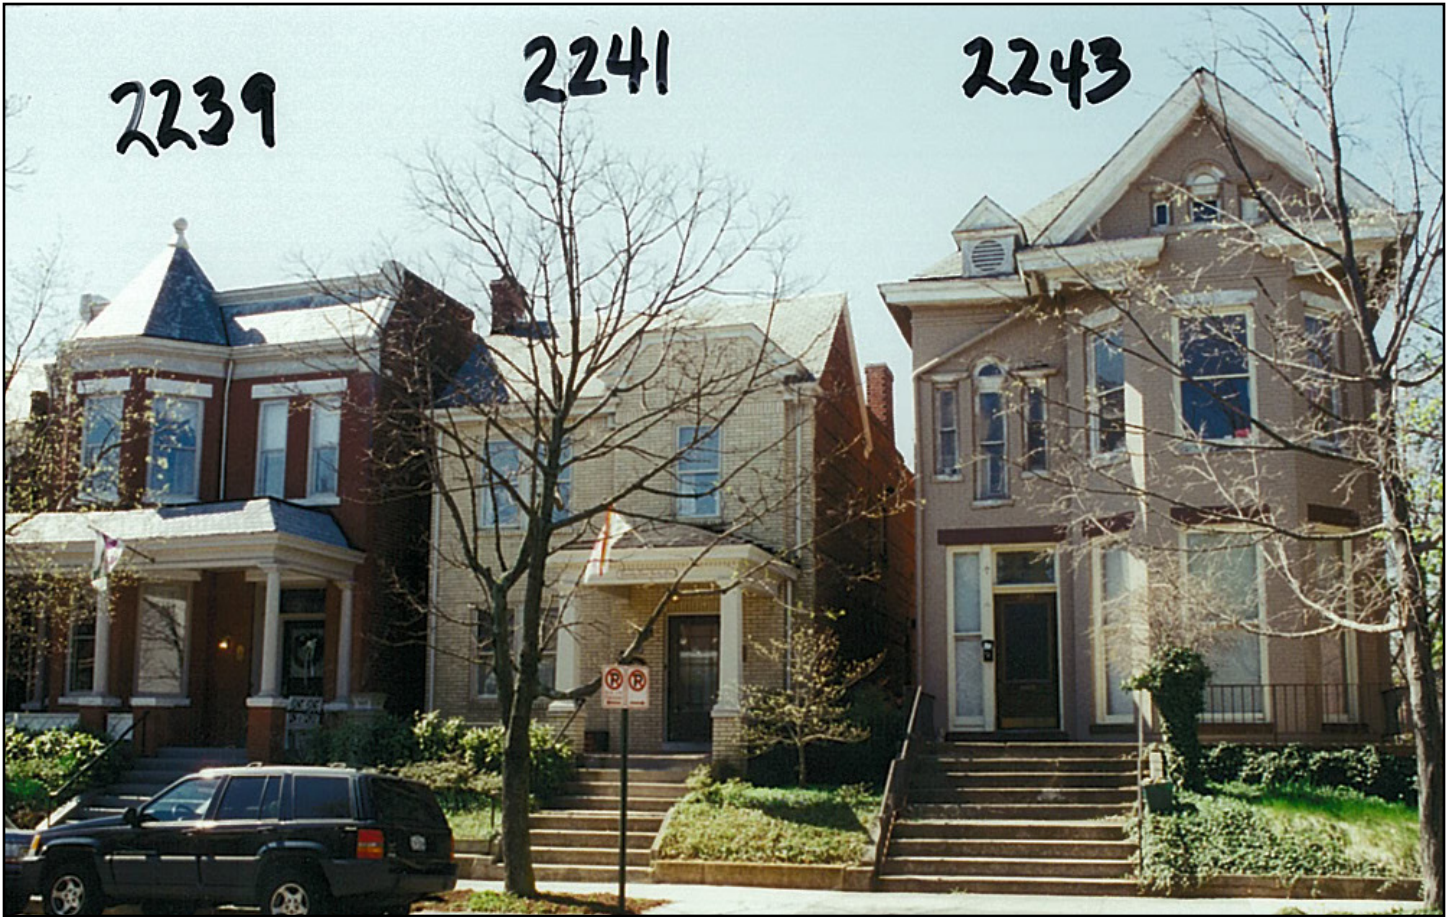
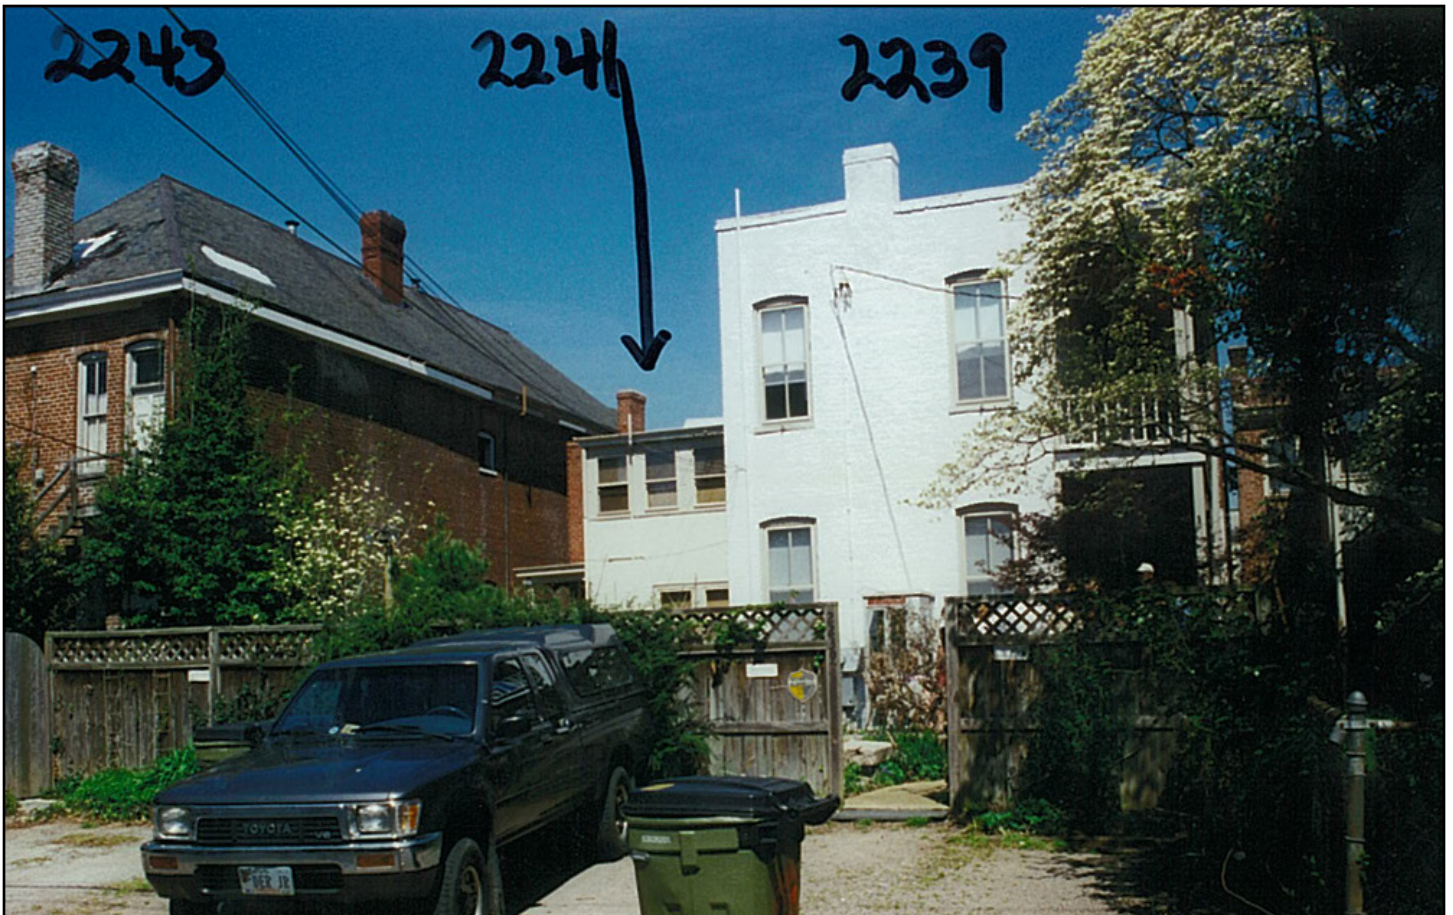
The applicant requests permission to replace all windows on the front, rear and sides of this structure within the West Grace Street Old & Historic District. The work was completed in 2008, and this application is the result of enforcement efforts. The applicant has indicated that there are a total of 32 windows on the structure, but has not provided details on how many are located on each façade. Due to adjacent structures, the windows on the side elevations are not visible from the public right-of-way. The replacement windows are six-over-one vinyl windows with grid-between-the-glass. While the applicant does not have any photos of the former windows, she has described them as being rotten beyond repair with missing hardware, broken glass, and in some cases they had been replaced entirely with plexiglass. Furthermore, the windows which were replaced may not have been original to the structure. Based on a photographic survey completed throughout the district at the time of its designation in 1996, the structure had one-over-one windows (photograph attached).

While there is no photographic evidence to support the replacement of the preexisting windows, the applicant has provided a description of the windows being in a condition beyond repair. The windows that were replaced may not

have been historic or original to the structure, and the work has been completed for at least six years. However, the installed grid-between-the-glass windows do not meet the requirements of the *Guidelines*. Therefore, staff recommends that the applicant replace the windows on the front of the structure with simulated divided light wood or aluminum clad windows.
