Byrd Park Main Pumping Station Upgrade

Project Narrative

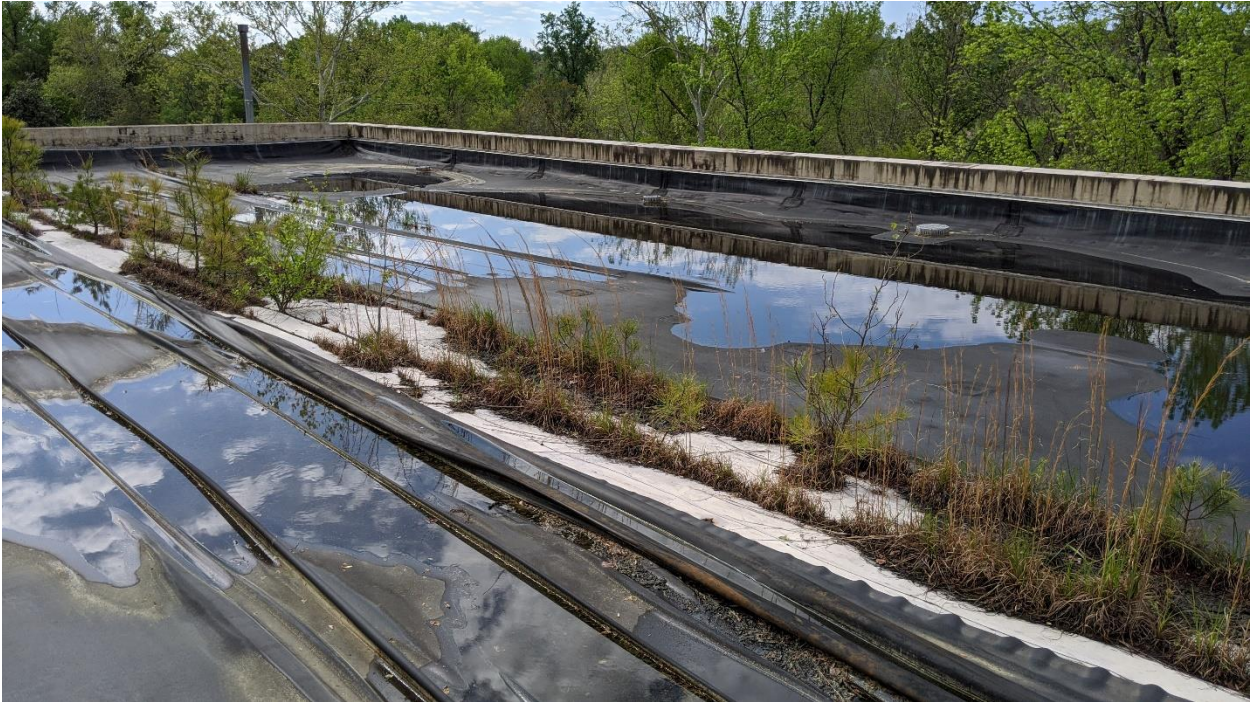
Current roof condition

The station roof is a low slope roof that is overdue for replacement. The roofing membrane is completely loose, and portions of the insulation underneath are exposed to the elements. Rainwater accumulation and vegetation are accumulating and growing on the roof compromising the integrity of the structure. Water leaks are present in the interior compromising the electrical equipment inside and posing a fire risk that can take the pump station out of service. The scope of work includes the immediate replacement of the roof.

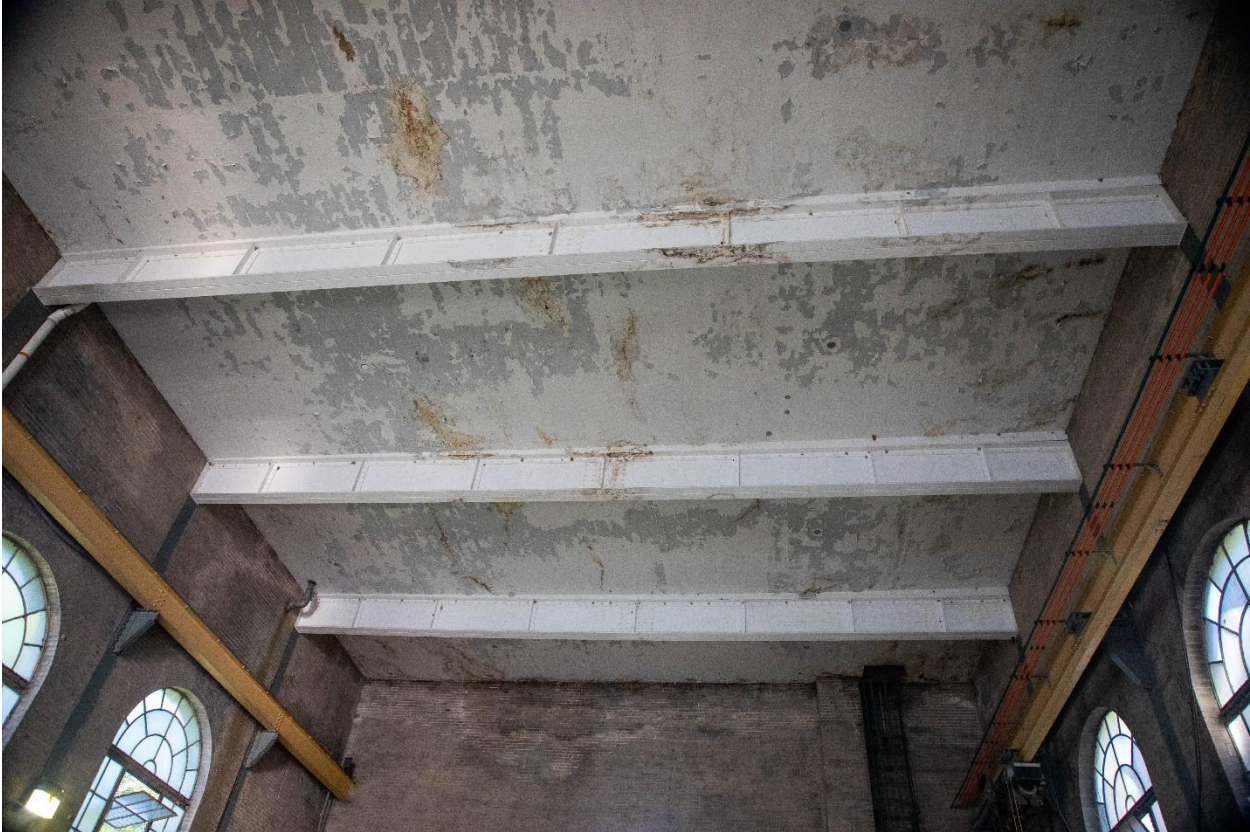
Water leaks through the roof structure.

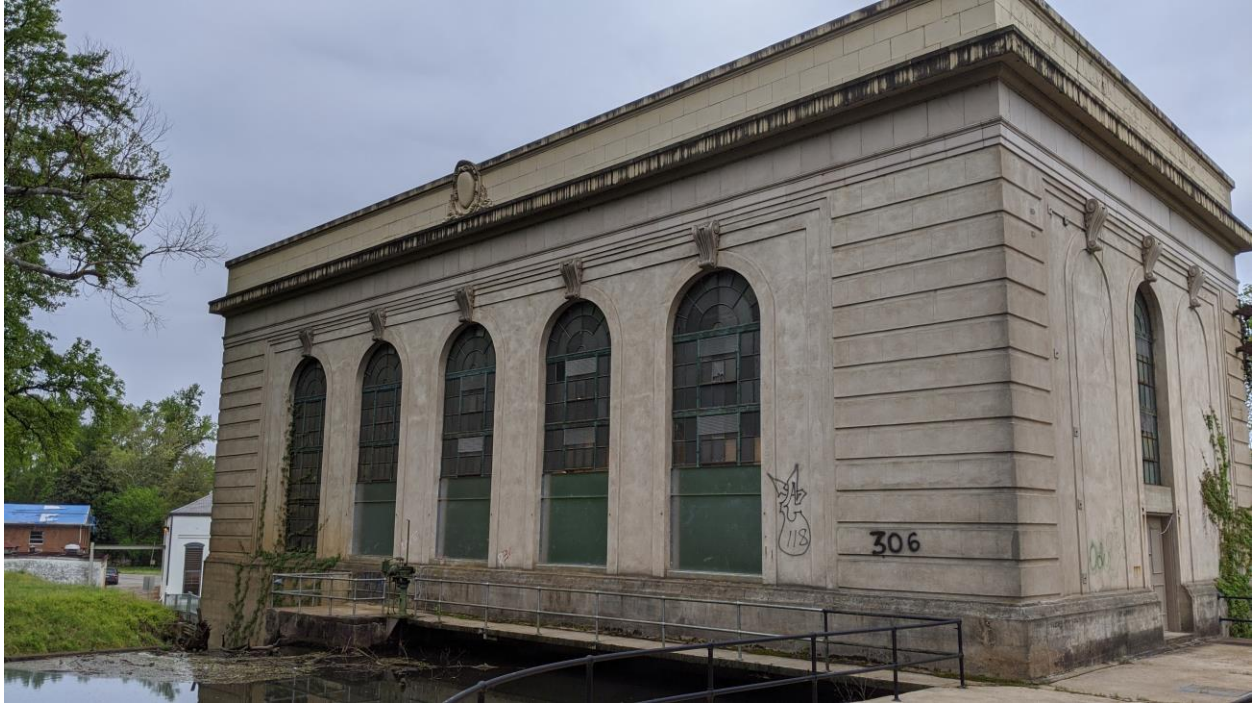
North façade existing condition

The building is in an acceptable condition except for the roof and windows. Currently the bottom portion of the windows are covered with metal panels on the exterior to prevent the entrance of critters and water into the building though broken glass panes. Glass panes on the bottom of the four north westerly windows on the north façade have been broken by vandals. Other windows have broken panes, but they are not the result of vandalism but the result of aging, freeze and thaw, accidental hits, etc.

The bottom portion third module of the windows on the north façade has been covered with a metal panel to prevent extended vandalism damage.

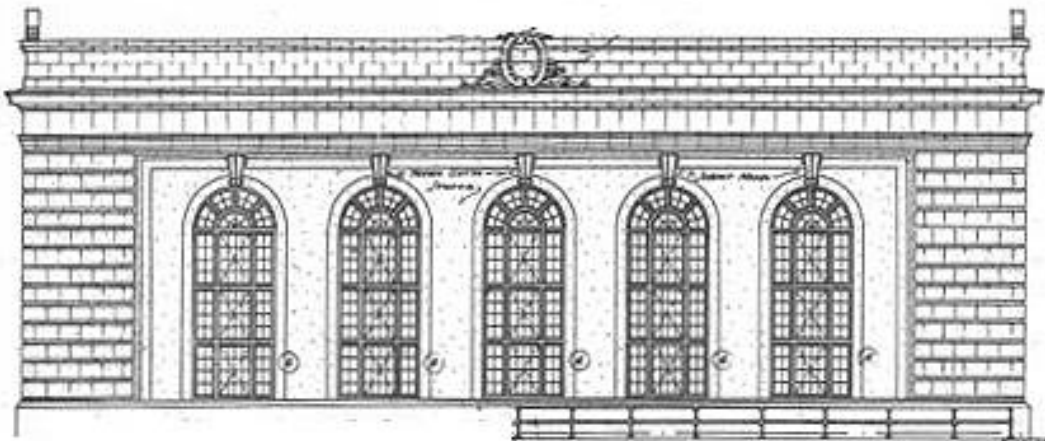
Original drawing of the North Facade

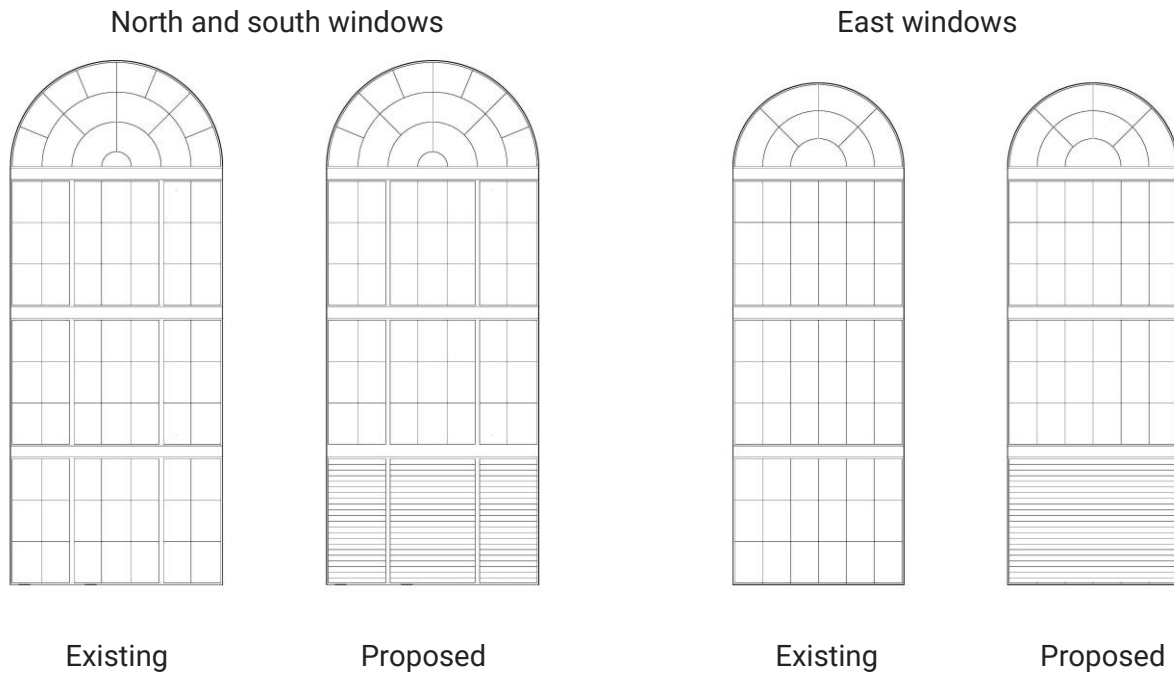
As a result of the improvements, six new louvers are needed to provide the required amount of air by the new air handling units to be installed on the building's roof.

For functional purposes the proposed louvers have to be located on the lower portion of the building to allow air to be captured low and exhausted high up on the roof. To maintain the aesthetics of the station and the integrity of the façade, as well as the ventilation functional needs, the louvers need to be located at the bottom of the windows. The louvers will be made of anodized aluminum painted in a dark color to match the main sight lines and the green color of the existing window frames.

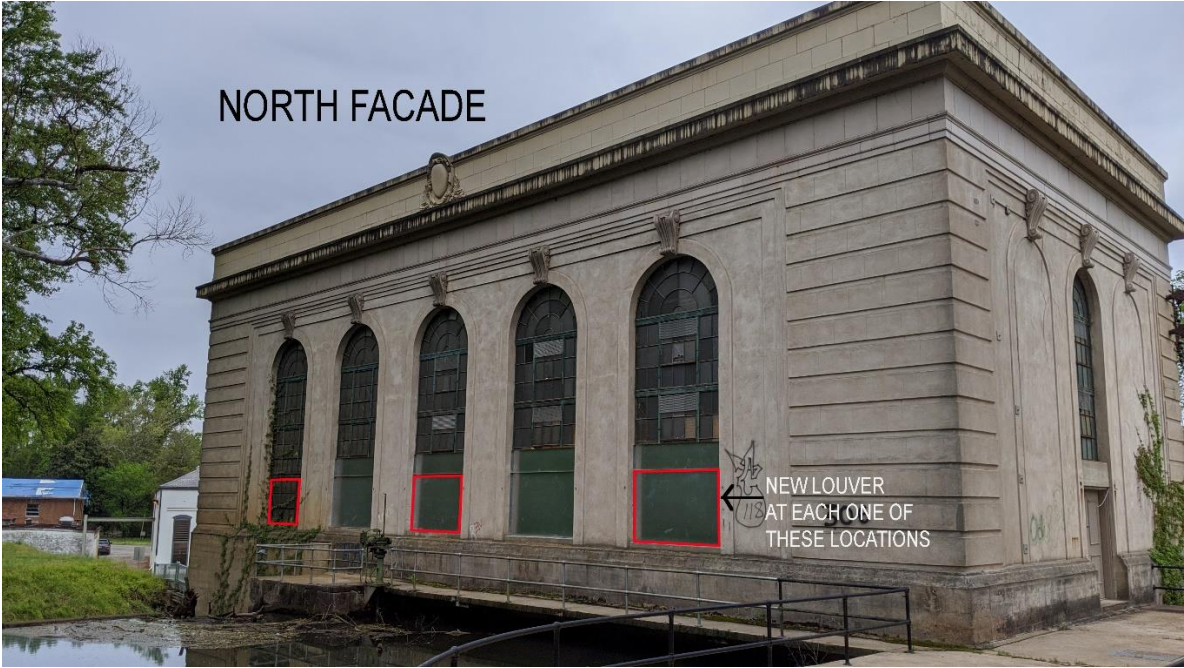
The North façade showing current blank off panels.

The North façade as it could look with the new louvers installed.

The drawings below show the original look of the facades and the proposed look after the new louvers are installed at the bottom window panel.

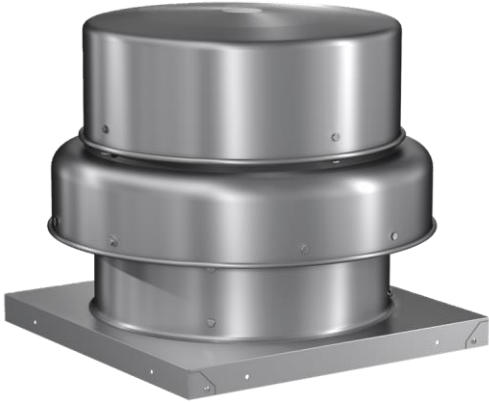
Conventional mushroom type fan

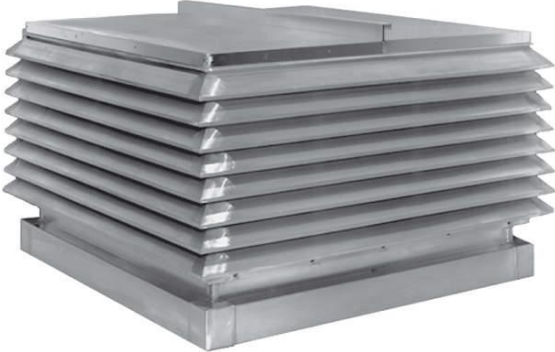
Proposed louvered type exhaust fan

The louvered enclosure will be aluminum made and painted in a color to match the exterior stucco tone of the building's façade.

To provide the required building ventilation, exhaust fans are required to be installed on the roof. This way fresh air will be drawn into the building through the louvers at the bottom of the windows and pulled up to the roof and out to the exterior by the exhaust fans located on the roof. Instead of installing conventional industrial type mushroom shaped exhaust fans, two new

louvered centrifugal fans will be located on roof to mitigate the visual impact they may have when seen from far away on the building façade.

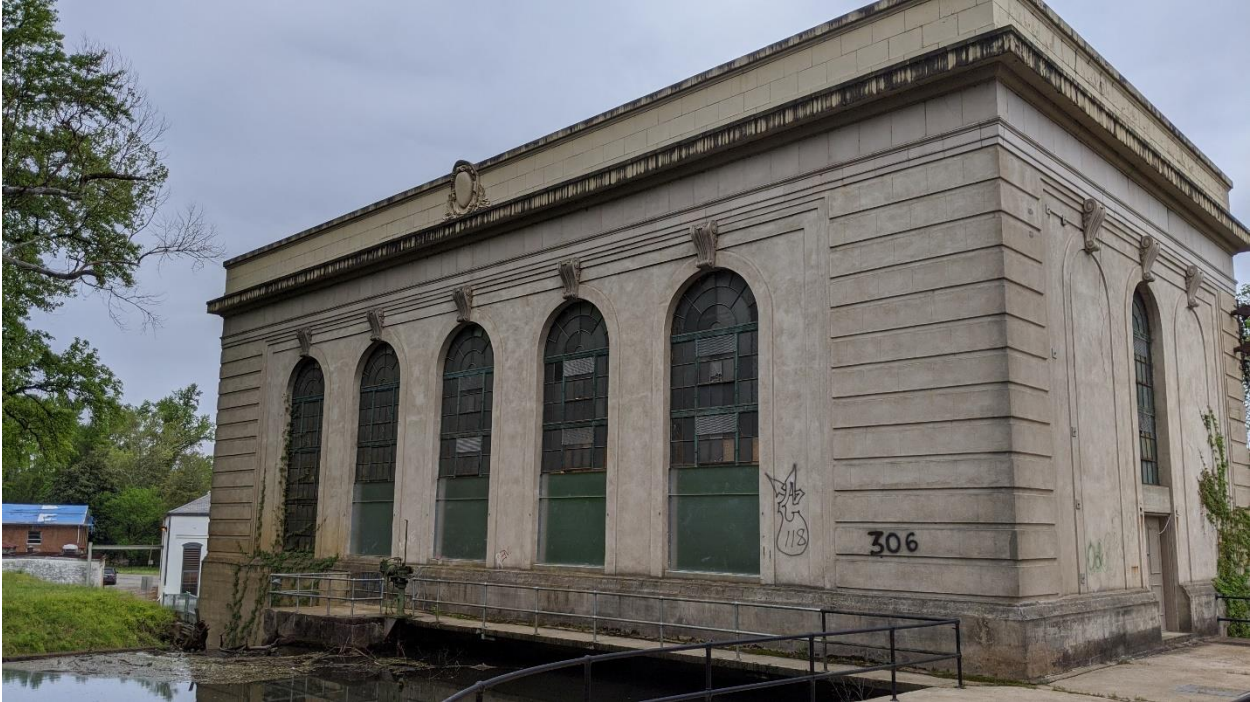
North façade showing the existing blank off panels at the bottom of the windows.
