**COMMISSION OF ARCHITECTURAL REVIEW  
STAFF REPORT  
September 23, 2014 Meeting**

13. **CAR No. 14-105** (S. Hodges)

**2241 W. Grace Street  
West Grace Street Old & Historic District**

**Replace windows**

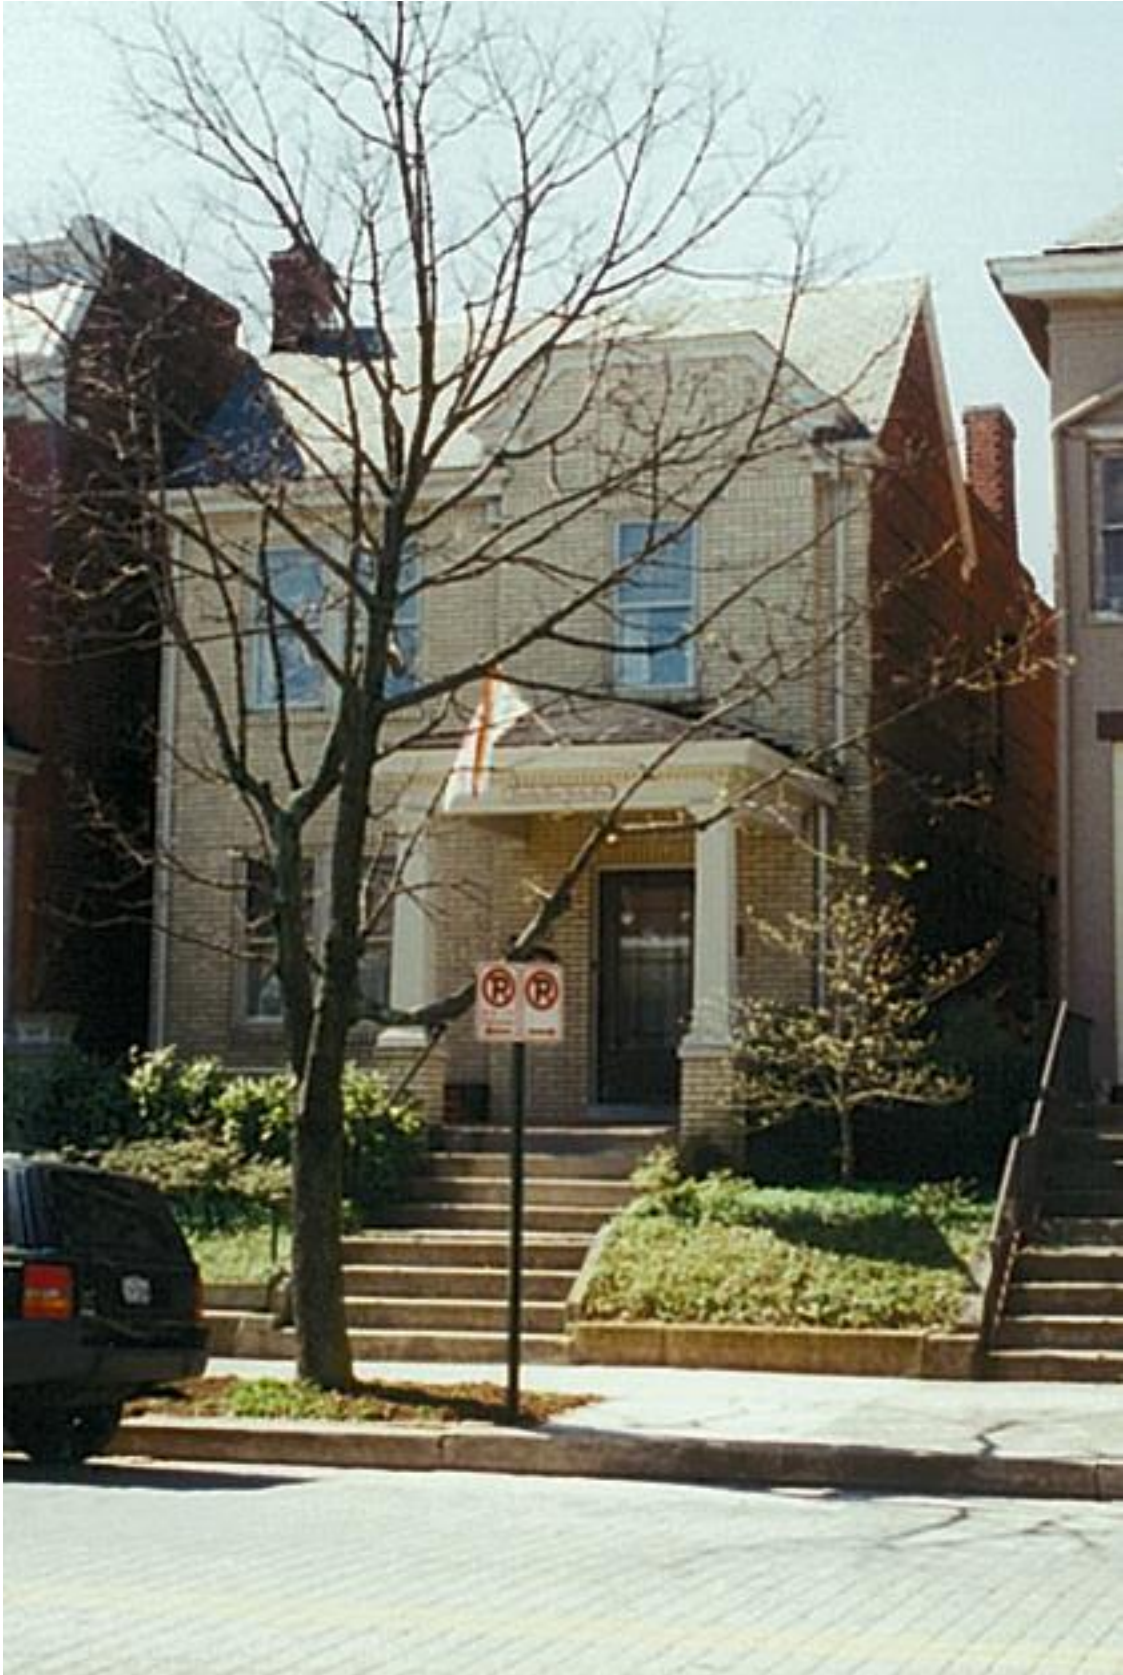
Photograph of 2241 W. Grace Street from 1996 Photographic Survey.

The applicant has not provided, and staff was unable to find any historic photographic evidence for the existence of six-over-one windows at this property. Based on a photographic survey completed throughout the district at the time of its designation in 1996, the structure had one-over-one windows (photograph attached). However, it is unclear whether these were original to the structure or not. As the house appears to be standalone construction, not designed and built in a row with similar designs, it is not possible to divine historic elements from adjacent properties. Many houses on this block of West Grace Street have one-over-one windows at the front elevation, and this would be a fairly common grid pattern found throughout the district historically.
