**COMMISSION OF ARCHITECTURAL REVIEW
STAFF REPORT
March 27, 2018, Meeting**

7. **COA-031853-2018** (C. Romero)

**818 North 25th Street
Union Hill Old and Historic District**

Project Description: **Install front porch railings and wooden picket fence.**

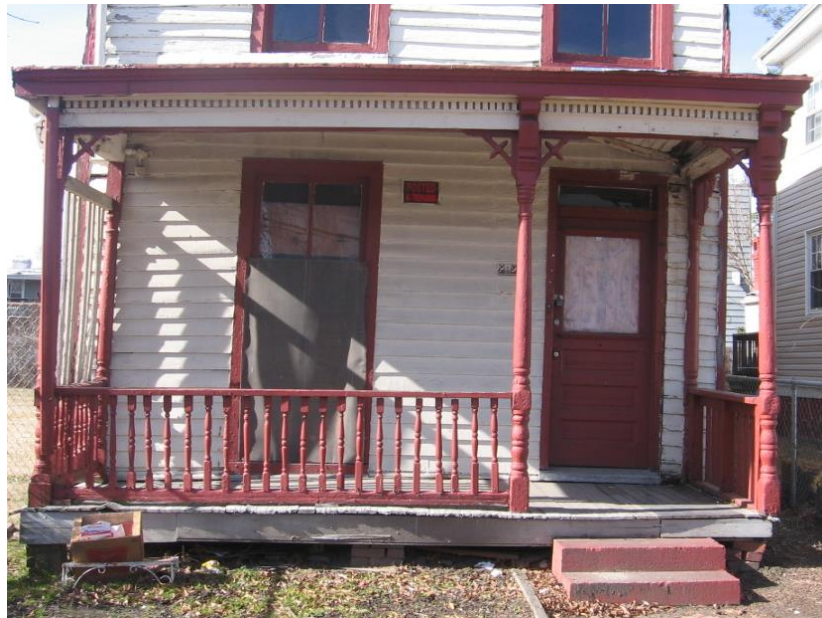
818 North 25th Street Railing (February 2015)

Porch: *The Richmond Old and Historic District Handbook and Design Review Guidelines* state available documentation including pictorial, historical or physical documentation should be used when reconstructing missing elements (pg. 59, #7). Prior to the rehabilitation of the structure in 2015/2016, the structure had a railing with a turned balustrade though it appears that some pickets had been replaced over time. Staff recommends approval of the addition of a railing to the front porch with the condition that the railing be a turned balustrade to match the pictorial evidence of the railing that was present on the property rather than the proposed Richmond rail.
